# Project: Restoration of the St. Joseph Lights and Catwalk

Project Completed: 2016

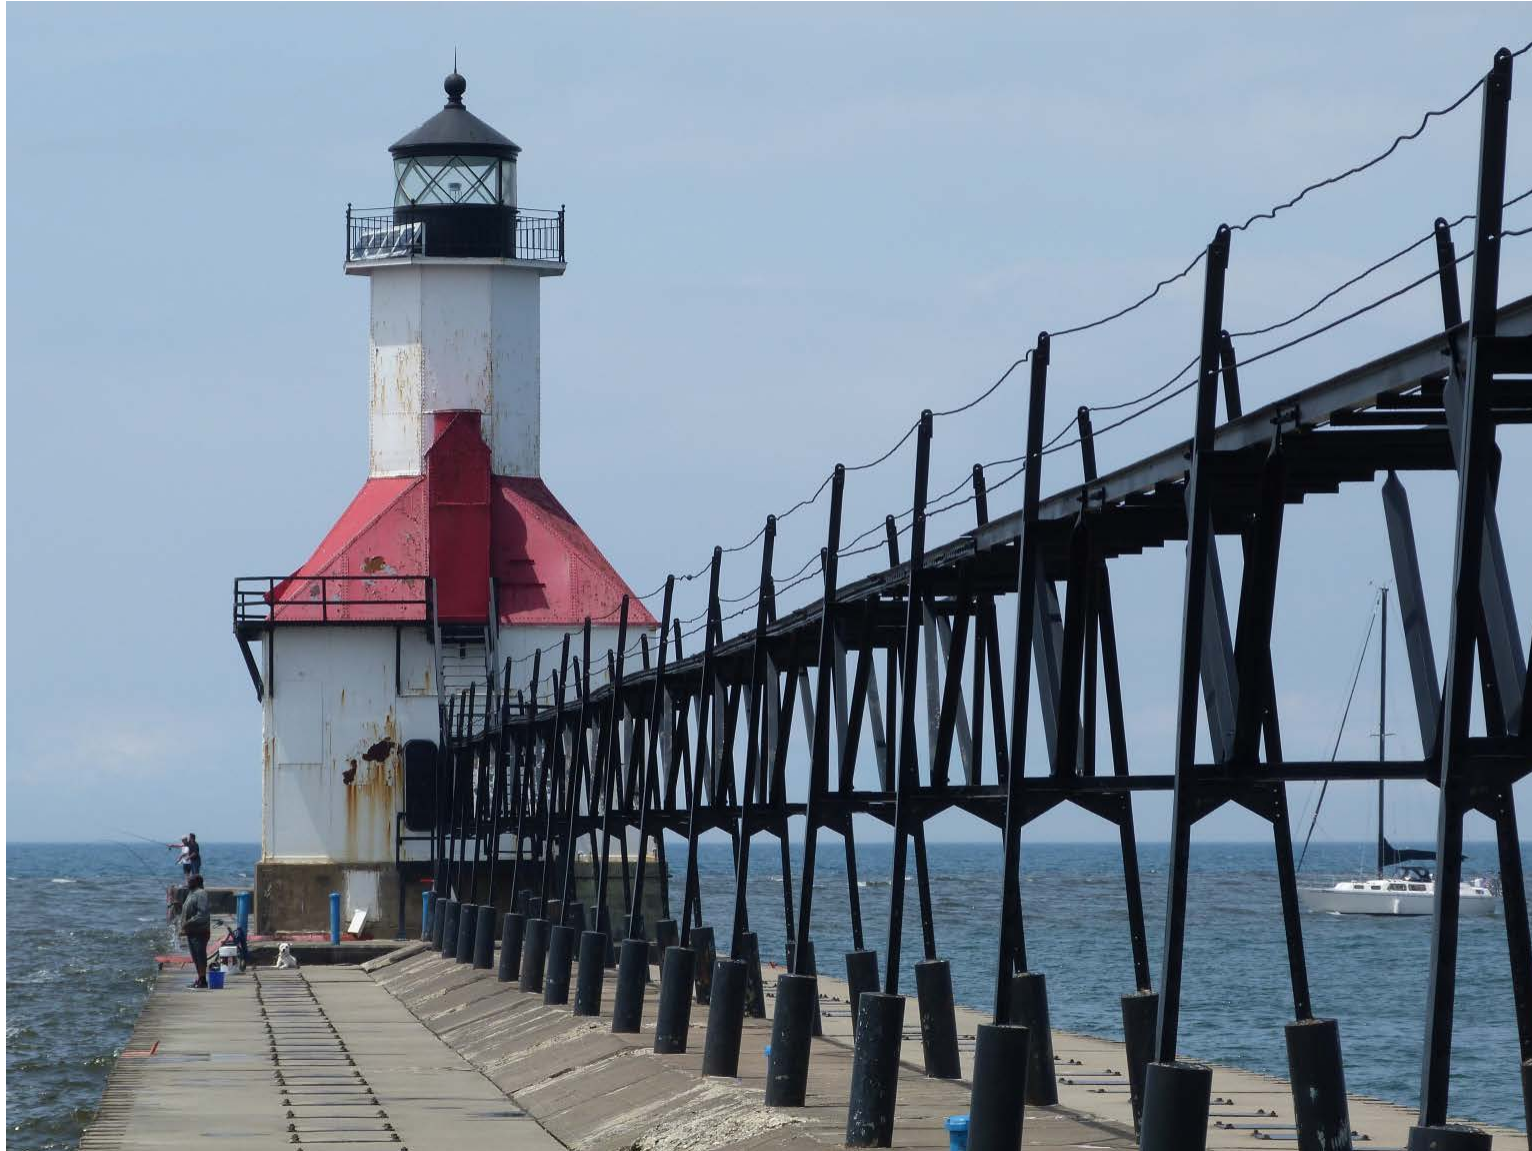
Lighthouse and Catwalks Before Project

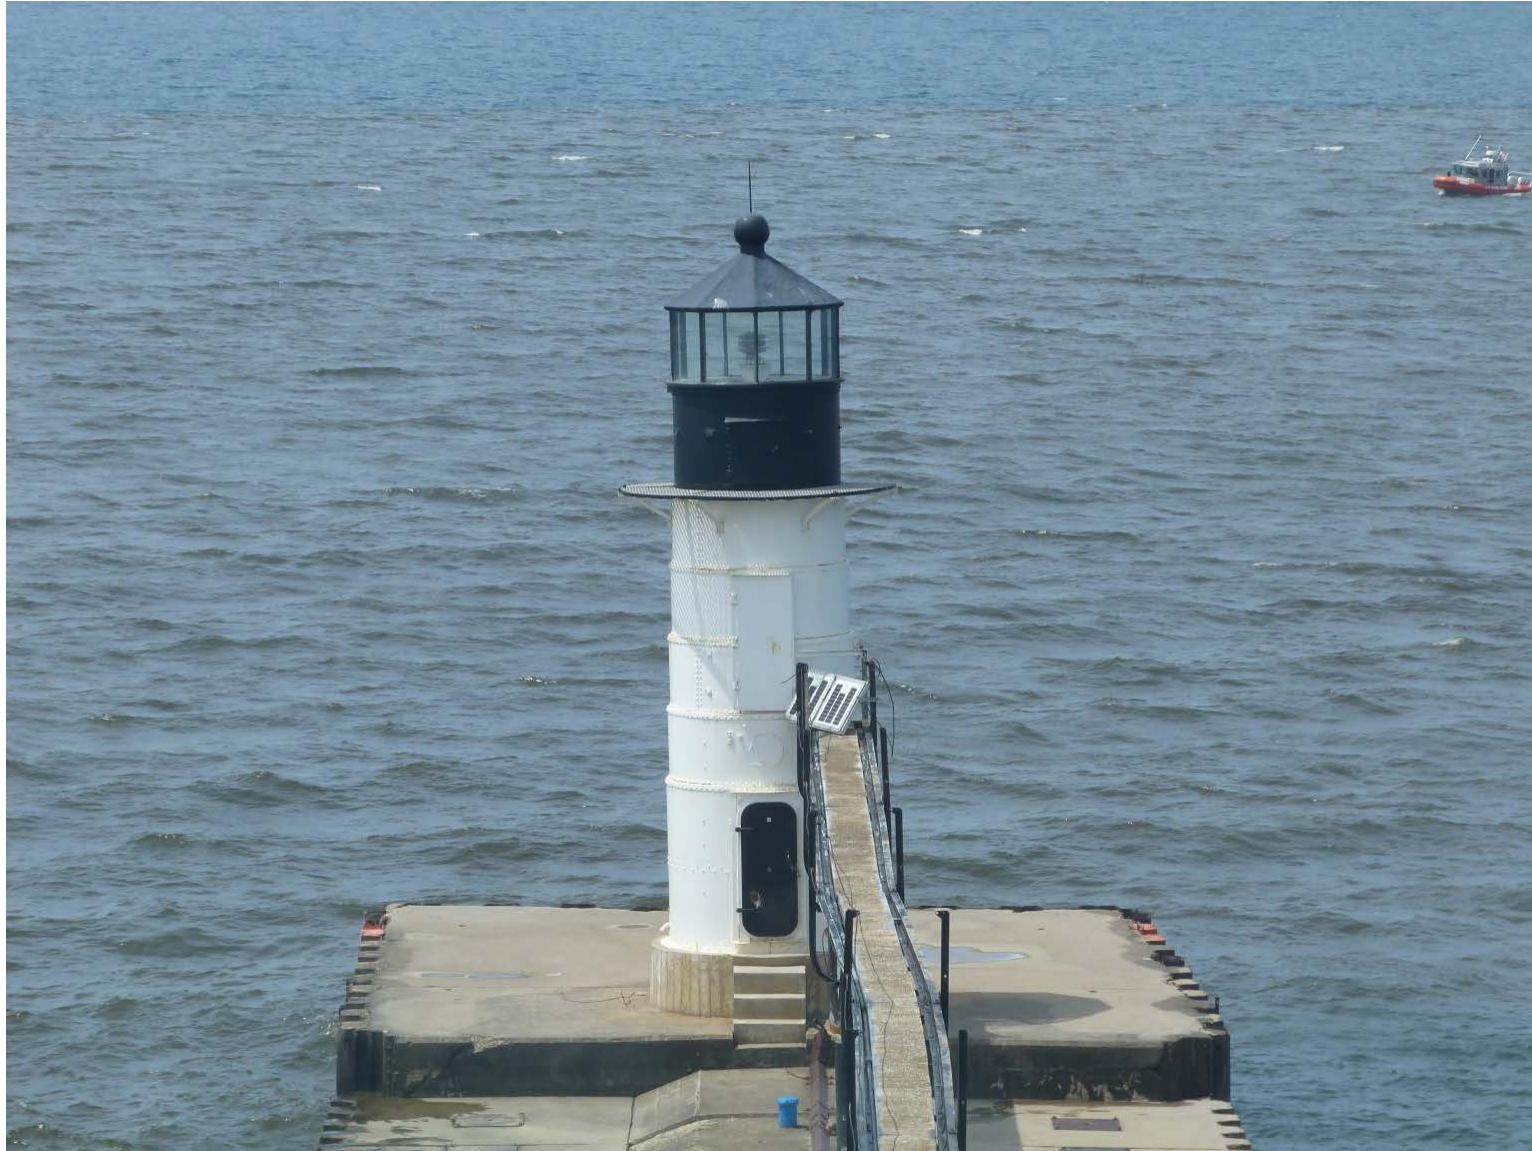
Lighthouse and Catwalks Before Project

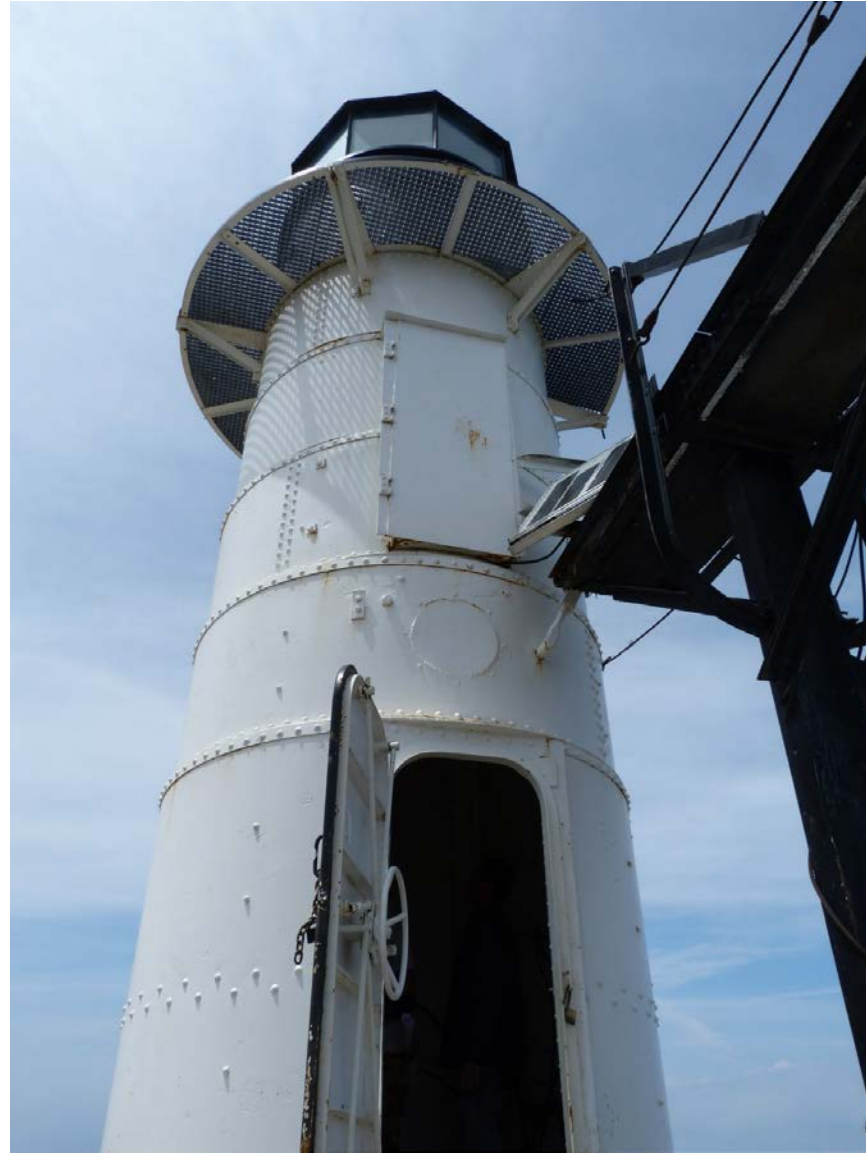
Lighthouse and Catwalks Before Project

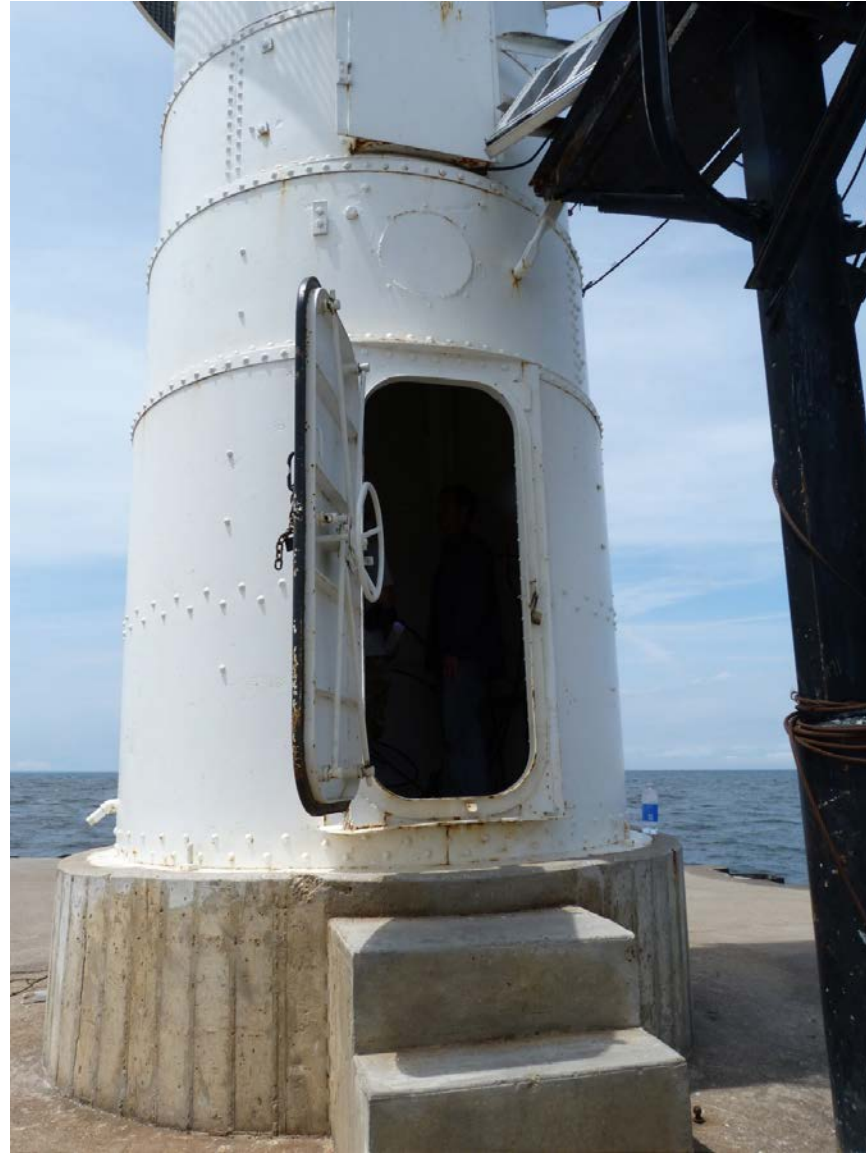
Lighthouse and Catwalks Before Project

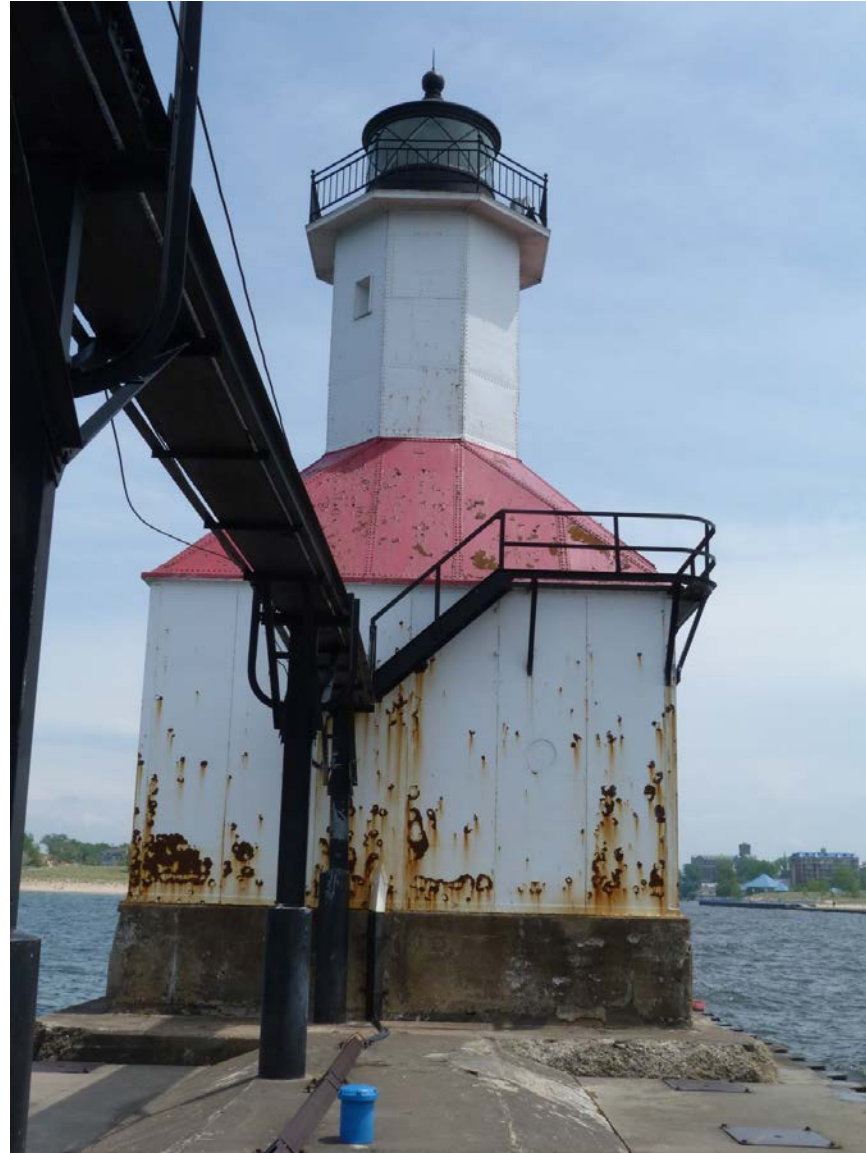
Lighthouse and Catwalks Before Project

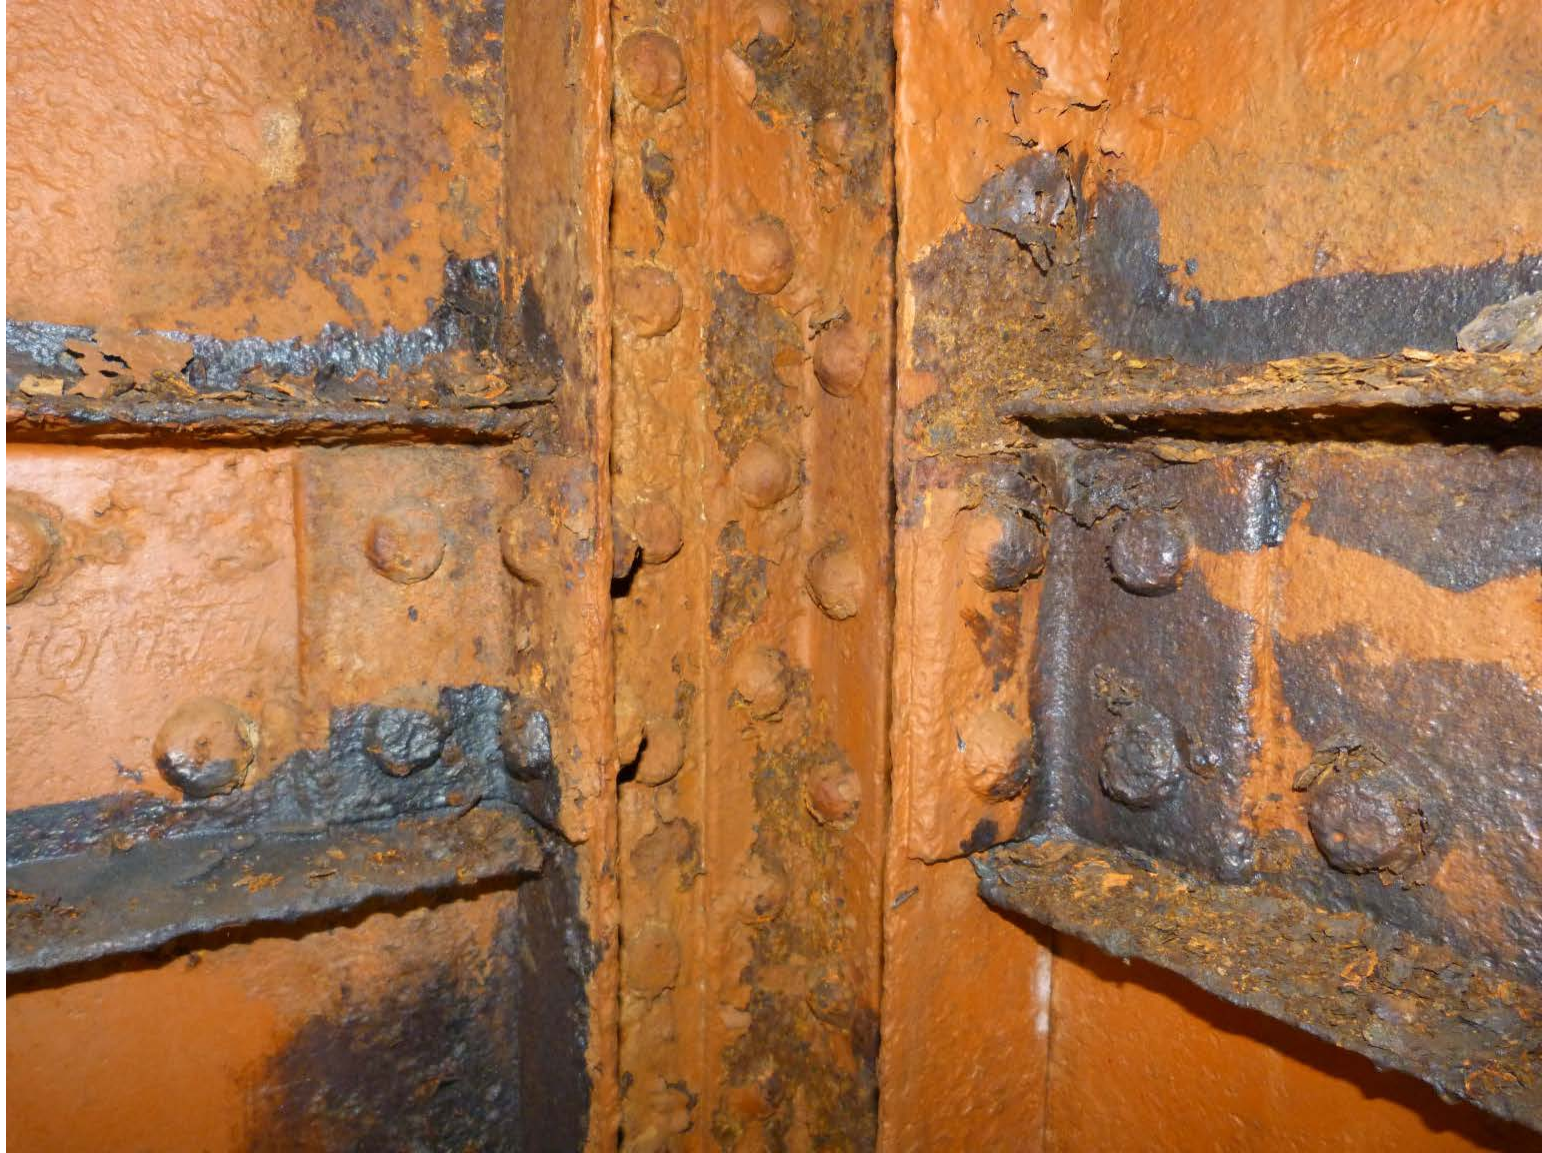
Lighthouse and Catwalks Before Project

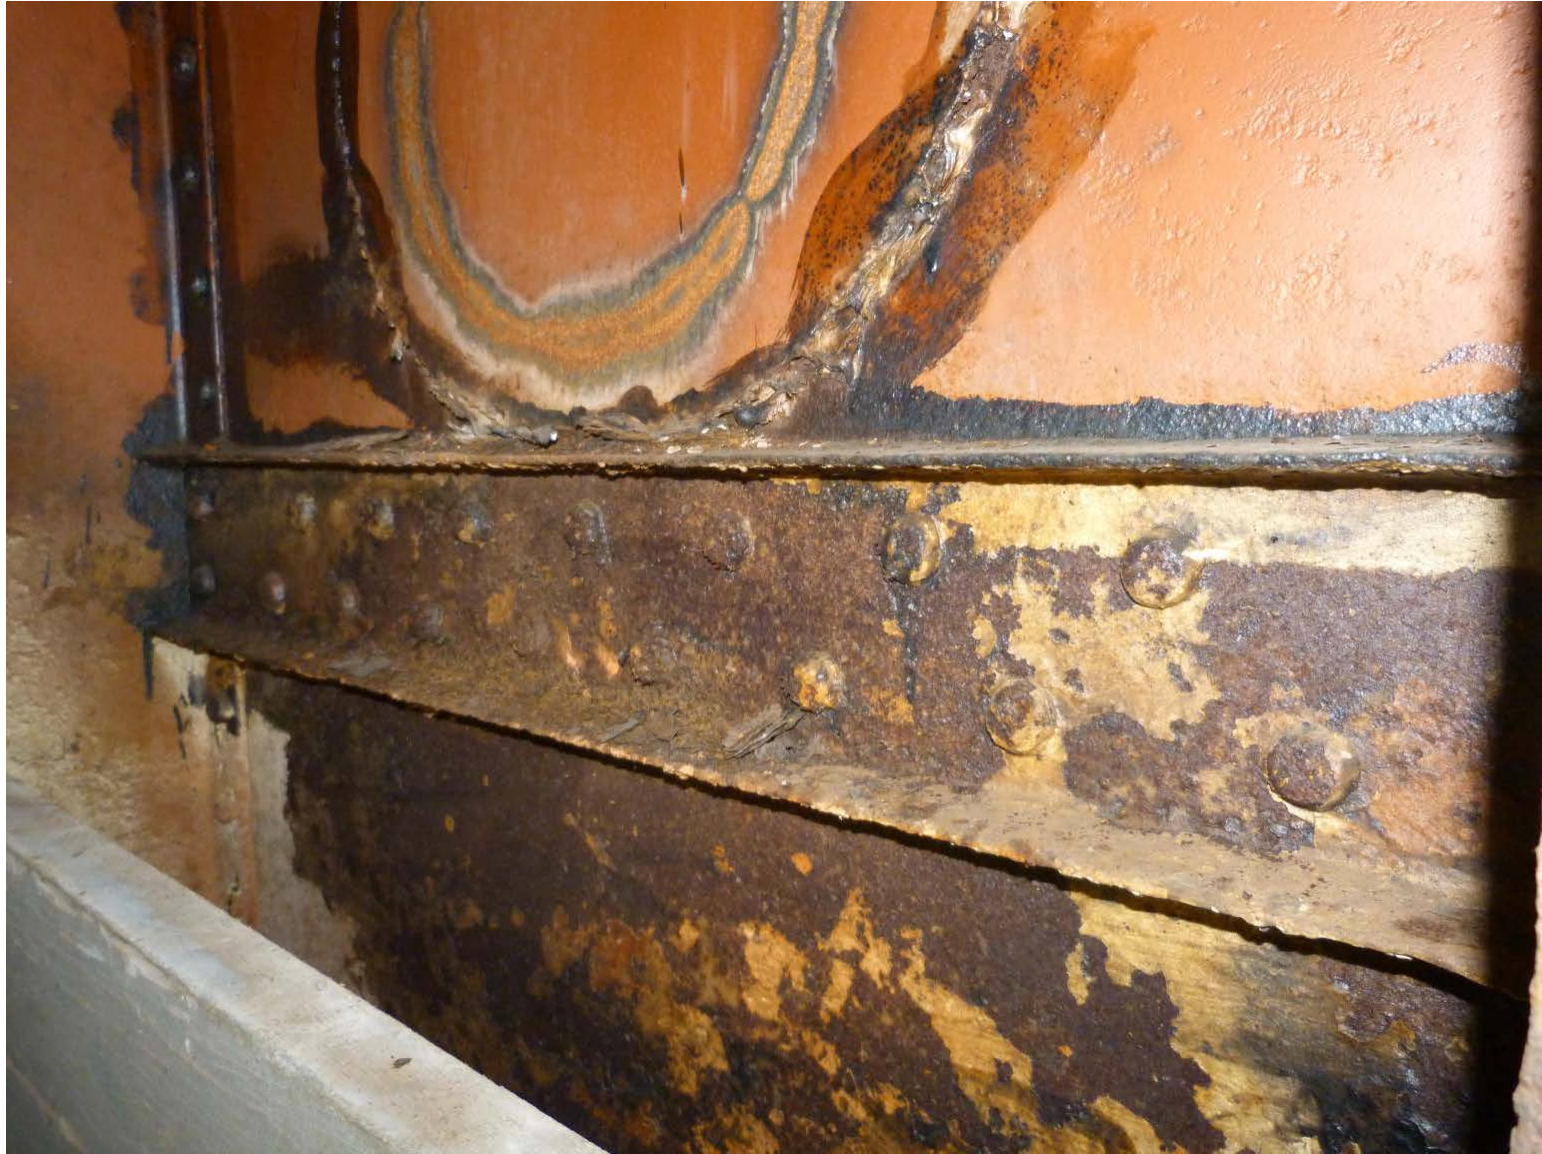
Lighthouse and Catwalks Before Project

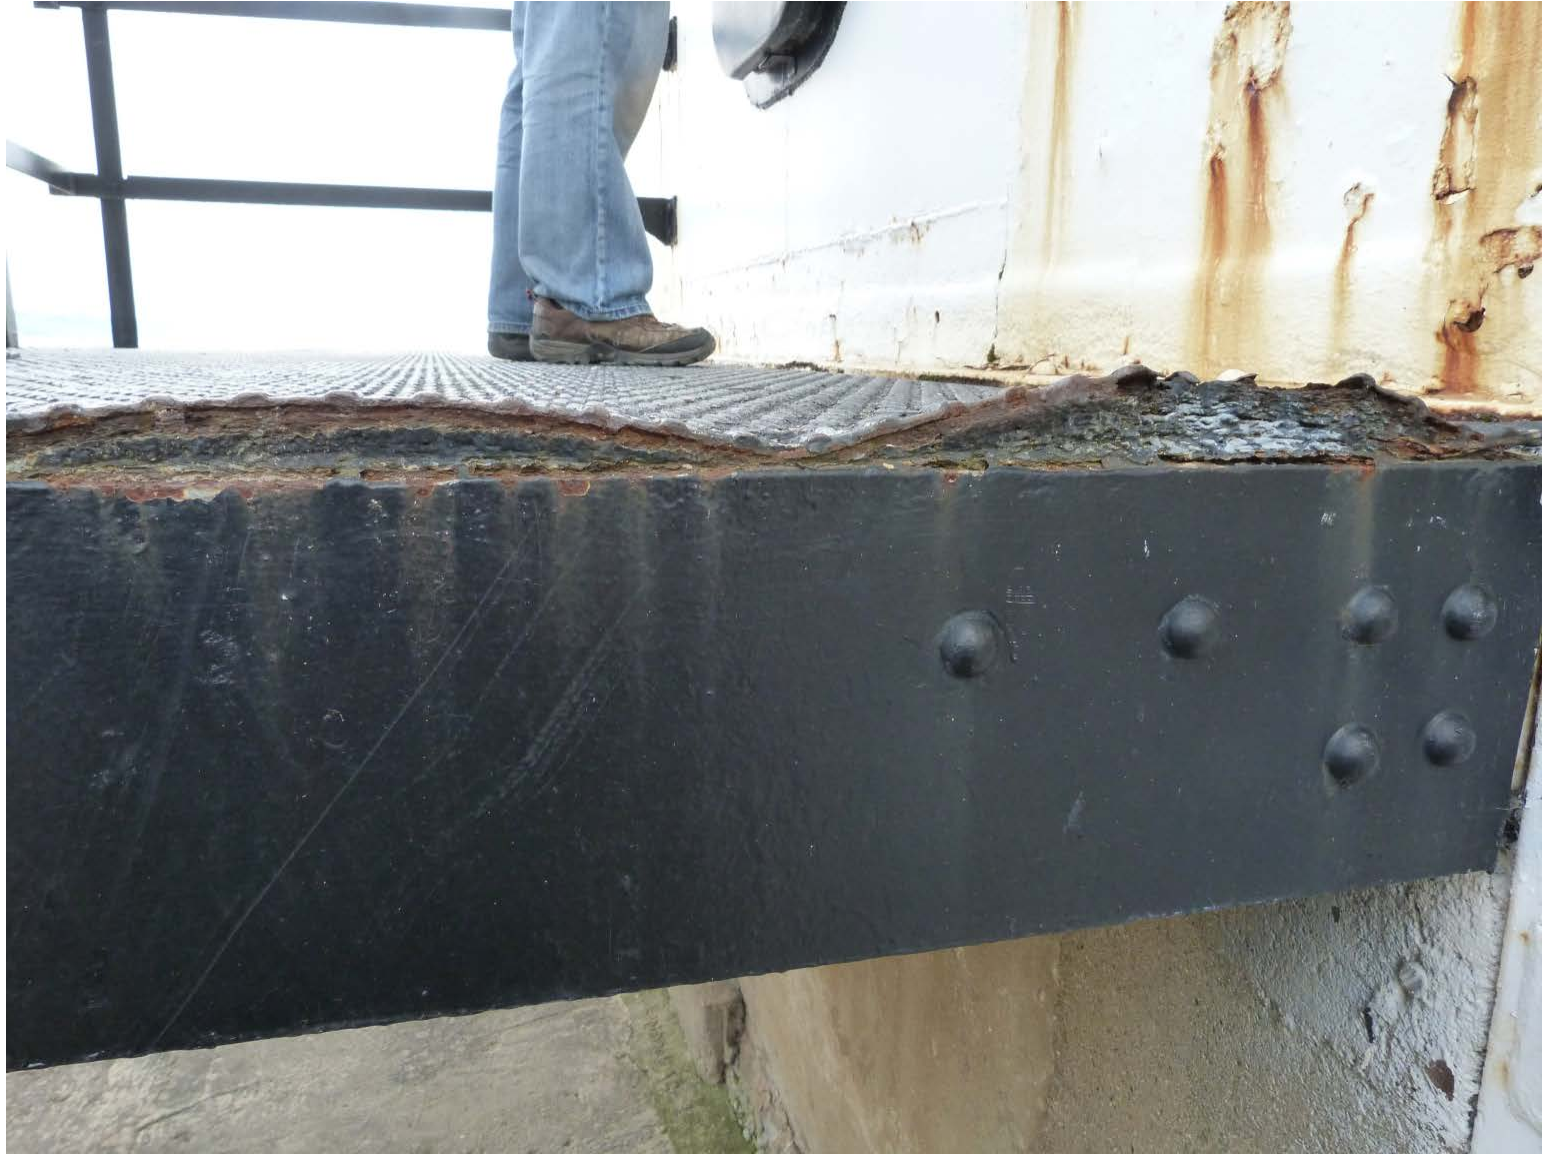
Lighthouse and Catwalks Before Project

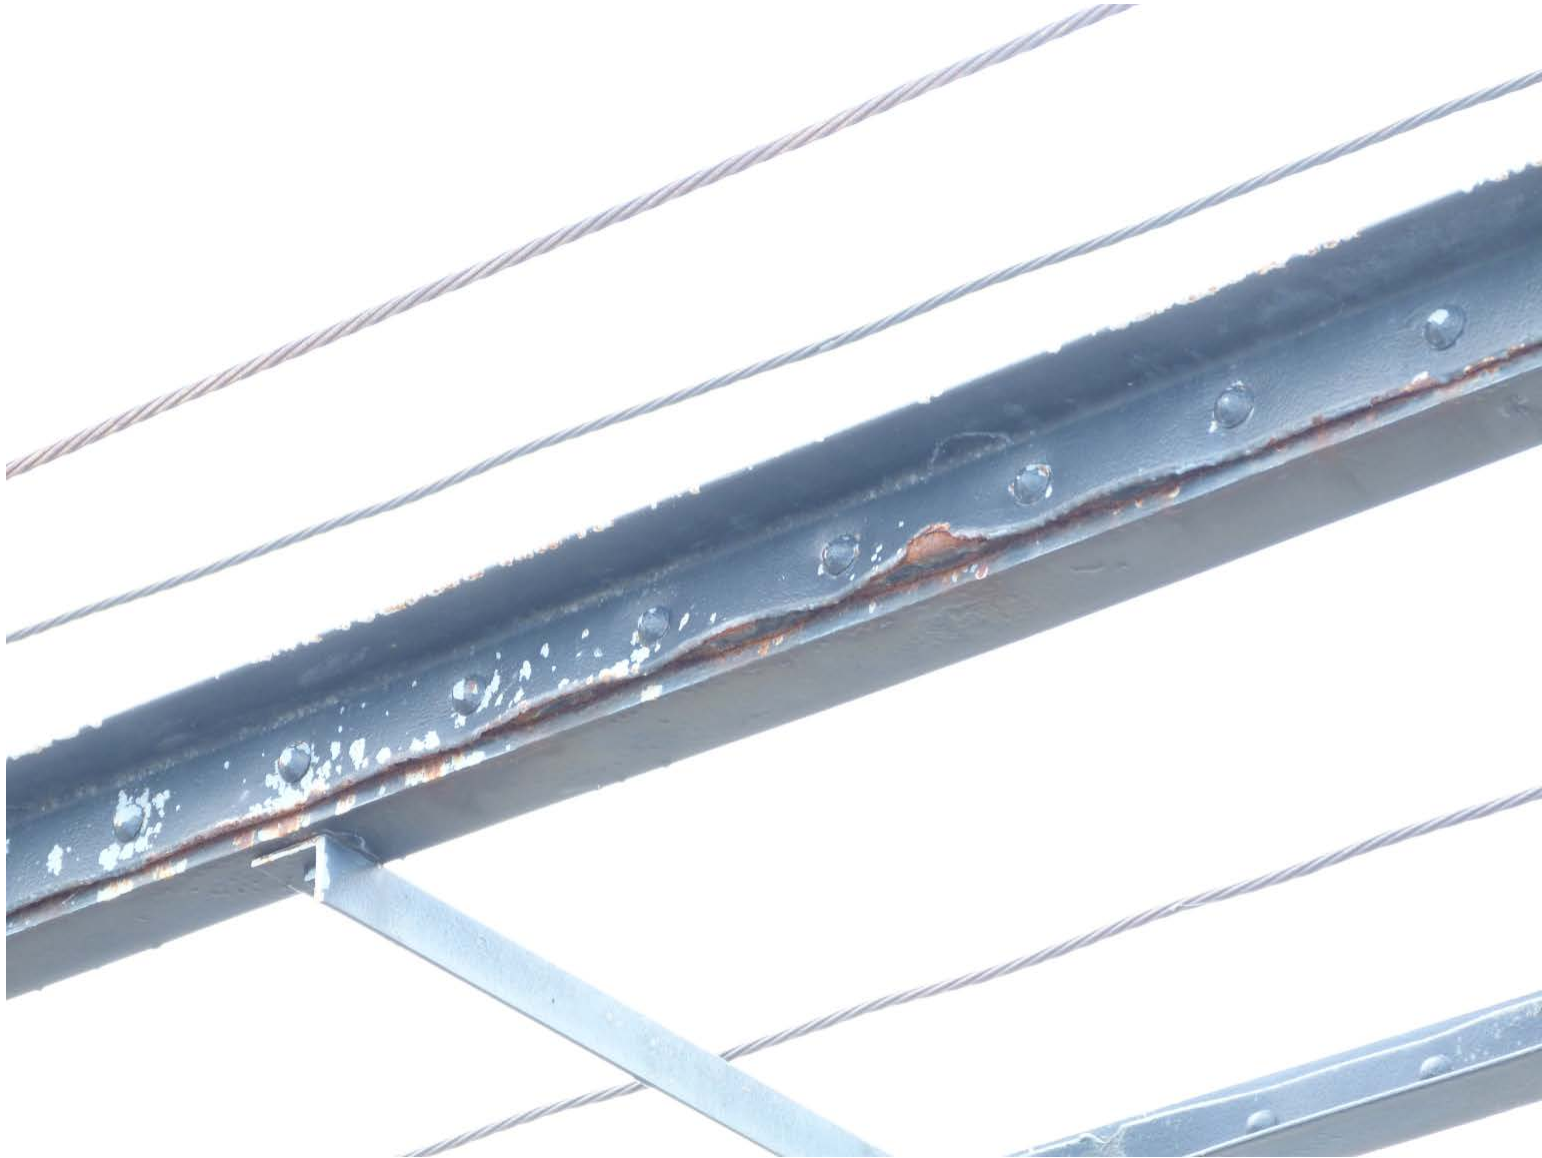
Lighthouse and Catwalks Before Project

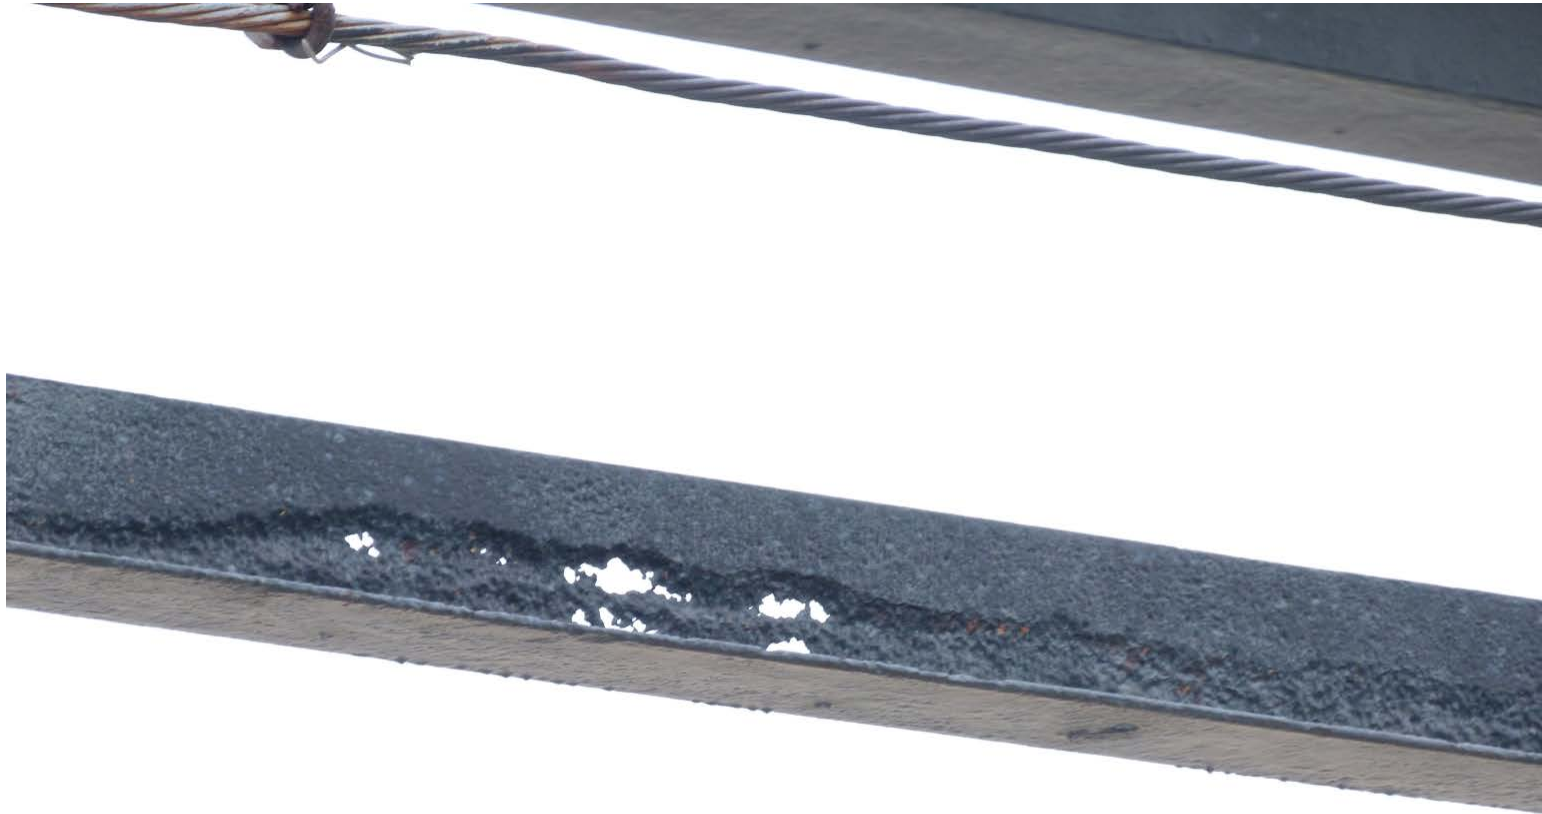
Lighthouse and Catwalks Before Project

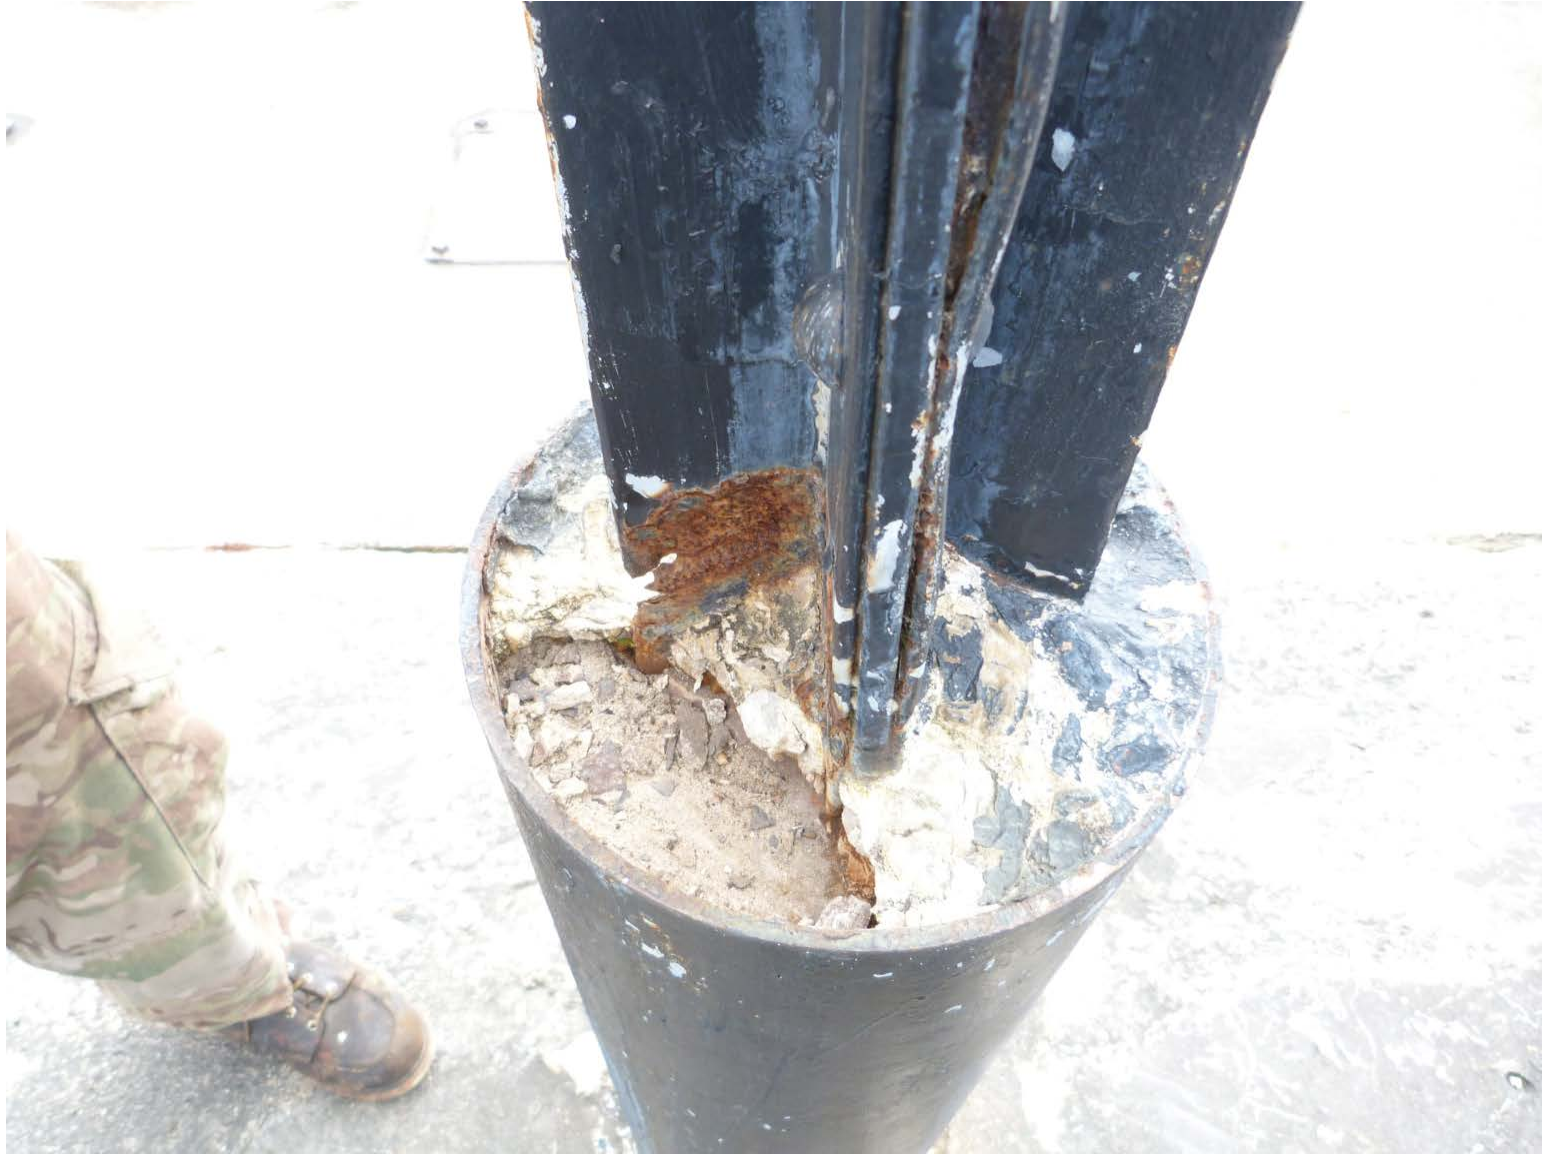
Deteriorated leg prior to work.

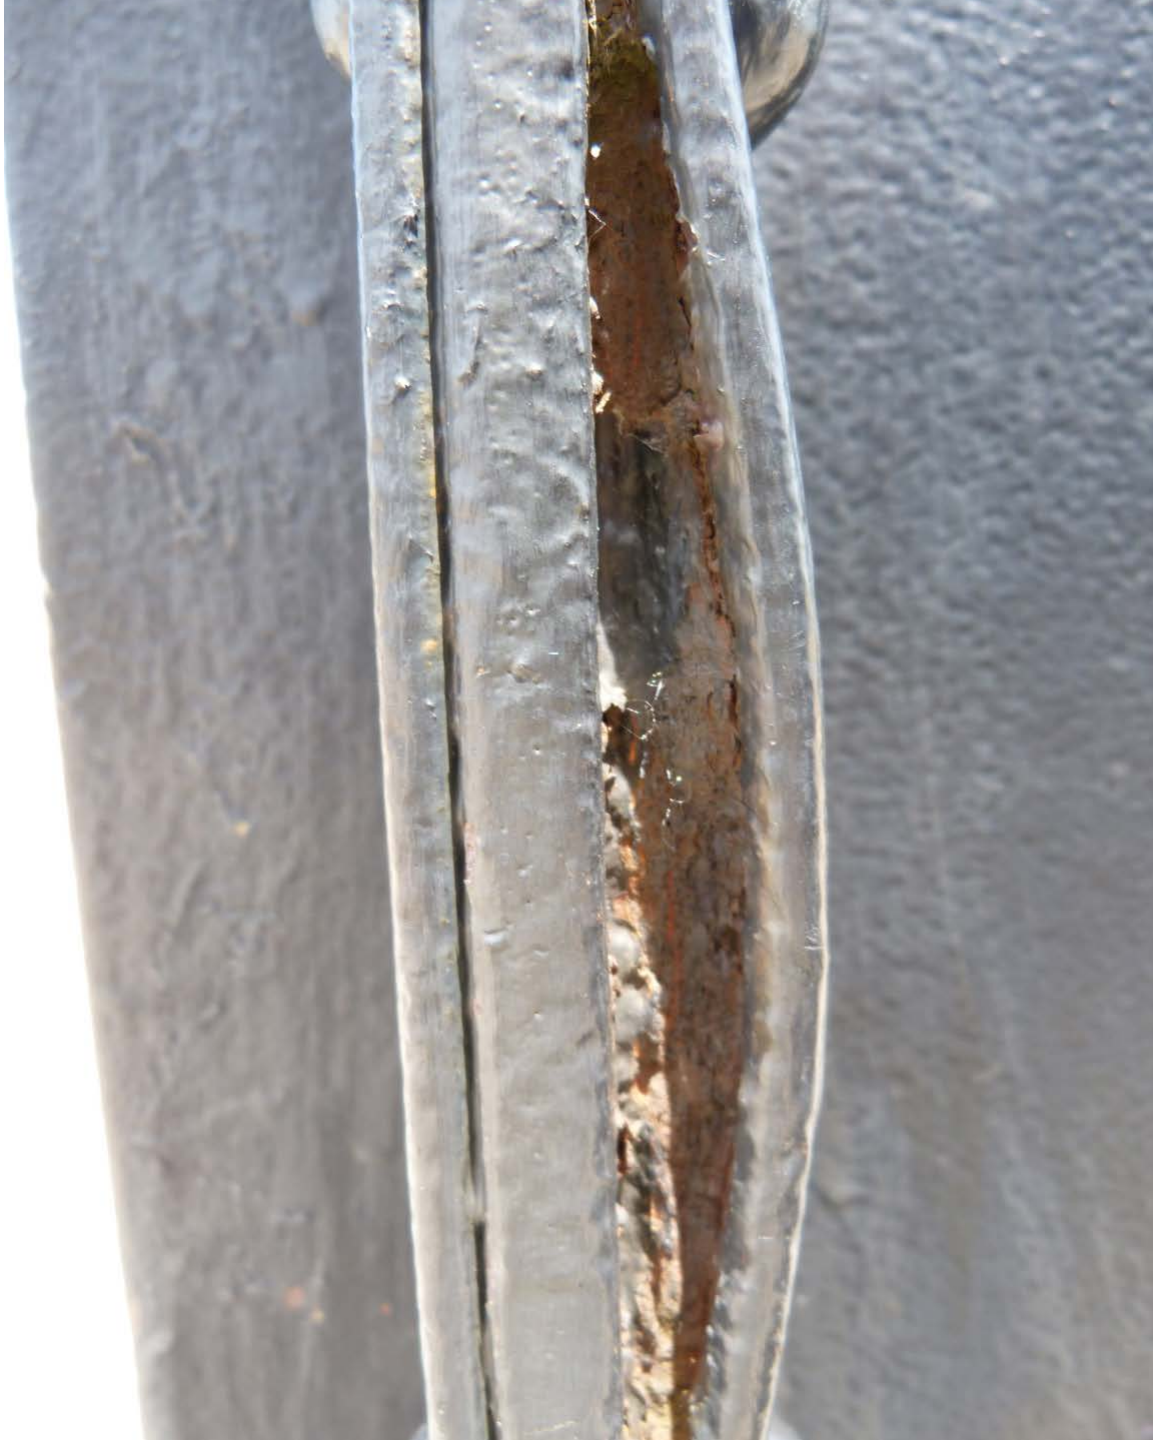
Extent of pack rust  
prior to work on  
catwalk legs.

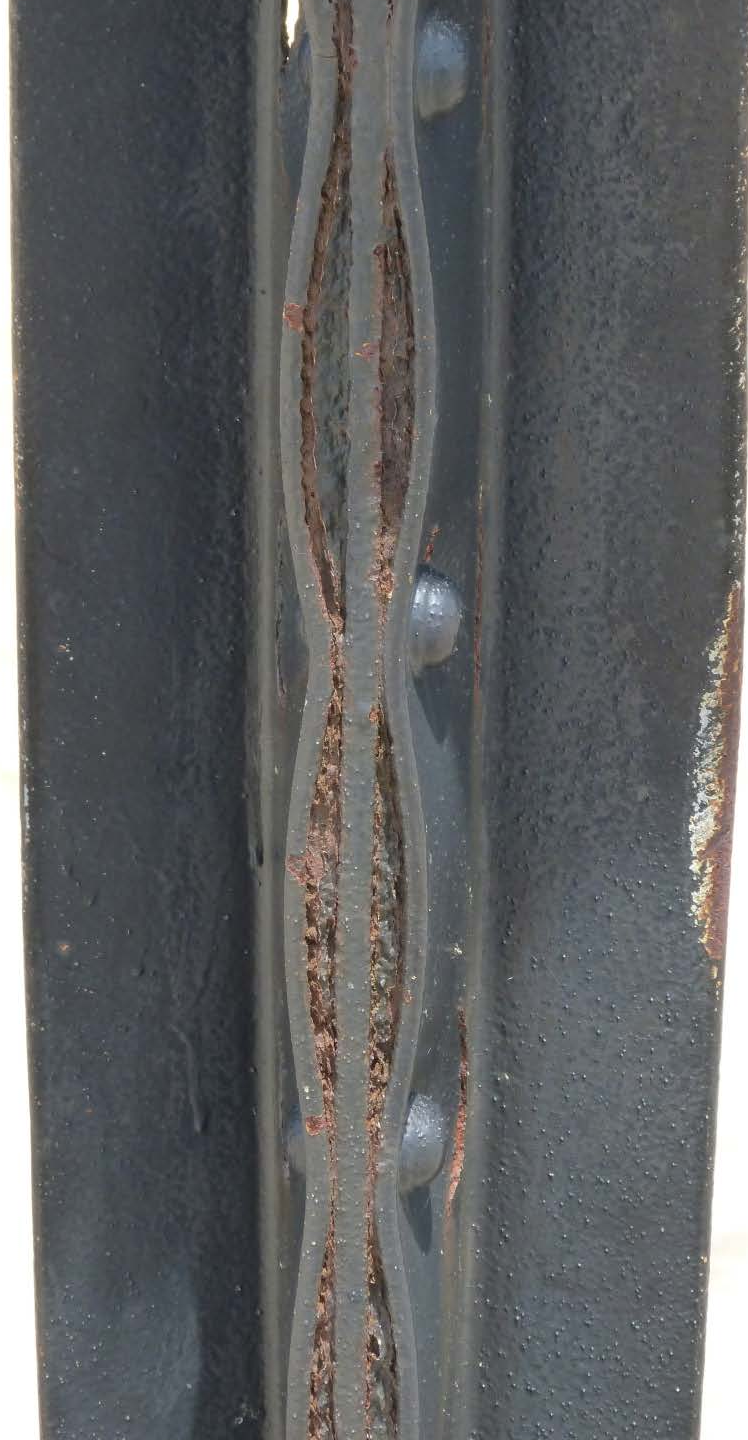
Extent of pack rust prior to  
work on catwalk legs.

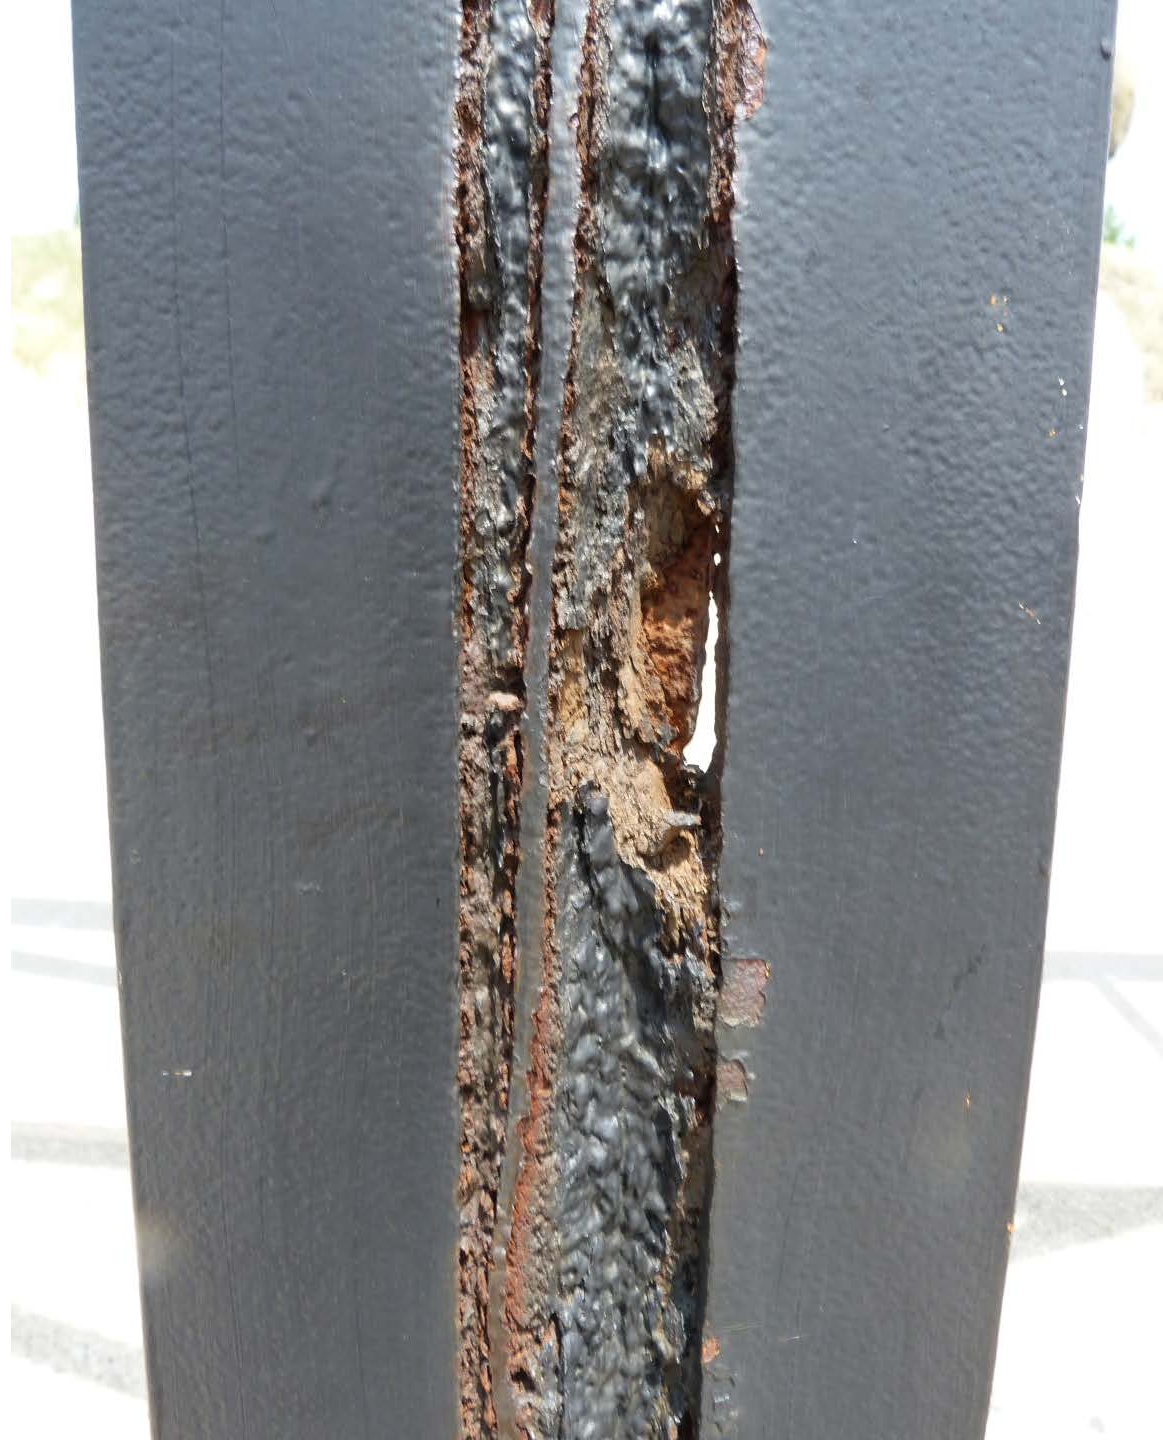
Extent of pack rust  
prior to work on  
catwalk legs.

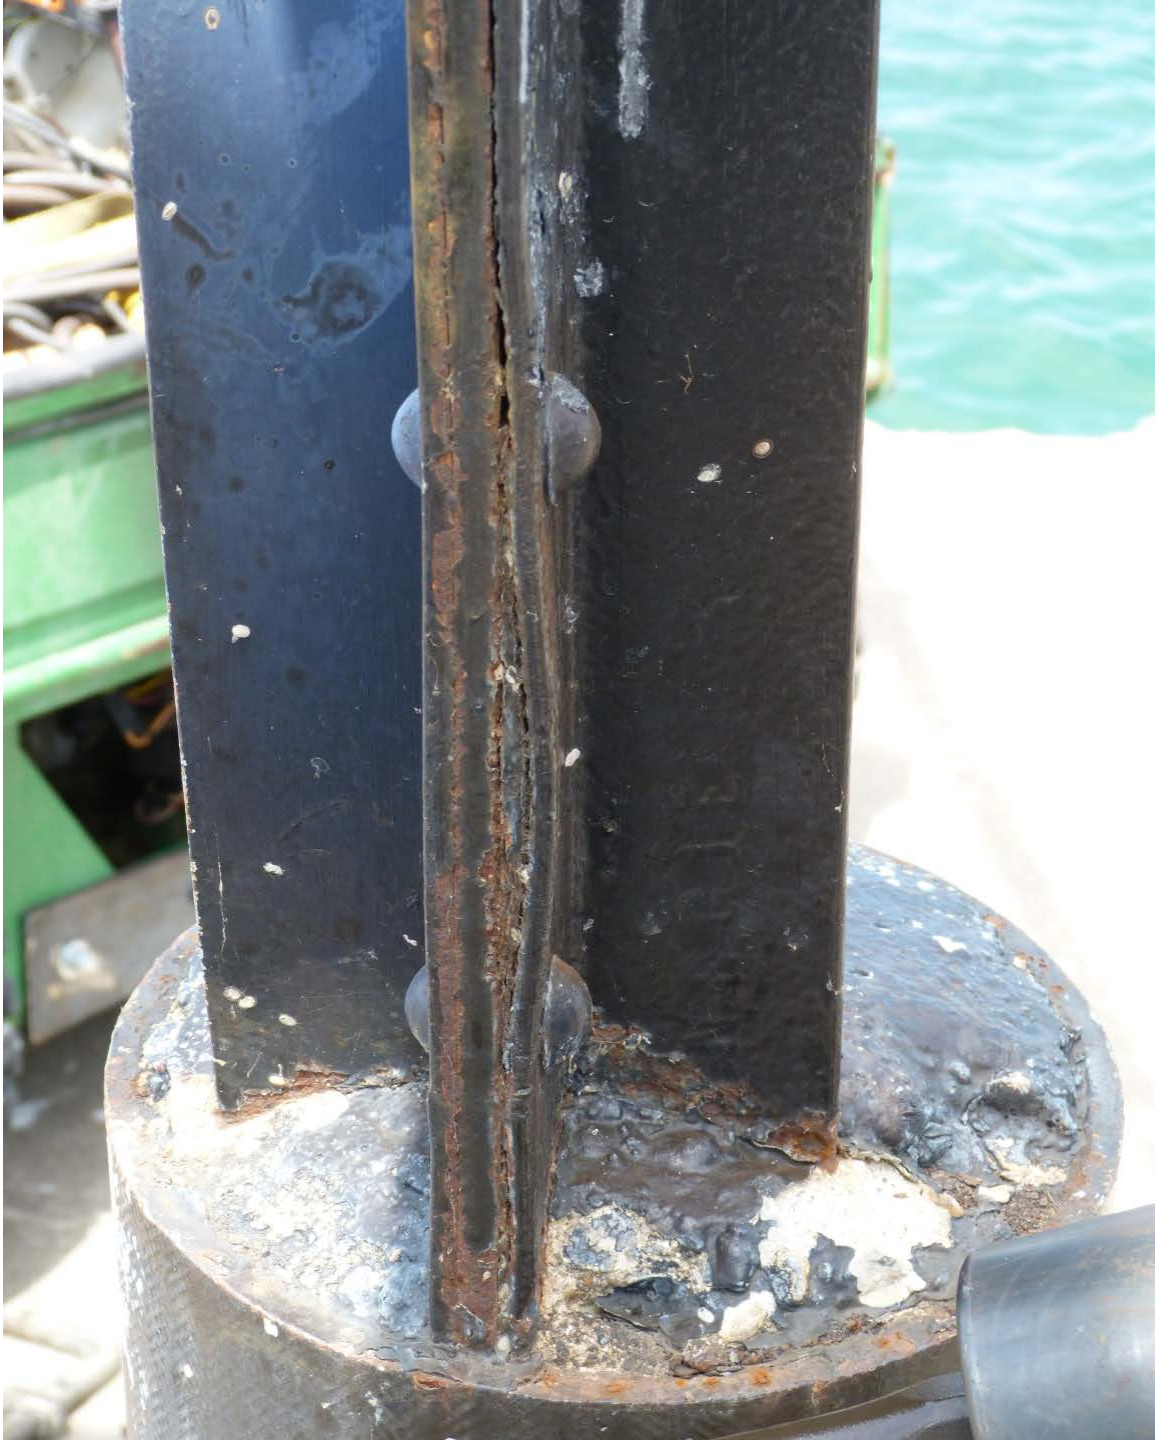
Extent of pack rust  
prior to work on  
catwalk legs.
