# Rivets and Relocation

## New Life for the Pierceville Bridge

The 113-foot Pierceville Bridge was built in 1881 to carry SR-1029 over Tunkhannock Creek in Wyoming County, Pennsylvania. The Pierceville Bridge is a rare lenticular truss bridge, so-called because the top and bottom chords of the trusses create a distinctive “lens” shape. The single span bridge is 113 feet 8 inches long with a width of 14 feet 9 inches between centers of trusses. Only five lenticular truss bridges remain in Pennsylvania, including the well-known Smithfield Street Bridge in Pittsburgh. The Pierceville Bridge is also noteworthy because it is the oldest lenticular truss bridge in Pennsylvania and one of the oldest lenticular truss bridges in the United States. It was built by the Corrugated Metal Company of East Berlin, Connecticut, which later changed its name to the Berlin Iron Bridge Company and was a promoter of this bridge type. The company held rights to inventor William Douglas’ patent for a distinctive variety of lenticular trusses. Except for the Smithfield Street Bridge, which was designed by Gustav Lindenthal, all other surviving lenticular truss bridges in America were designed and built by

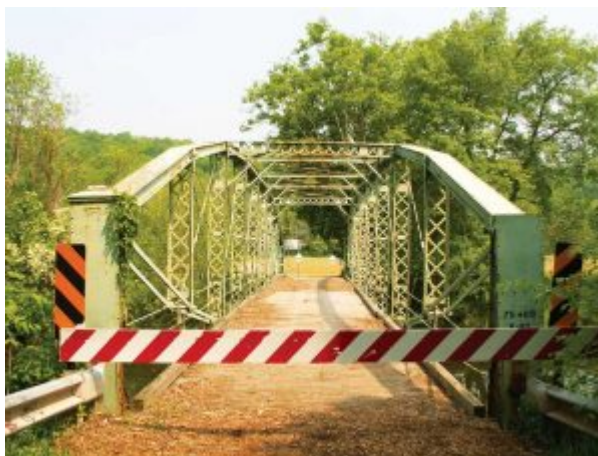
Pierceville Bridge before.

The Pierceville Bridge served traffic in its original location until 2005, when deck, stringer, and floorbeam deterioration prompted the closure of the bridge to traffic. The bridge remained closed in this condition, with no repairs made for several years, while a plan could be developed to determine the best course of action going forward. In 2011, the Pennsylvania Department of Transportation (PennDOT) initiated a study to reopen the crossing to traffic, while also addressing the need for farm equipment, emergency vehicles, and school buses to cross the bridge. The bridge's maximum twenty-ton rehabilitated capacity, 9.5-foot overhead clearance, and 12.3-foot one-lane roadway were obstacles to finding a way for the lenticular truss to meet these needs. Because the bridge was considered eligible for listing in the National Register of Historic Places, a Section 106 Review was required by the FHWA to consider feasible and prudent alternatives to meet the project purpose and need, while avoiding adverse effects (such as demolition or alteration) of the historic bridge. During this process, it was determined that the bridge could not be rehabilitated to the project specifications. However, it was discovered that Tunkhannock Township, less than ten miles away, was interested in relocating and preserving the historic bridge for pedestrian use in Lazy Brook Park over a flood relief channel of Tunkhannock Creek. Through additional discussions during the Section 106 review, it was agreed that the bridge was a suitable candidate for relocation and reuse as a primarily pedestrian facility in the park.

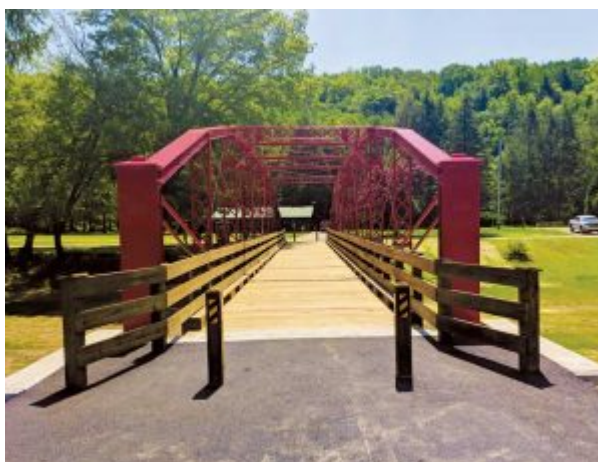
Pierceville Bridge after.

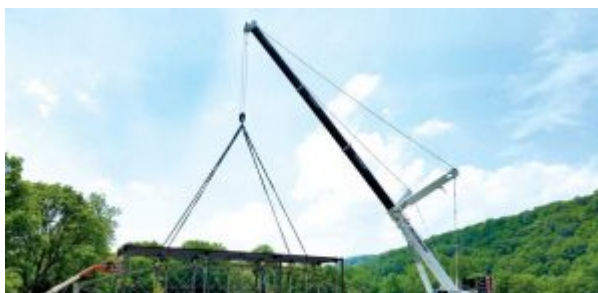
Figure 1. Removal of the bridge from its original location. Courtesy of McCormick Taylor.

The \$3M project included the relocation and restoration of the Pierceville Bridge and construction of the new replacement highway bridge on SR-1029. The first step of the historic bridge portion of the project was the removal and non-destructive disassembly of the historic truss bridge. After the timber deck was removed, the approximately 54,000-pound truss bridge was lifted off its abutments and moved to a nearby laydown and disassembly area. The process involved using a 500-ton crane and a specialized steel lifting frame that had been designed and fabricated to act both as a spreader beam system for the lift and as a disassembly/assembly jig (*Figure 1*). After the crane had moved the bridge and lifting frame to the laydown area, vertical steel columns were attached and the whole structure was laterally braced with guy wires anchored to concrete deadmen. This transformed the lifting frame into a supporting structure from which the truss hung, enabling safe disassembly of the truss. The third and final use of the steel support structure was to provide the structural support for the containment system necessary to blast the lead-containing paint off the bridge to protect workers and the environment before disassembly.

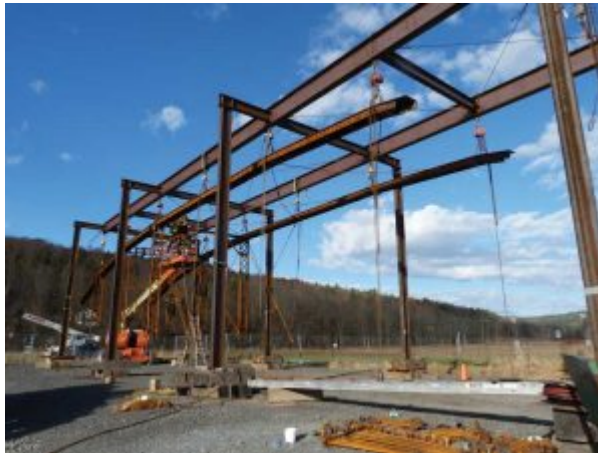
Figure 2. Disassembly of the bridge. Courtesy of Bach Steel.

After removal of the steel deck stringers, disassembly of the truss itself was completed generally from the bottom to the top, with the floorbeams, lower bracing, and lower chords removed first (*Figure 2*).

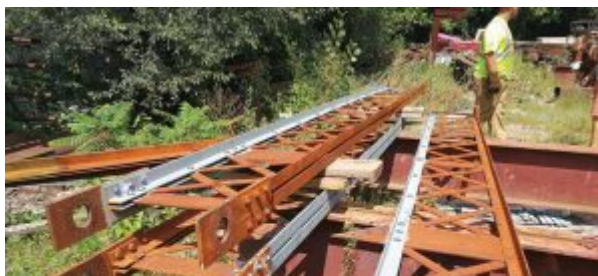
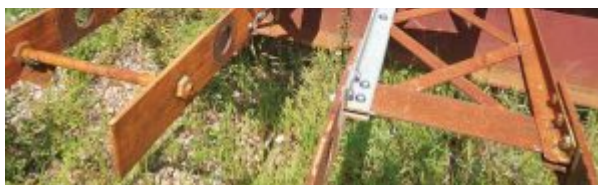
Figure 3. Completed shop repairs of vertical members. New steel is painted grey in this photo. Courtesy of Bach Steel.

The built-up vertical members and portal bracing on the bridge were in good condition overall. However, some sections had been impacted by vehicles, and one vertical member had been crudely repaired with welded splices in the angles. Rather than completely replace these damaged members, a partial replacement was undertaken. The impacted and poorly repaired areas of the verticals were removed and replaced with new steel riveted to match the original sections (*Figure 3*). Similar repairs were made to the portal bracing. The bridge's floorbeams are built-up, variable depth, "fishbelly" shaped beams. Some of them had section loss on the angles and at the lateral bracing connections. Deteriorated angles were removed and replaced with new angles riveted to the beams. The lateral bracing connection areas were strengthened by adding a small riveted plate to provide additional cross-sectional area. Once the top chord splices were disassembled, cracking between rivet holes was discovered. The original splice plates were replaced with slightly larger plates to develop a friction connection that would provide a secure splice, to avoid having to replace these members or rely on a welded repair.

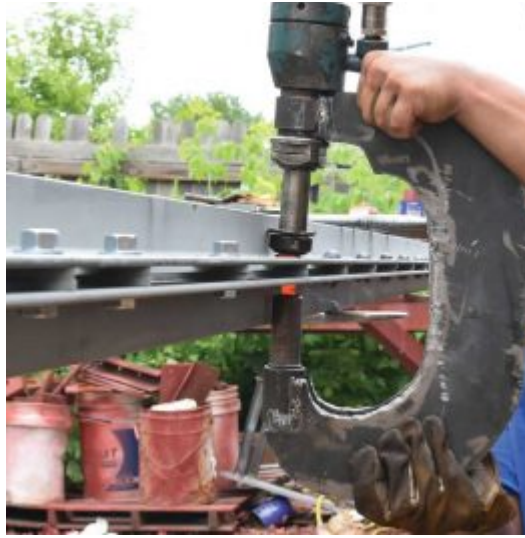
Figure 4. Shop riveting a new edge bracing member using a hydraulic riveter. Courtesy of Bach Steel.

Repairs to the historic truss were completed in a shop setting using new fabricated steel supplied to the repair contractor by a PennDOT-approved fabricator. Special provisions in the contract ensured that the rivets and associated repair work were completed by a firm with extensive prior experience. Since riveting is not part of typical bridge construction projects today, the standard bridge prequalification classifications used by transportation departments do not consider riveting experience. Rivets for the Pierceville Bridge were driven according to standard specifications including ASTM A 502 and ANSI Standard B18.1.2. The rivets were heated in a gas forge and driven with hydraulic riveters and pneumatic rivet hammers depending on the location and accessibility of the rivet being driven (*Figure 4*). Care was taken to closely match the new rivet head size and style (dome top versus countersunk) to the original rivets.

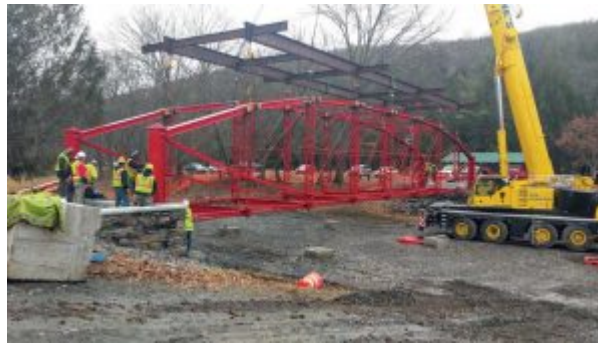
Figure 5. The restored truss is placed on the new abutments at Lazy Brook Park. Courtesy of McCormick Taylor.

While repairs to the truss were underway, abutment construction was accomplished at Lazy Brook Park, the new home for the historic bridge. A noteworthy aspect of this work was that the new concrete abutments were faced with some of the original stones that had been salvaged from the dry-laid stone abutments at the original bridge location. The original stones were transported to the new site, cleaned, cut down to an approximate 6-inch thickness, and attached with mortar to the freshly cast concrete abutments. This had the benefit of preserving some of the original abutment materials and also provided a more realistic simulation of a stone abutment.

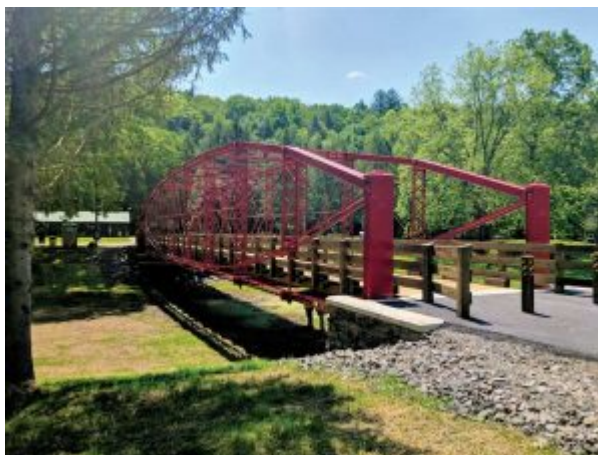
Figure 6. The completed Pierceville Bridge at Lazy Brook Park. Courtesy of McCormick Taylor.

Following completion of repairs, the truss parts were shipped to a paint shop to be blasted again and painted with a 3 coat inorganic zinc rich paint system. Once complete, the parts were shipped to their new home. The reassembly of the truss at Lazy Brook Park was essentially a reversal of the disassembly process, using the same temporary support and lifting frame system. This was followed by the setting of the truss onto its new abutments with the use of a smaller, 150-ton crane due to a much shorter lifting radius (*Figure 5*). Once the truss was in place on the new abutments, the new timber stringer, deck, and railing system were installed. The new deck is an all-timber system composed of pressure-treated Southern yellow pine; including 12- x 4-inch deck stringers, 10- x 3-inch deck planks, and pedestrian railing which provides a 10-foot walkway from curb to curb (*Figure 6*). The use and detailing (size and spacing) of the structural timbers for the stringers and planks were intended to mirror what is thought to have been originally installed on the truss, in a further effort to be historically accurate.
