Project: Bridgeport Bridge

Project Completed: 2010

Overview: This project, completed in 2010, involved the in-kind restoration and conversion of an abandoned historic pin-connected through truss that included two 124 foot truss spans for pedestrian use. The work included a substantial amount of hot metal riveting. The pier for the bridge was tipping over, slowly twisting the bridge. The trusses were removed from the river and completely and carefully dismantled and shipped to the shop for restoration, while the substructure was replaced by others. Truss restoration work included removing and replacing portions of truss members that exhibited extensive section loss. This avoided the complete replacement of truss members with severe deterioration confined to a portion of the member. Areas with lesser deterioration were repaired by welding new plate to the affected areas. Replacement of the highly deteriorated top chord and end post cover plate with a thicker, more durable cover plate was completed. The new cover plate was riveted to the bridge, replicating the original design and appearance.

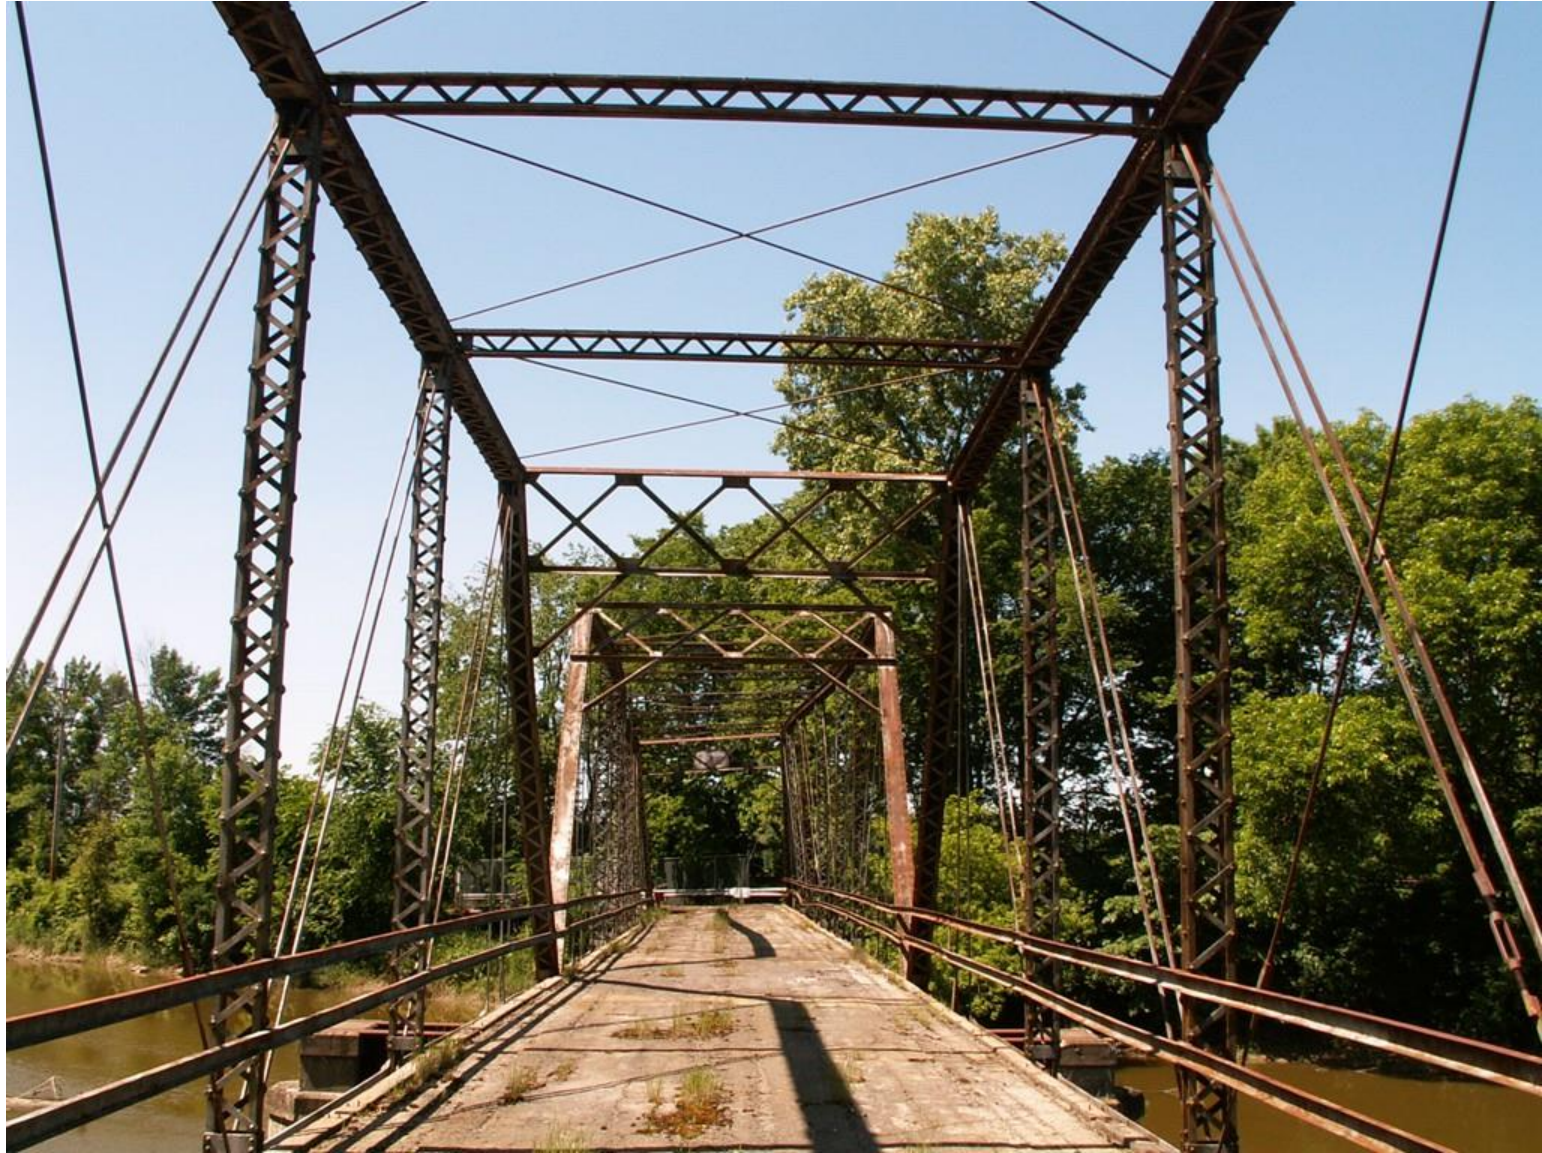
Bridge before restoration

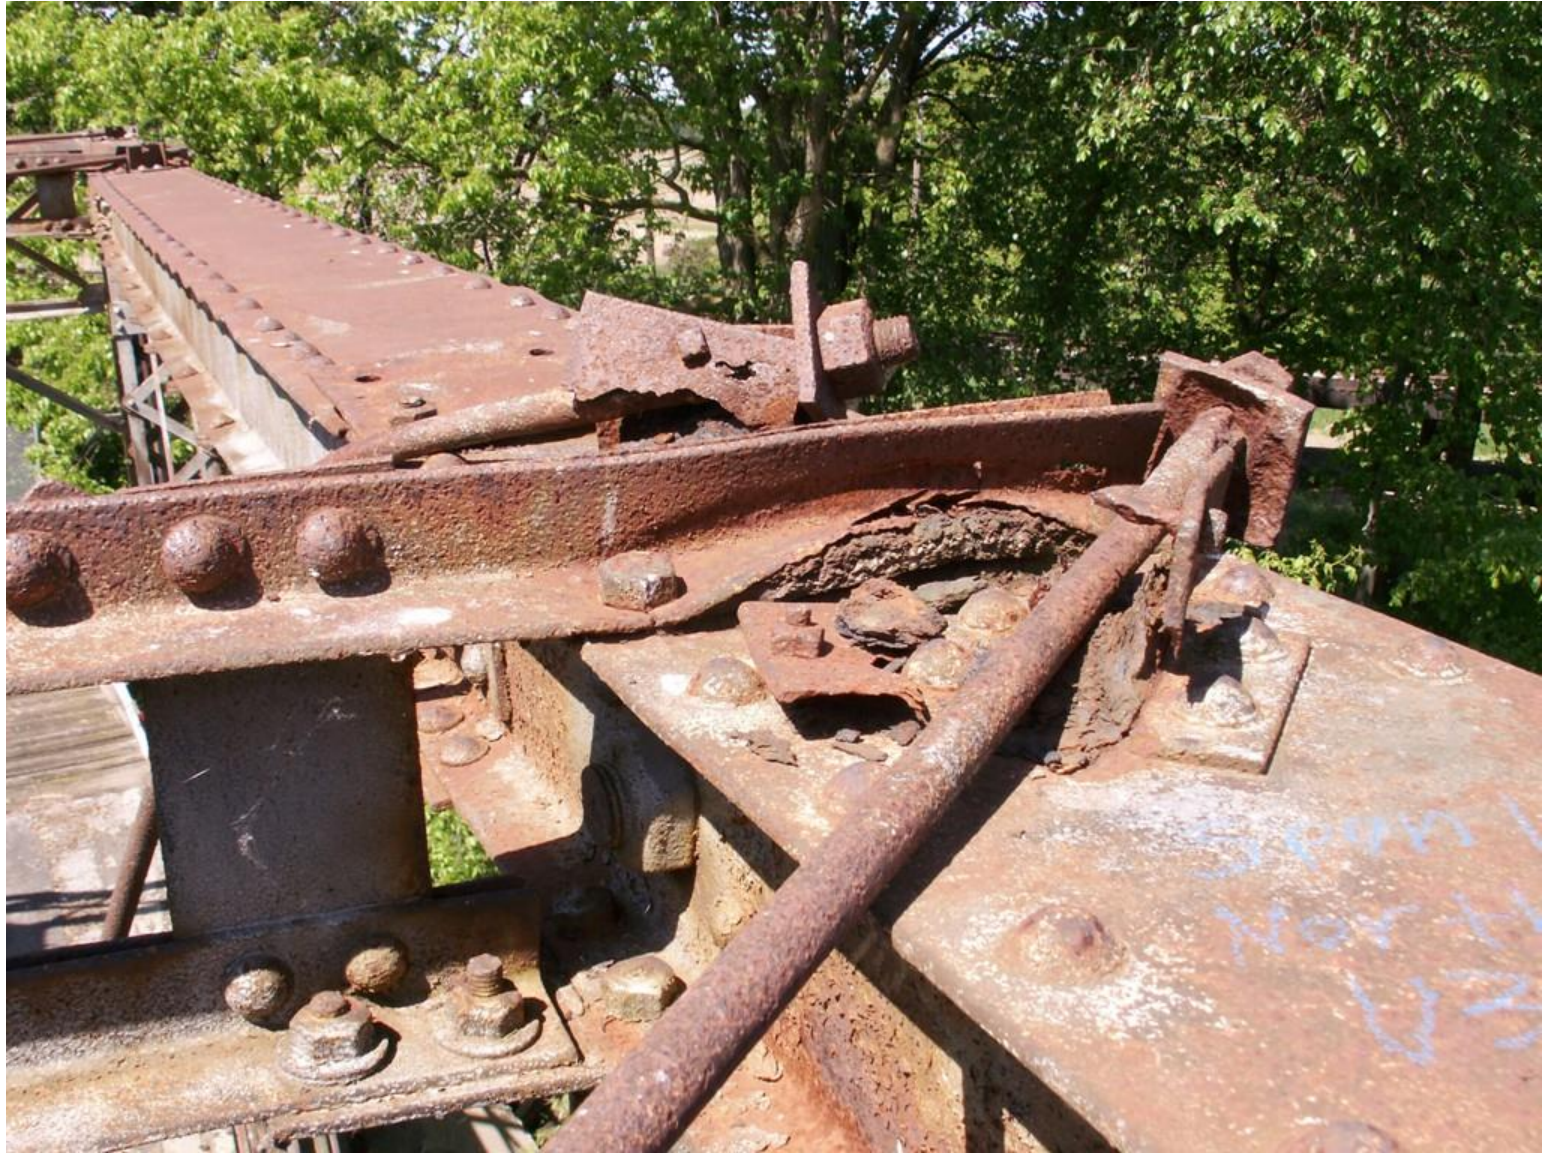
Bridge before restoration

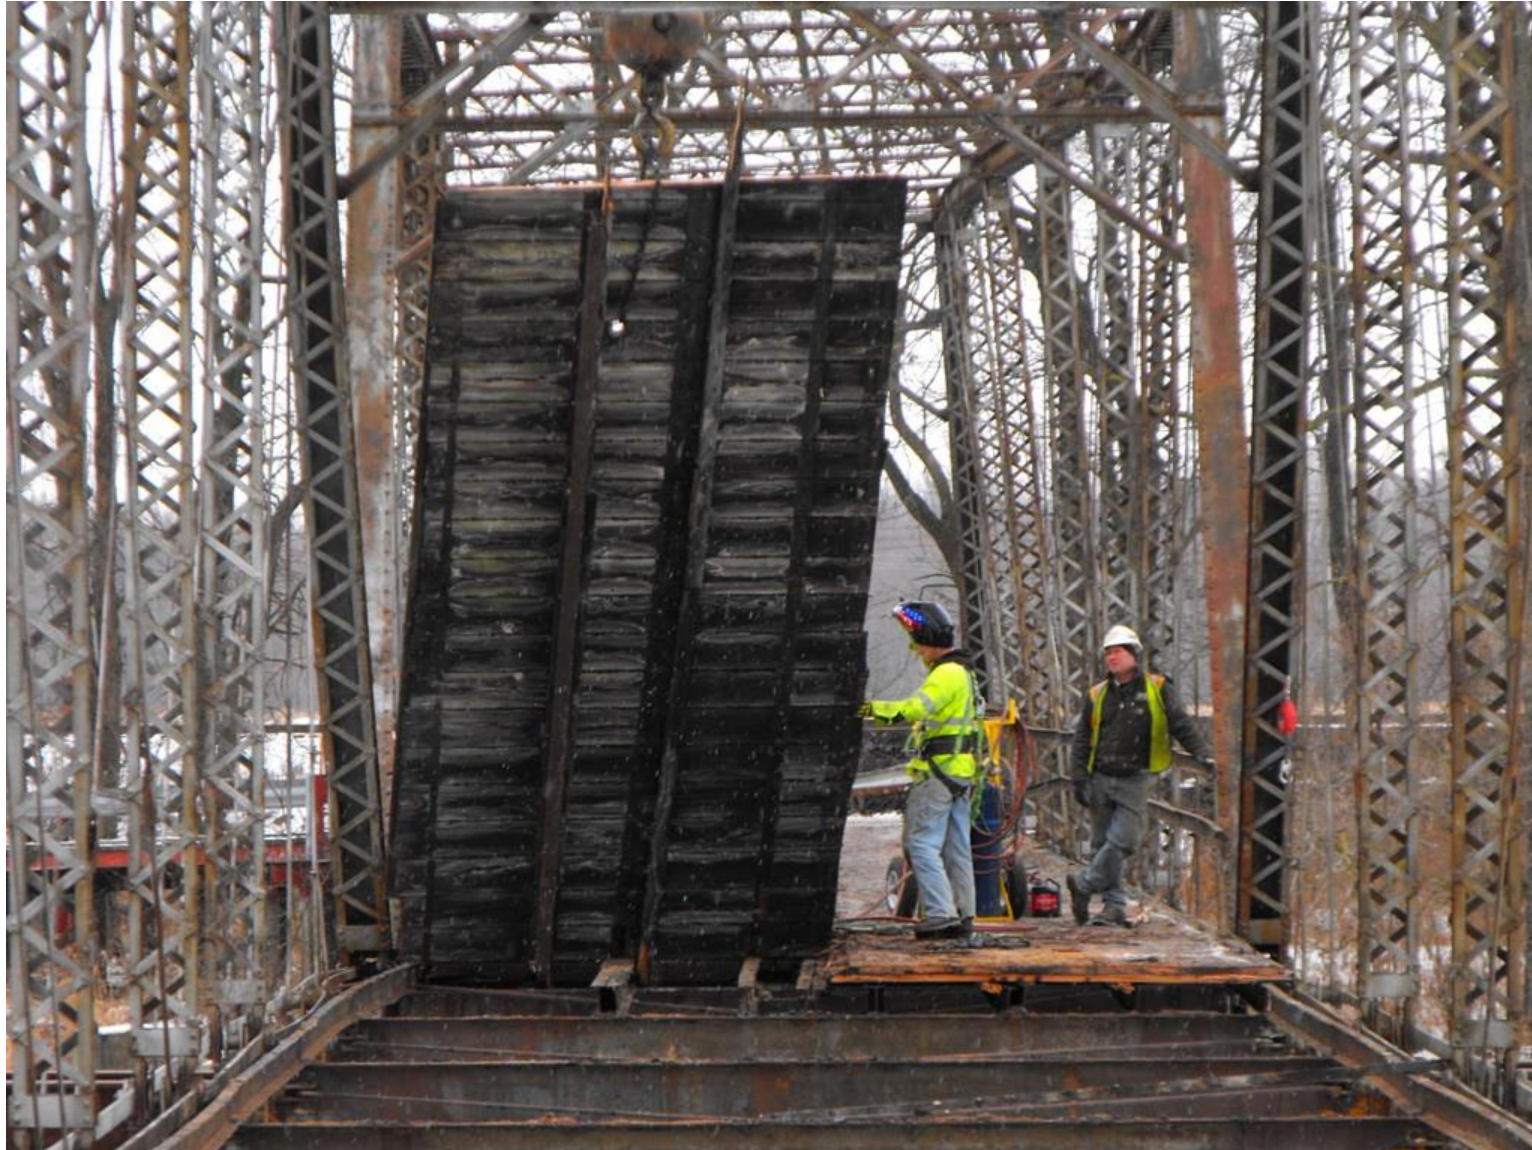
Removing the deck.

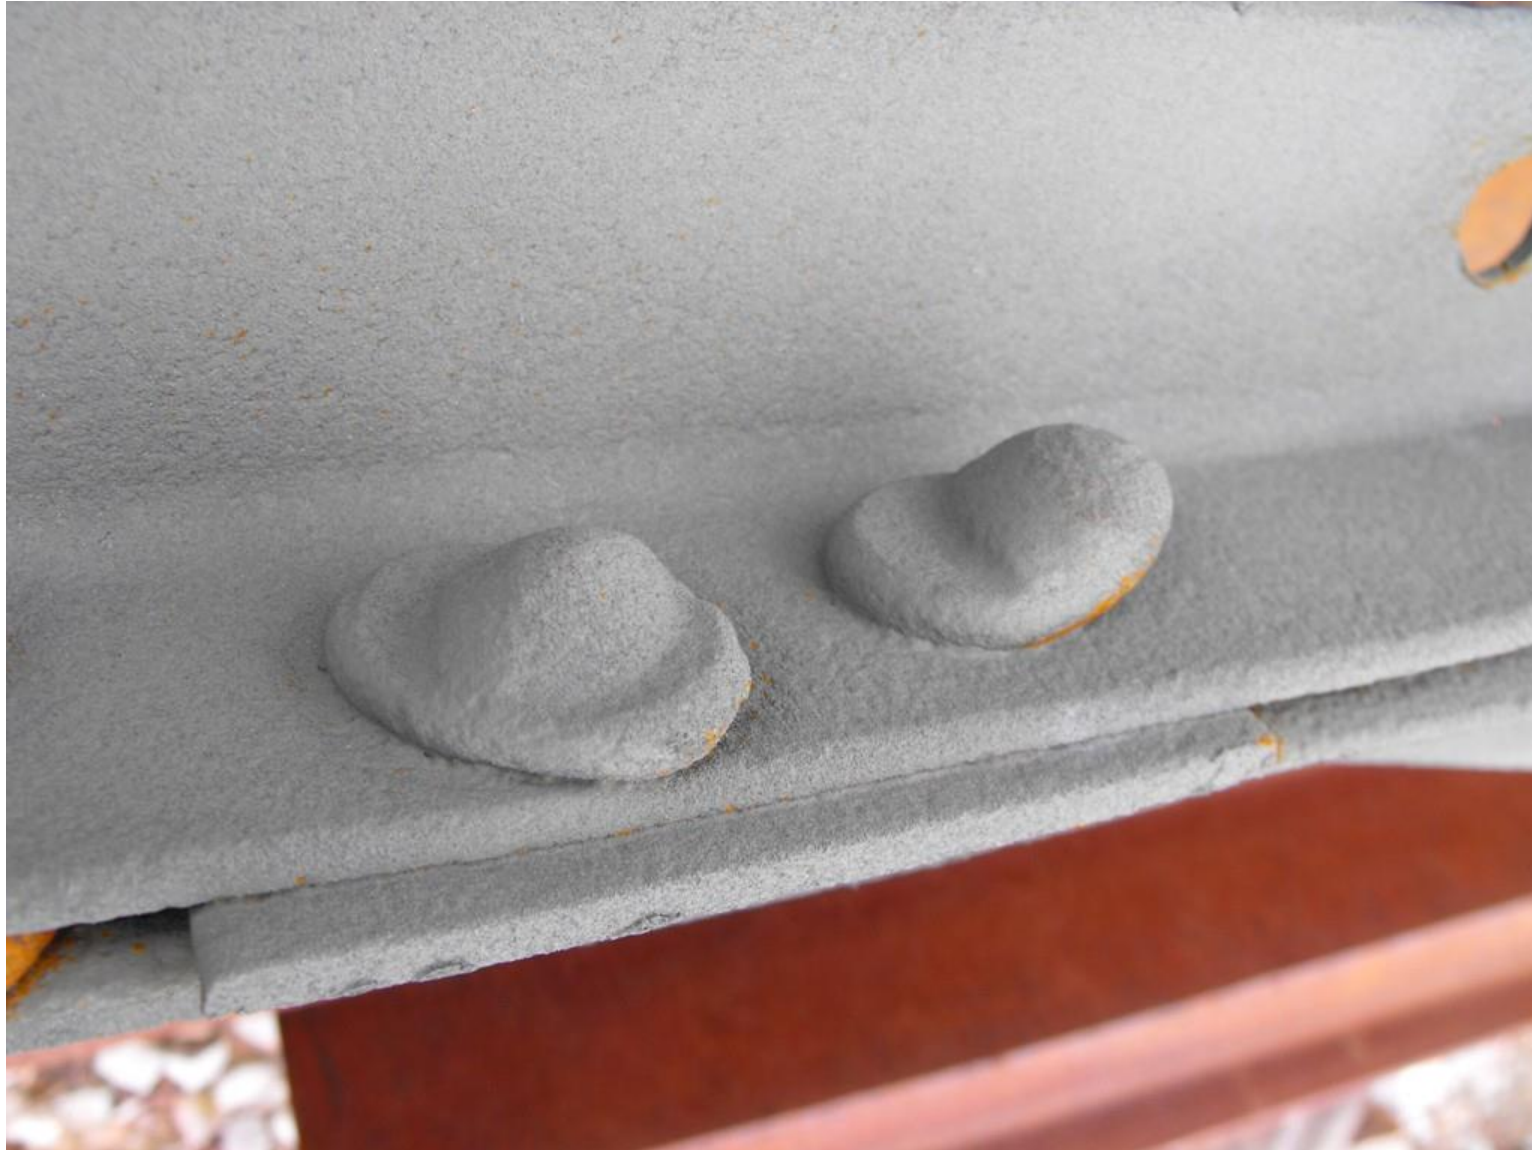
These are original rivets found on the Bridgeport Bridge that are obviously not driven very nicely. Yet, despite their imperfections, they worked for 100 years! The rivets driven by Bach Steel will look much nicer than these and will be ready for their century of service!

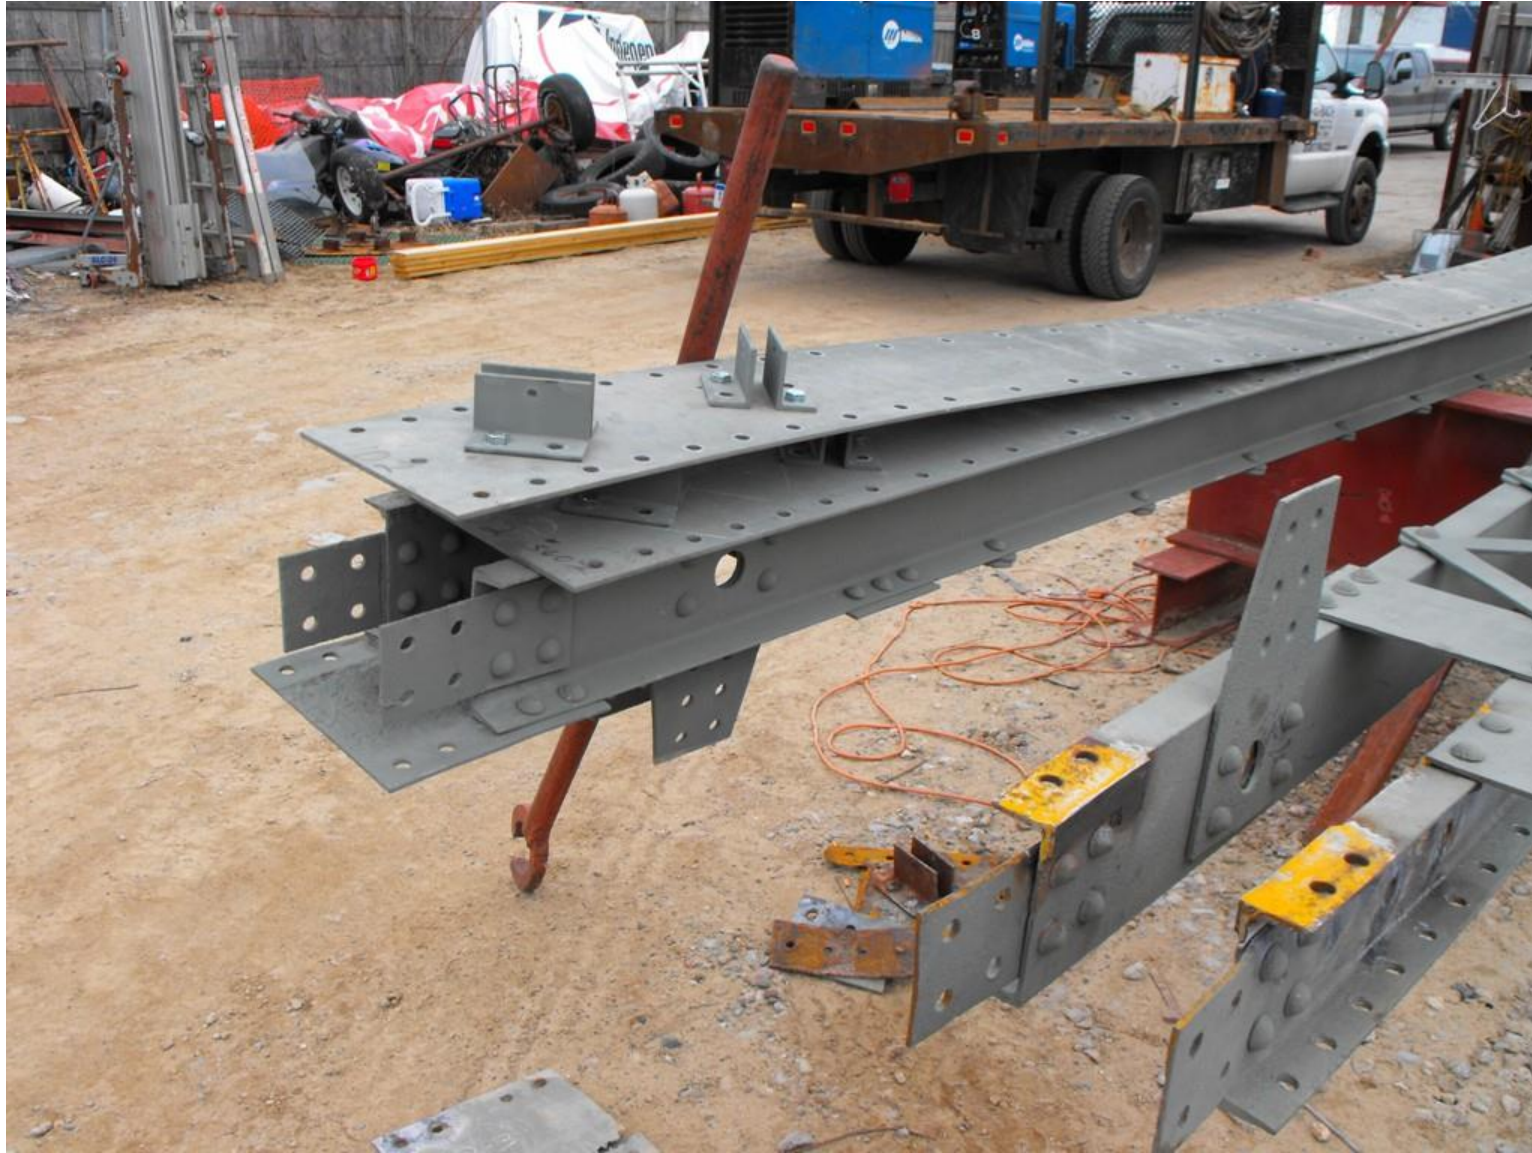
Sitting behind a vertical member is a section of top chord awaiting a new cover plate to be riveted onto it.

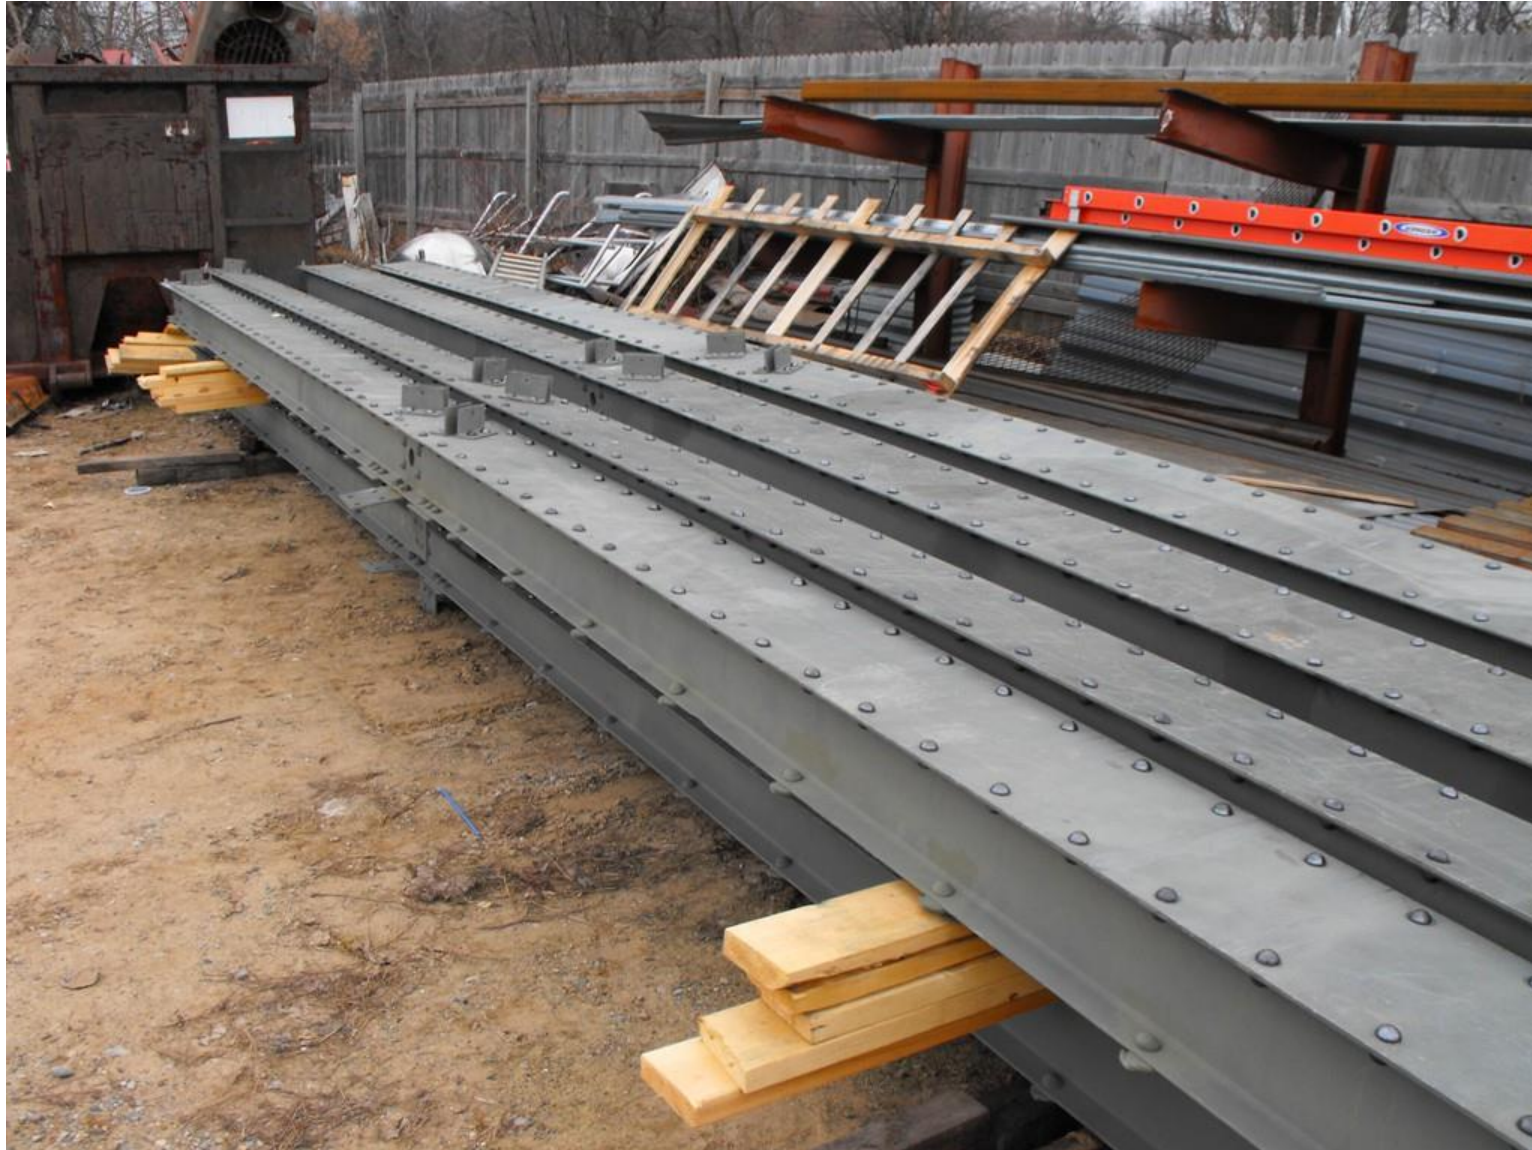
Top chord sections with newly riveted cover plate in place.

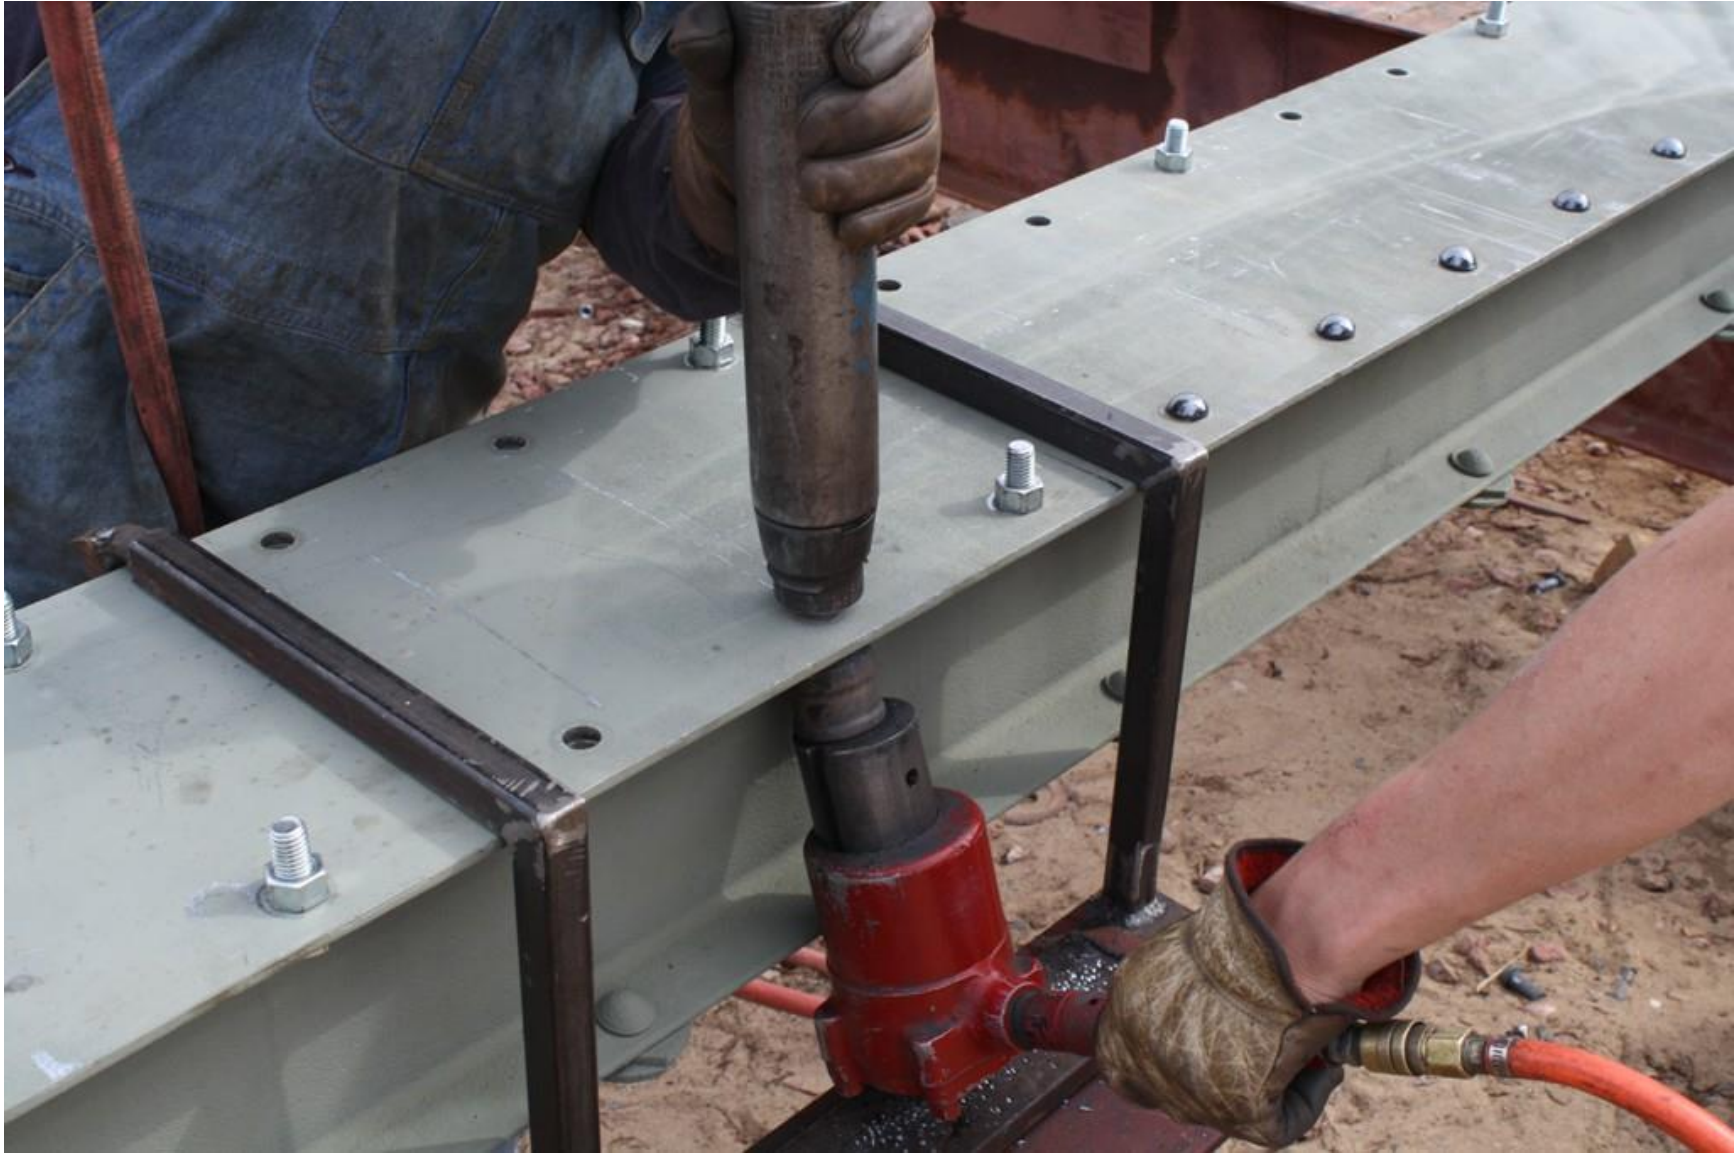
Driving a rivet into the top chord. The entire cover plate was highly deteriorated, so the old cover plate was removed and a thicker cover plate was riveted on in its place to the original channels.

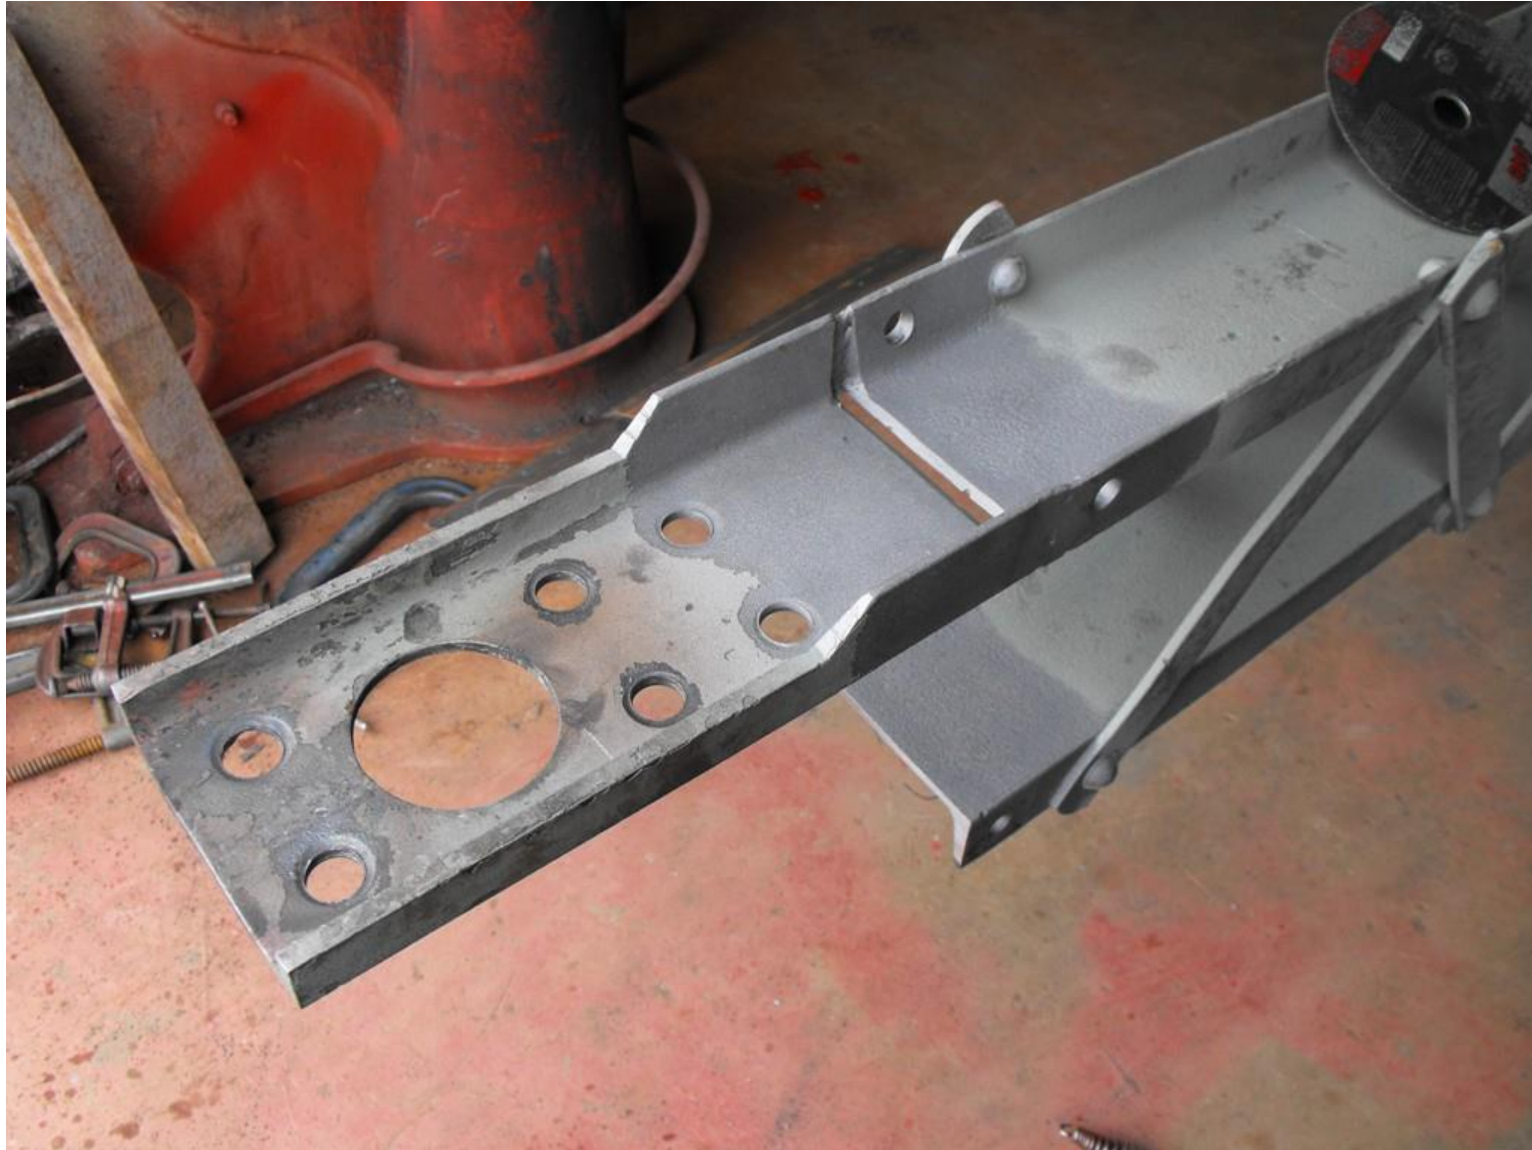
A replicated section of vertical member (to left) being welded onto the original portion of the member.

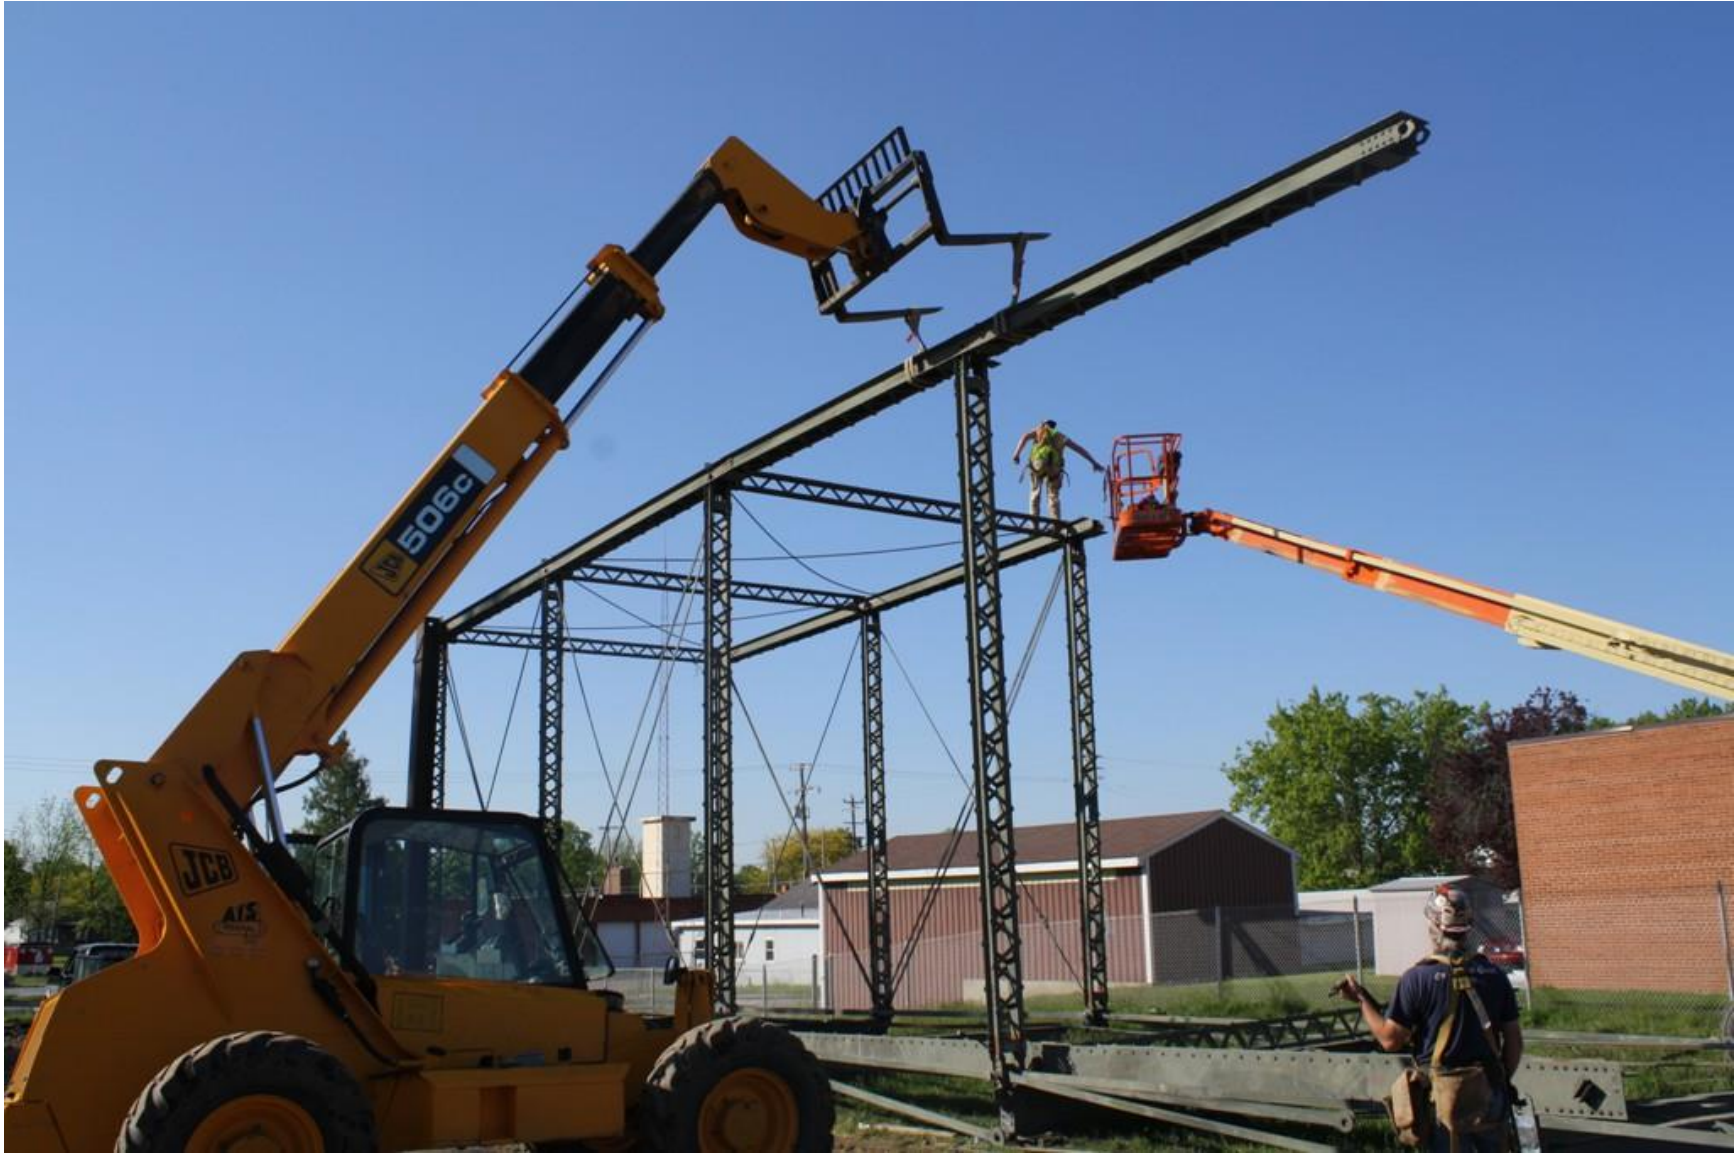
Reassembling the restored bridge.

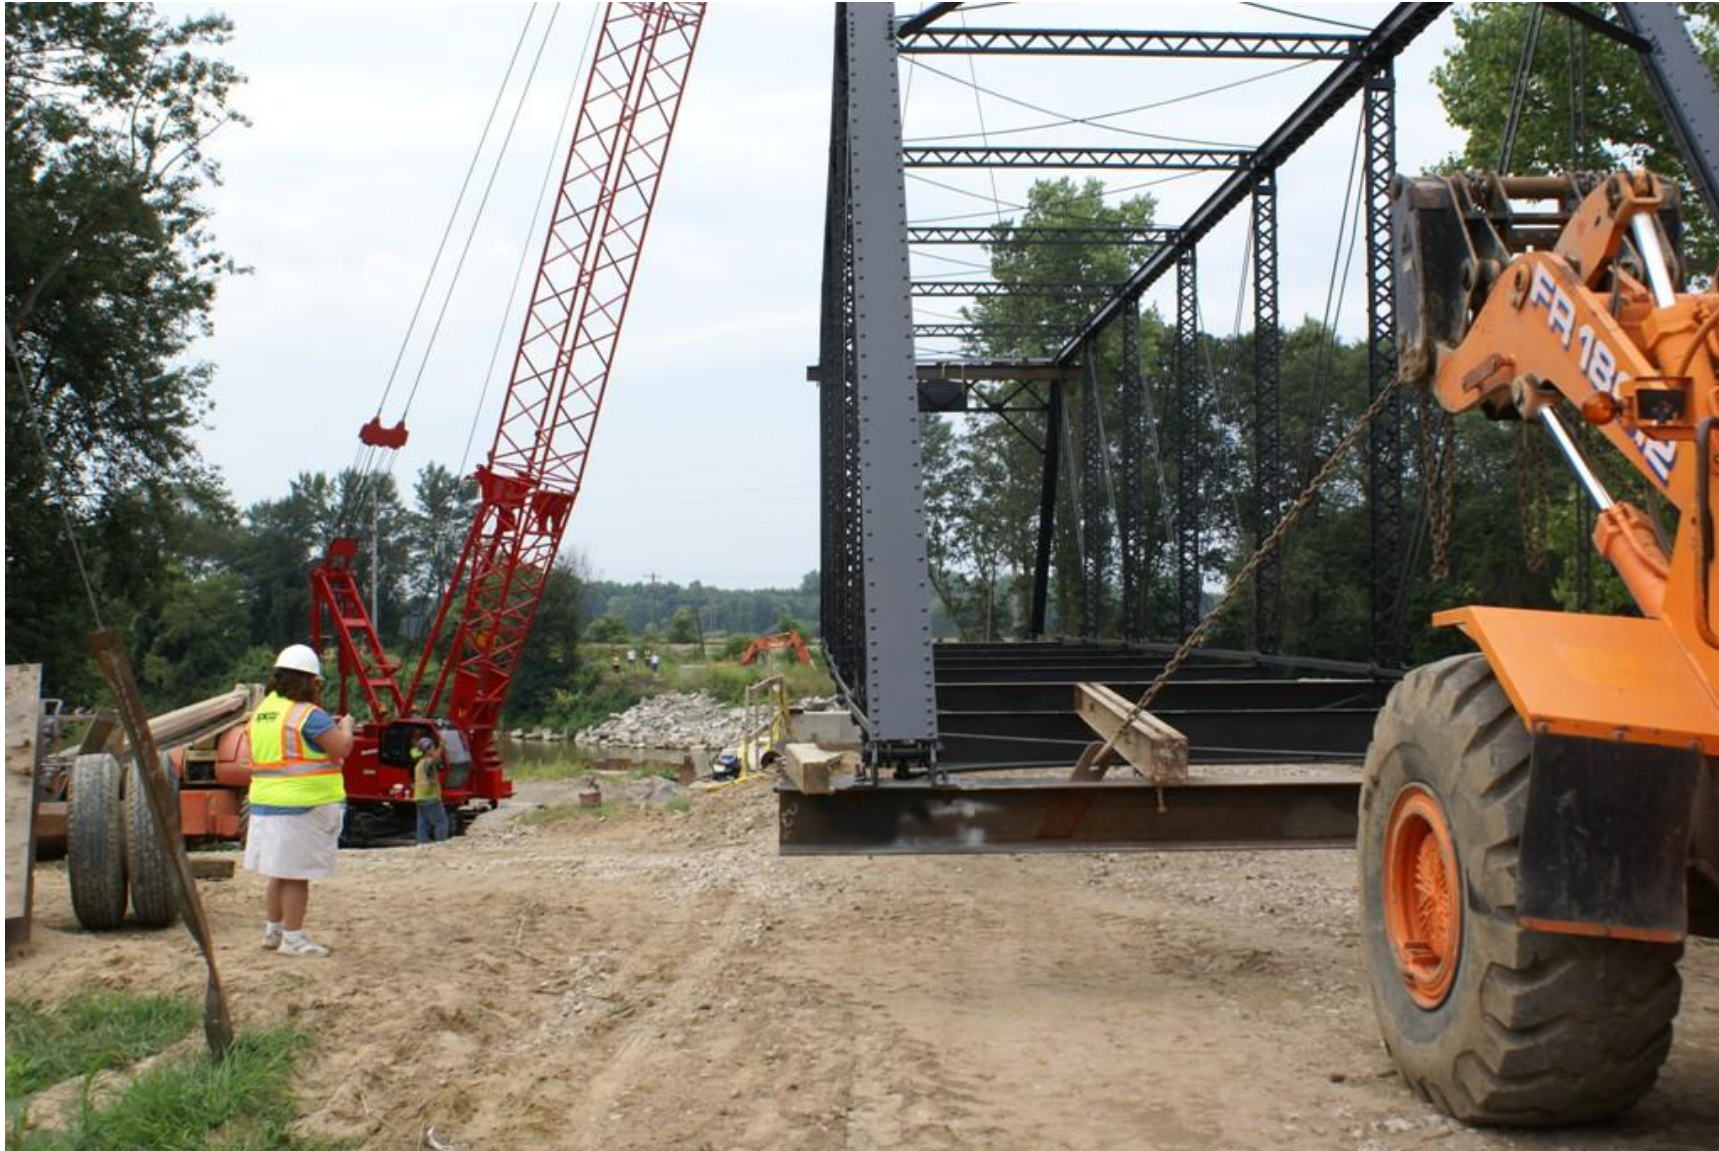
Lifting a restored span back over the river.

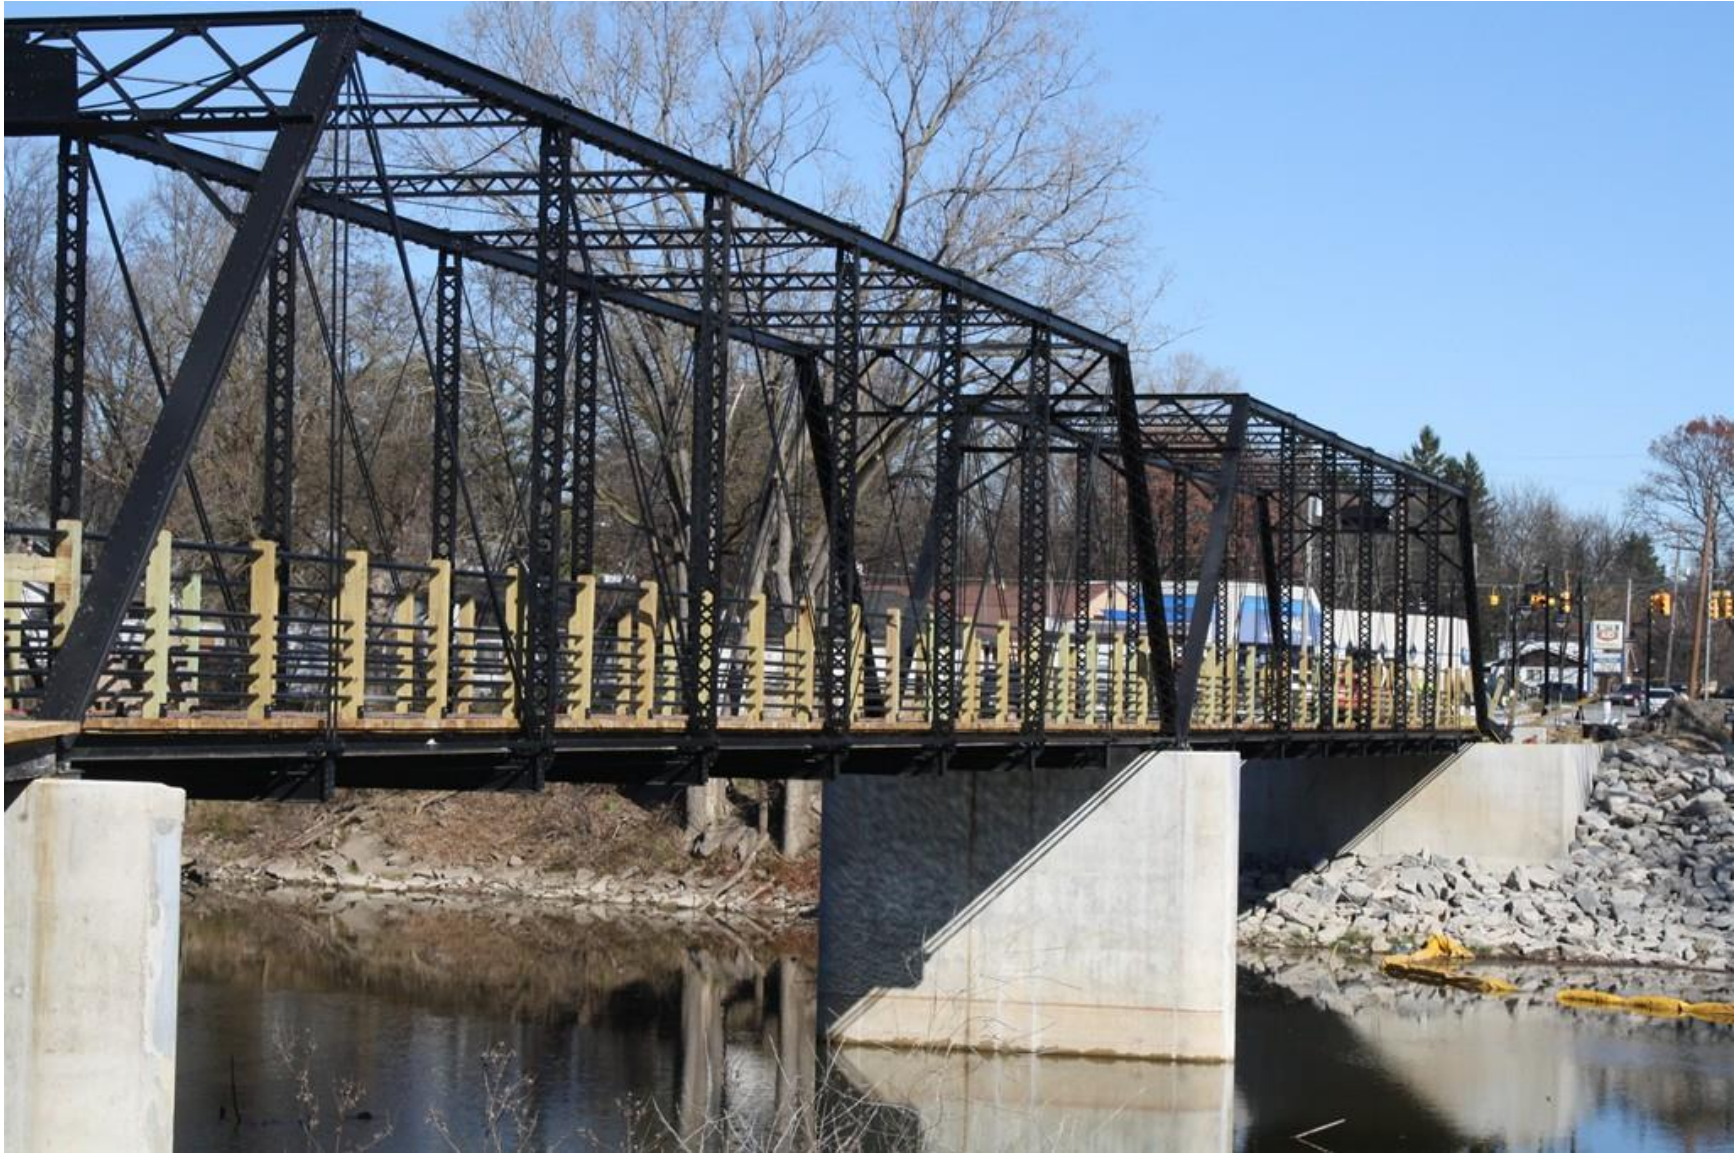
Bridge trusses after restoration and placement on the new substructure.
