Project: Piano Bridge

Project Completed: 2012

Overview: Full in-kind repair and restoration of this historic metal truss bridge for continued vehicular use. Bach Steel was responsible for repair of existing steel, including heat straightening, hot riveting as needed for fasteners, pack rust removal as needed. Heat straightening work included the heavily impact-damaged portal bracing, bent bottom chord eyebars (a fracture critical member), and impact damaged lattice railing.

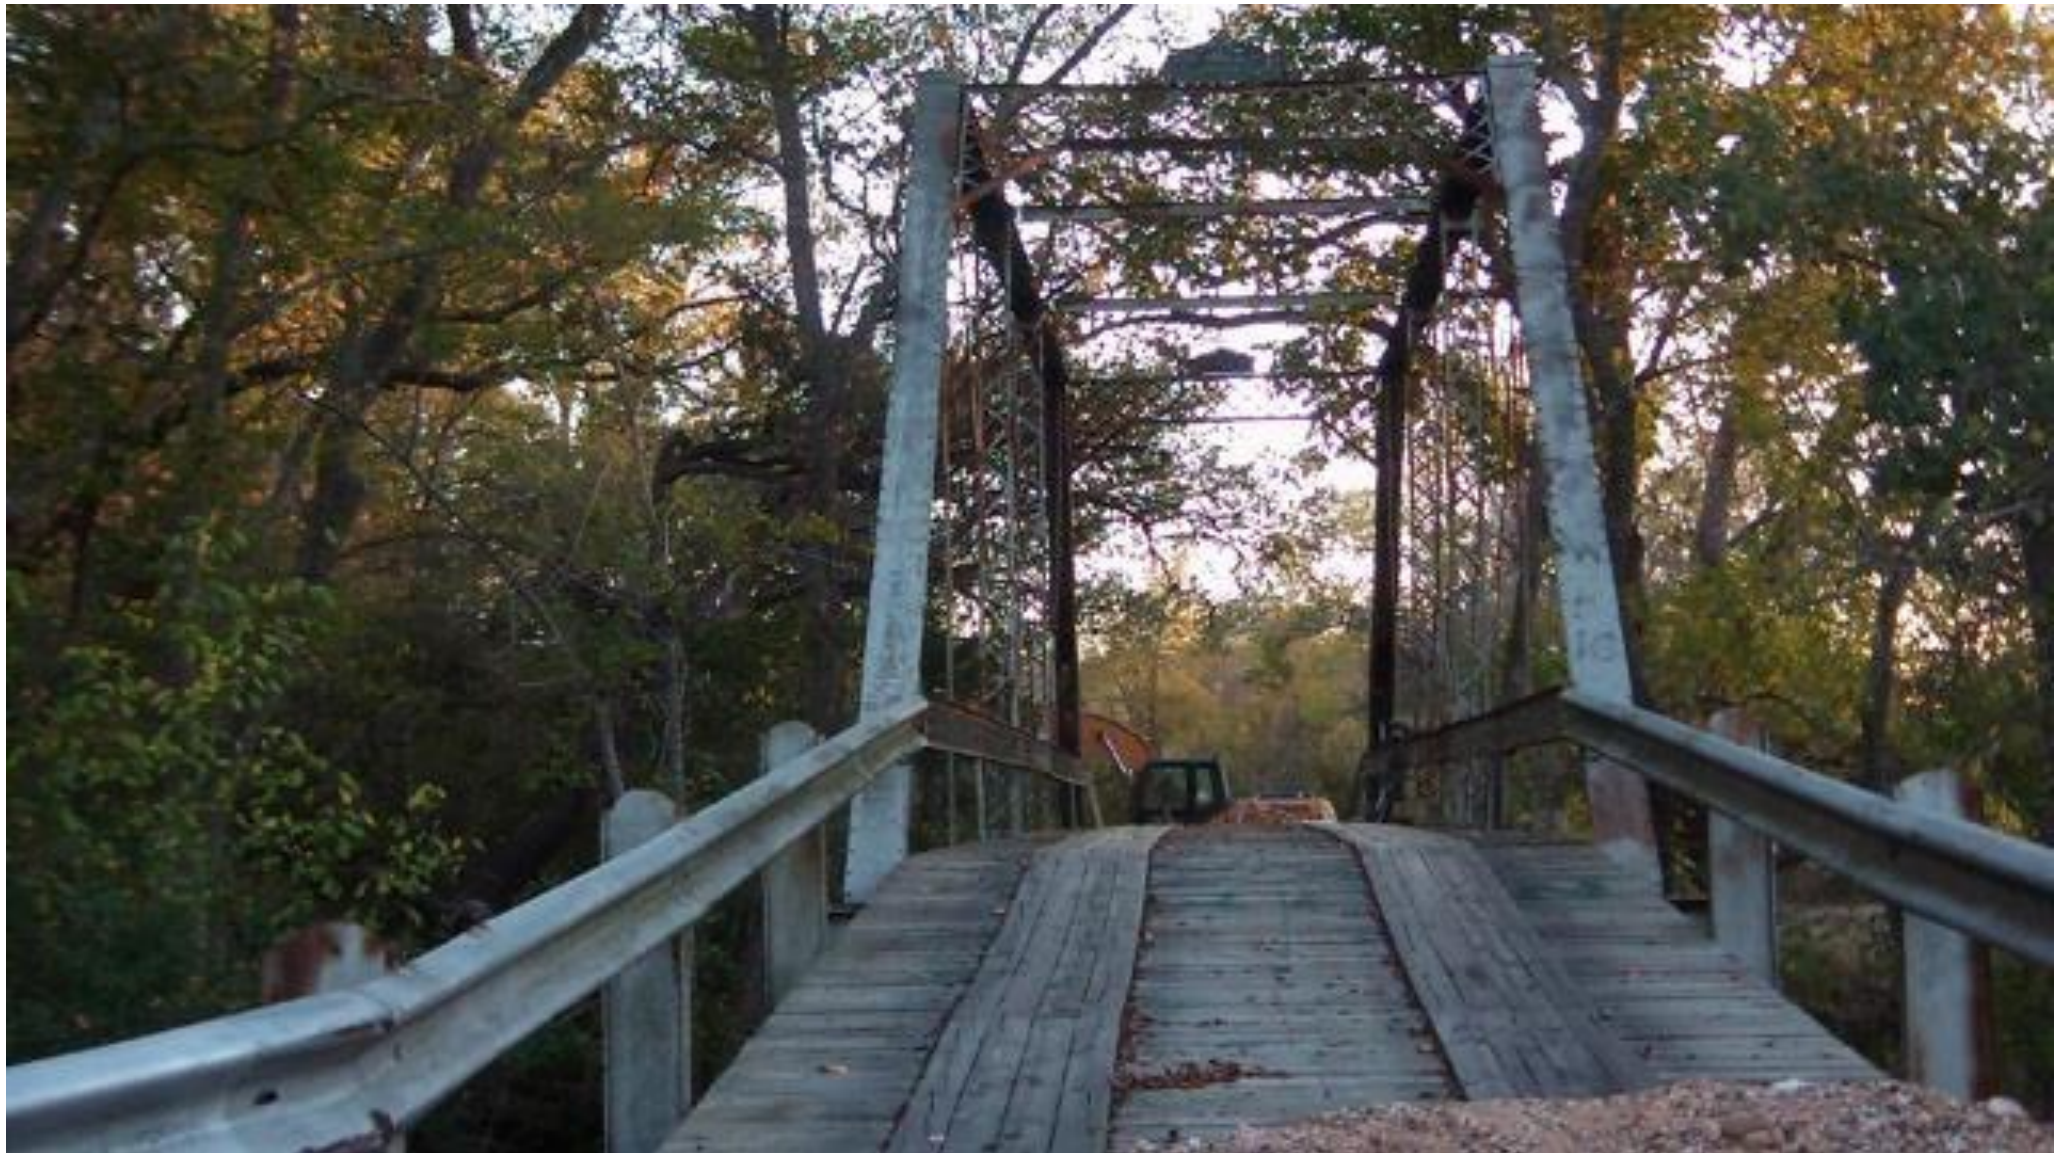
Bridge before restoration.

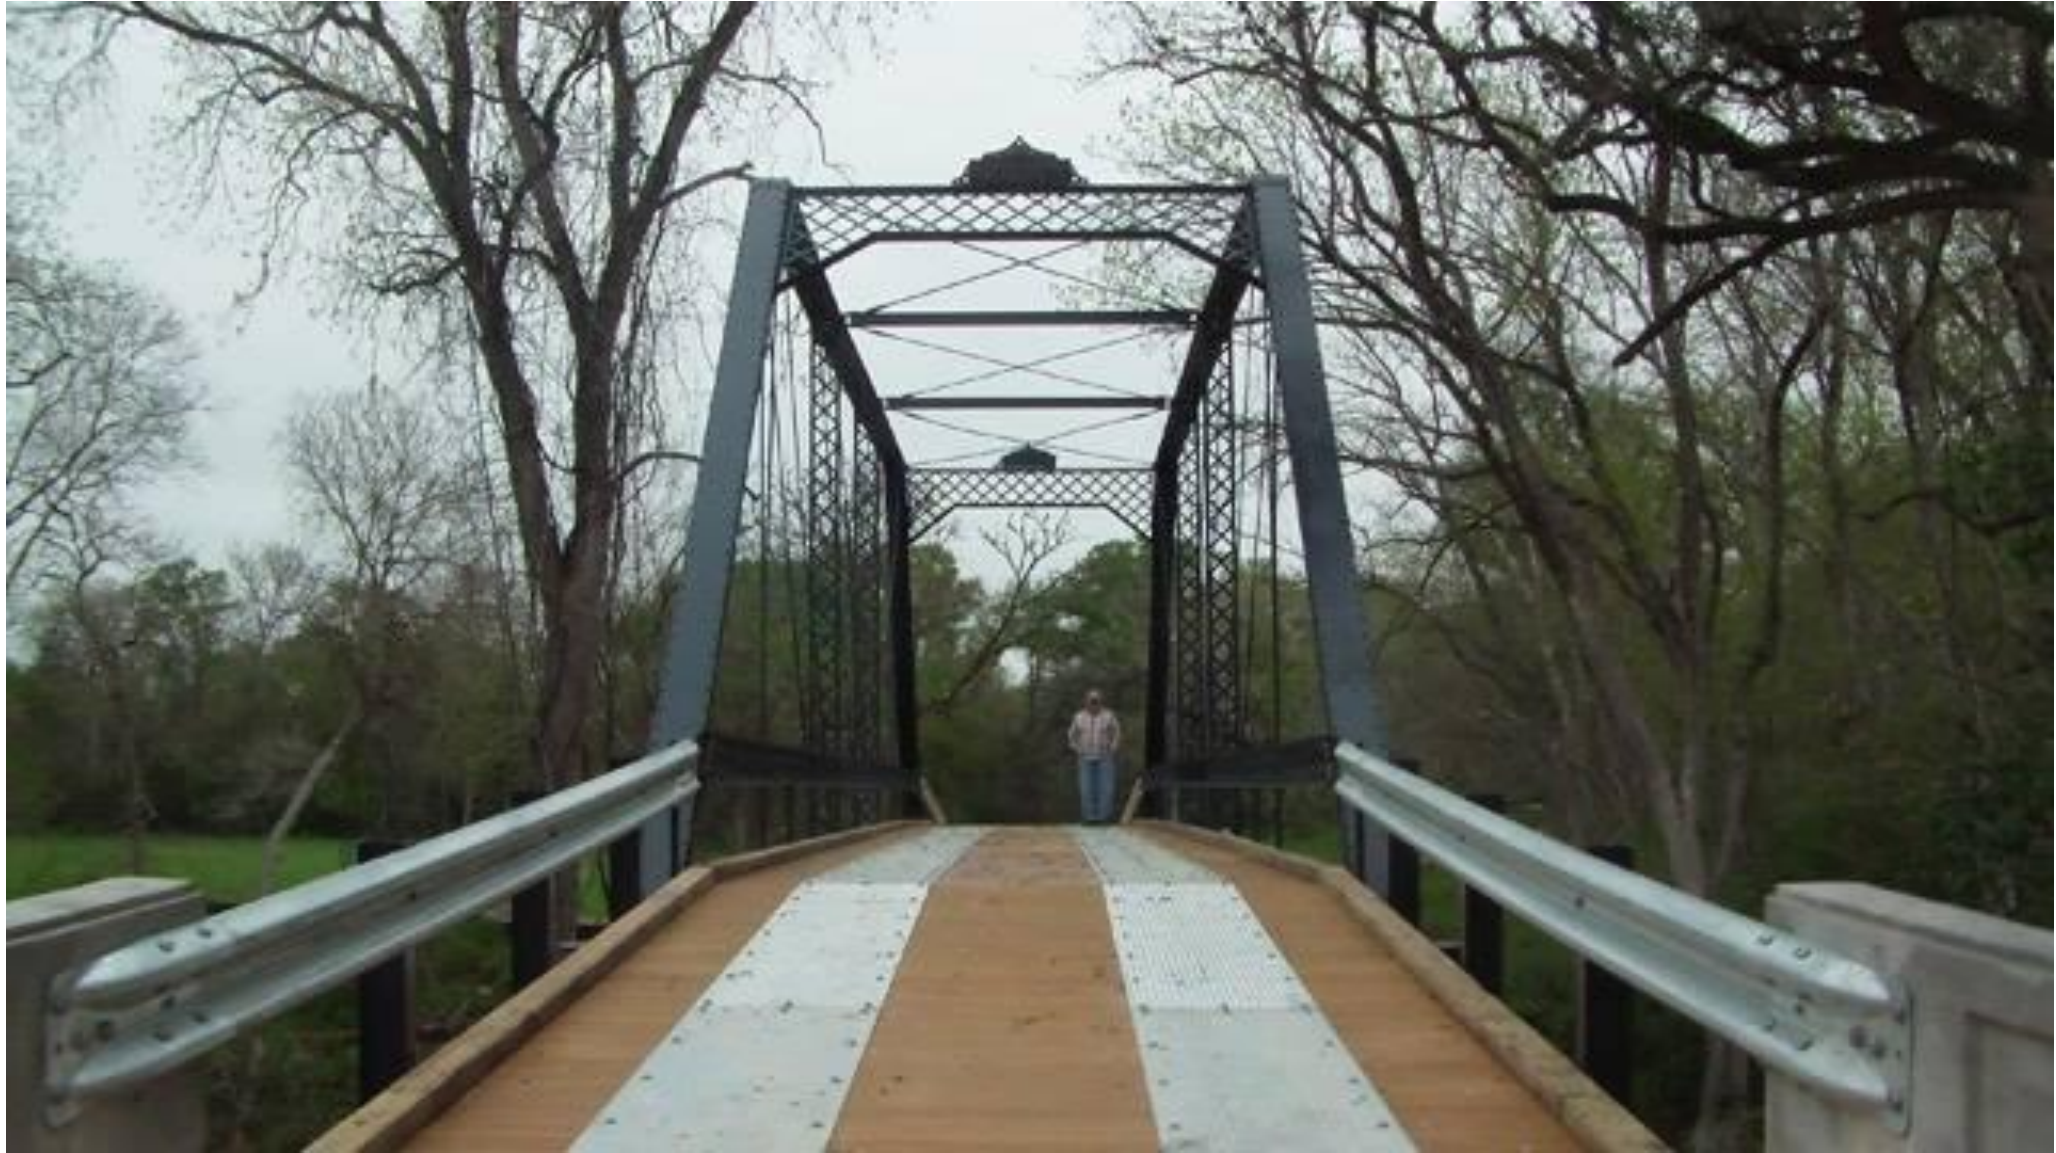
Bridge after restoration.

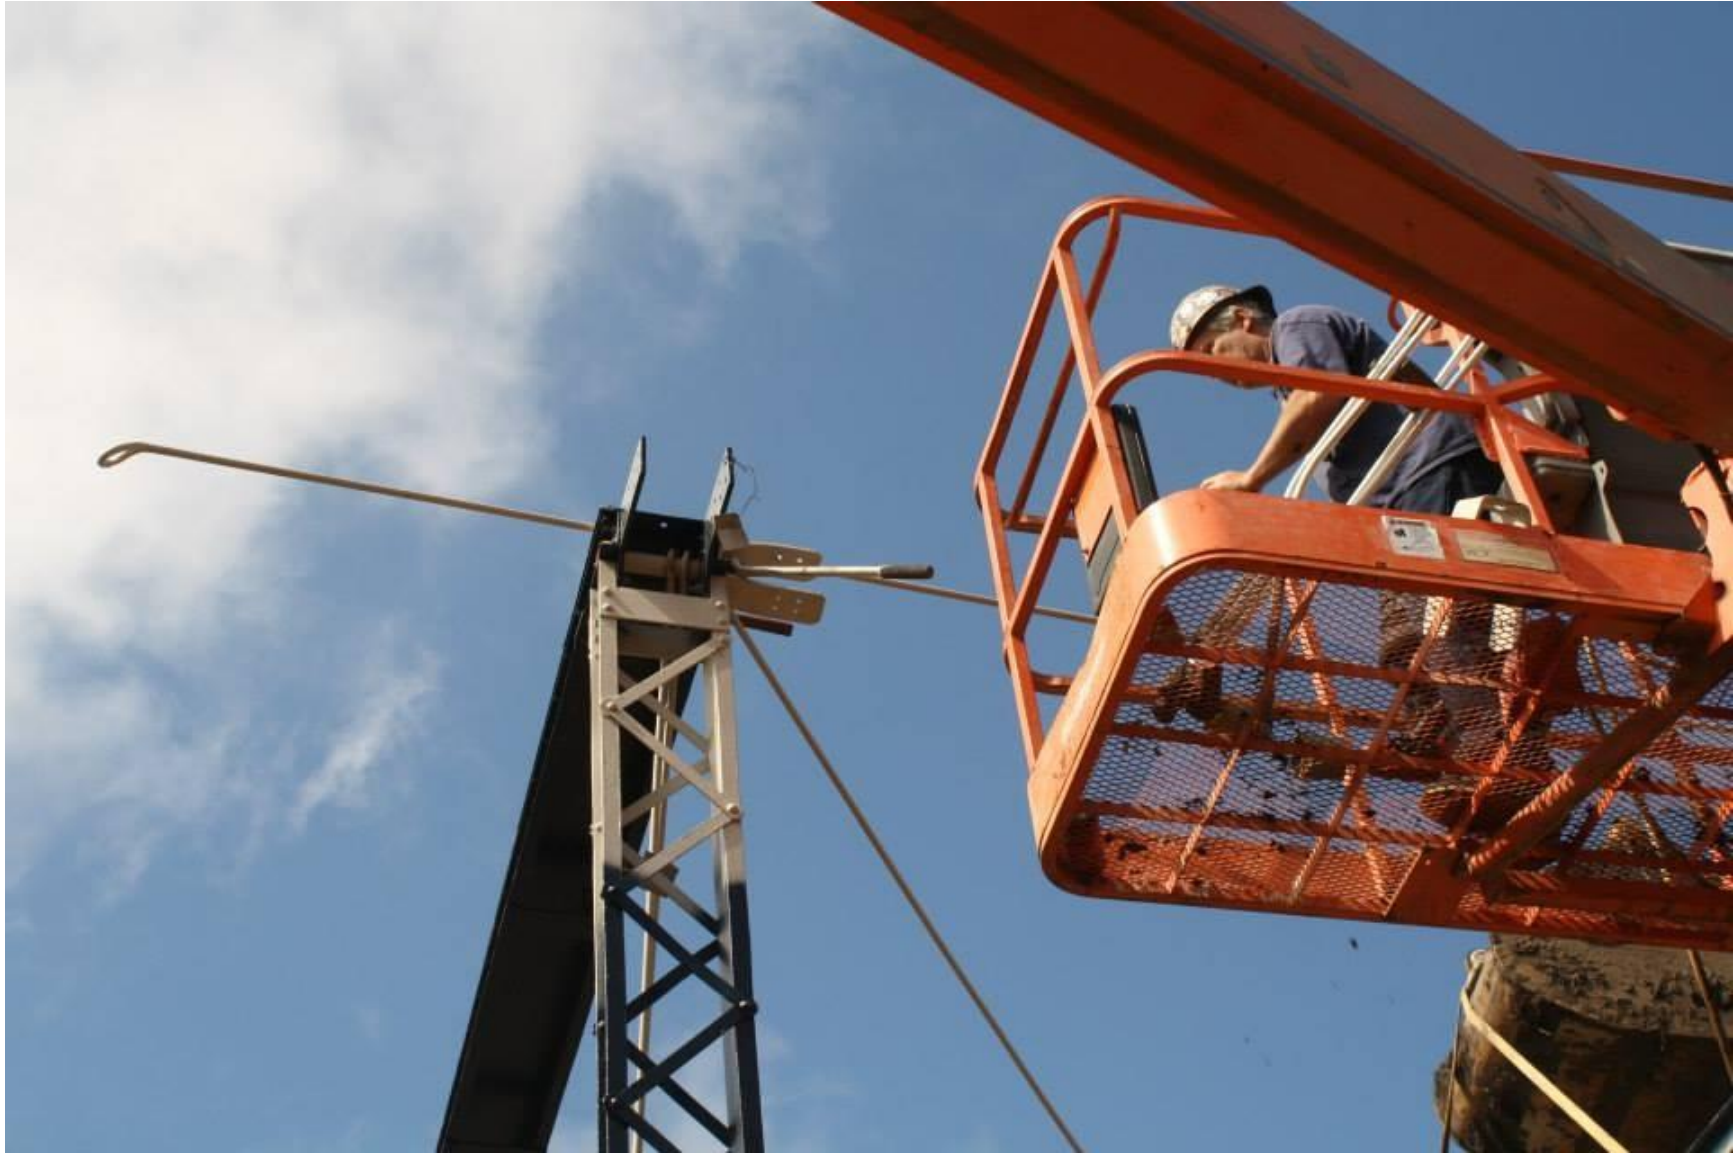
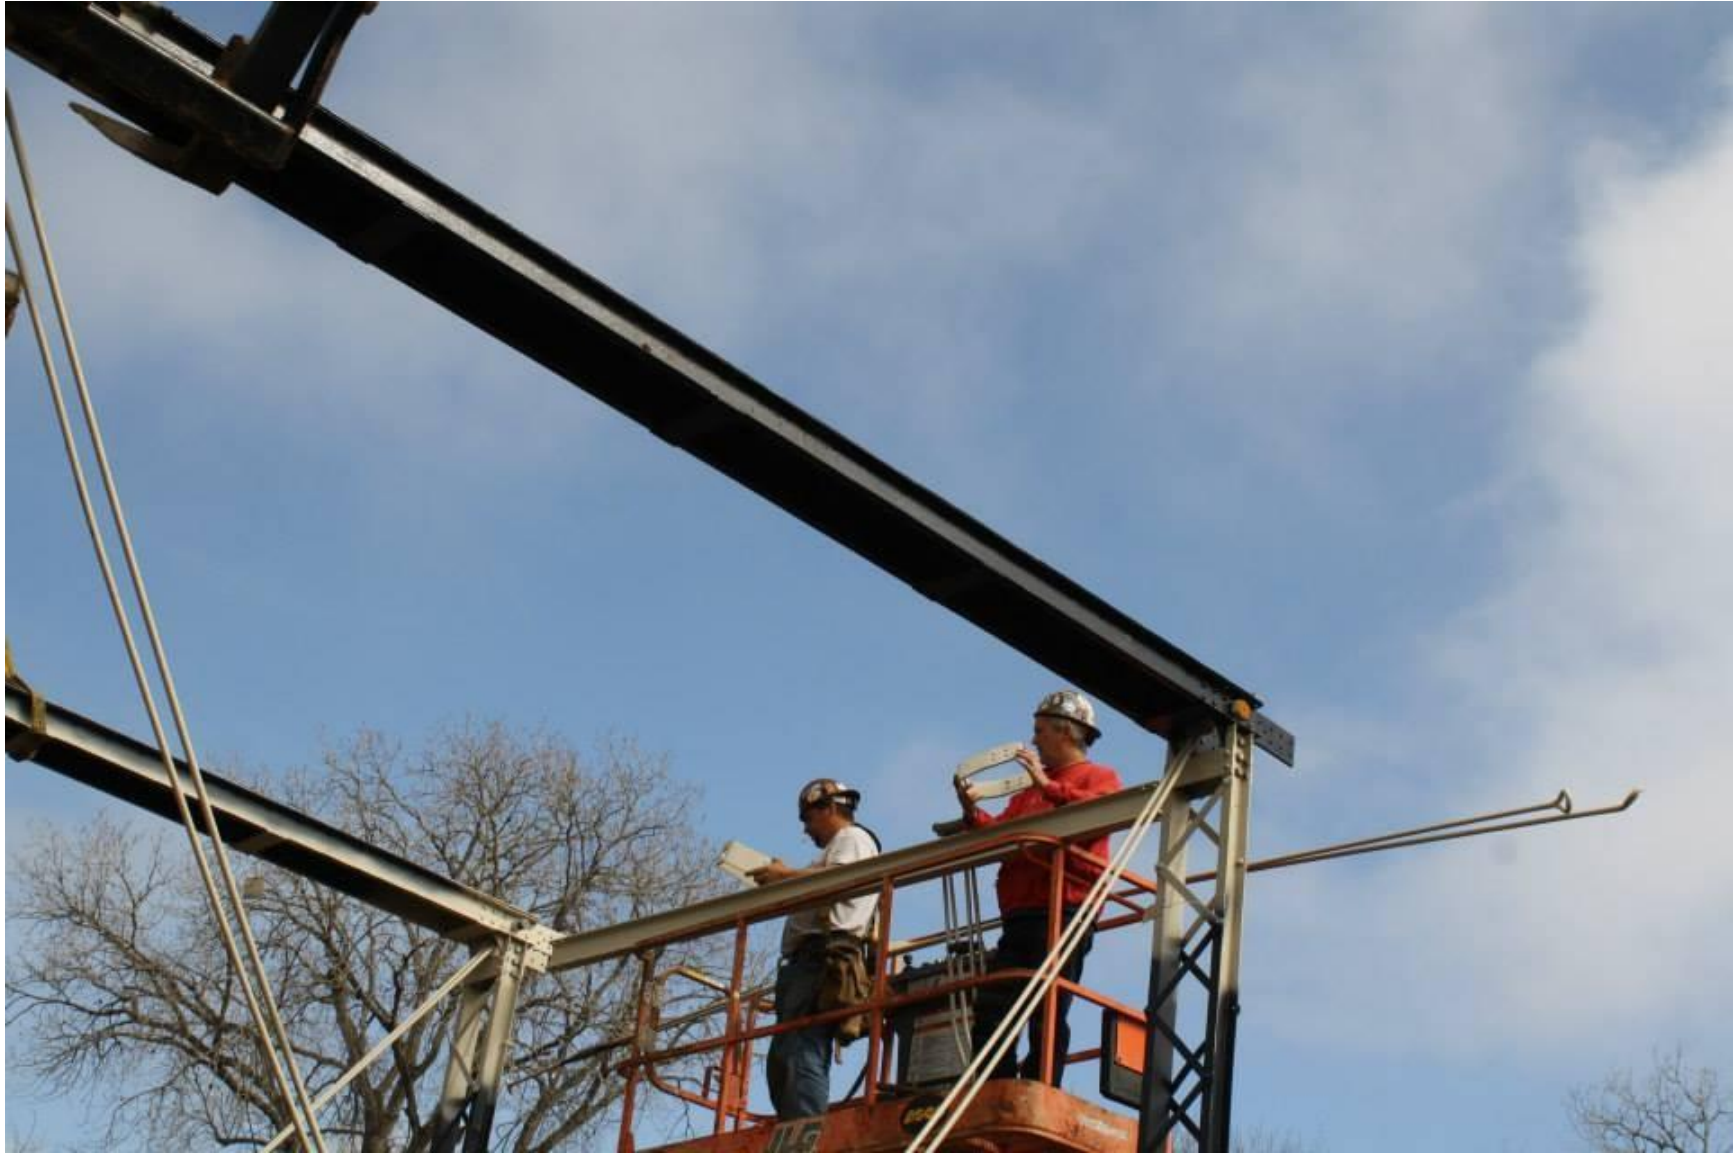
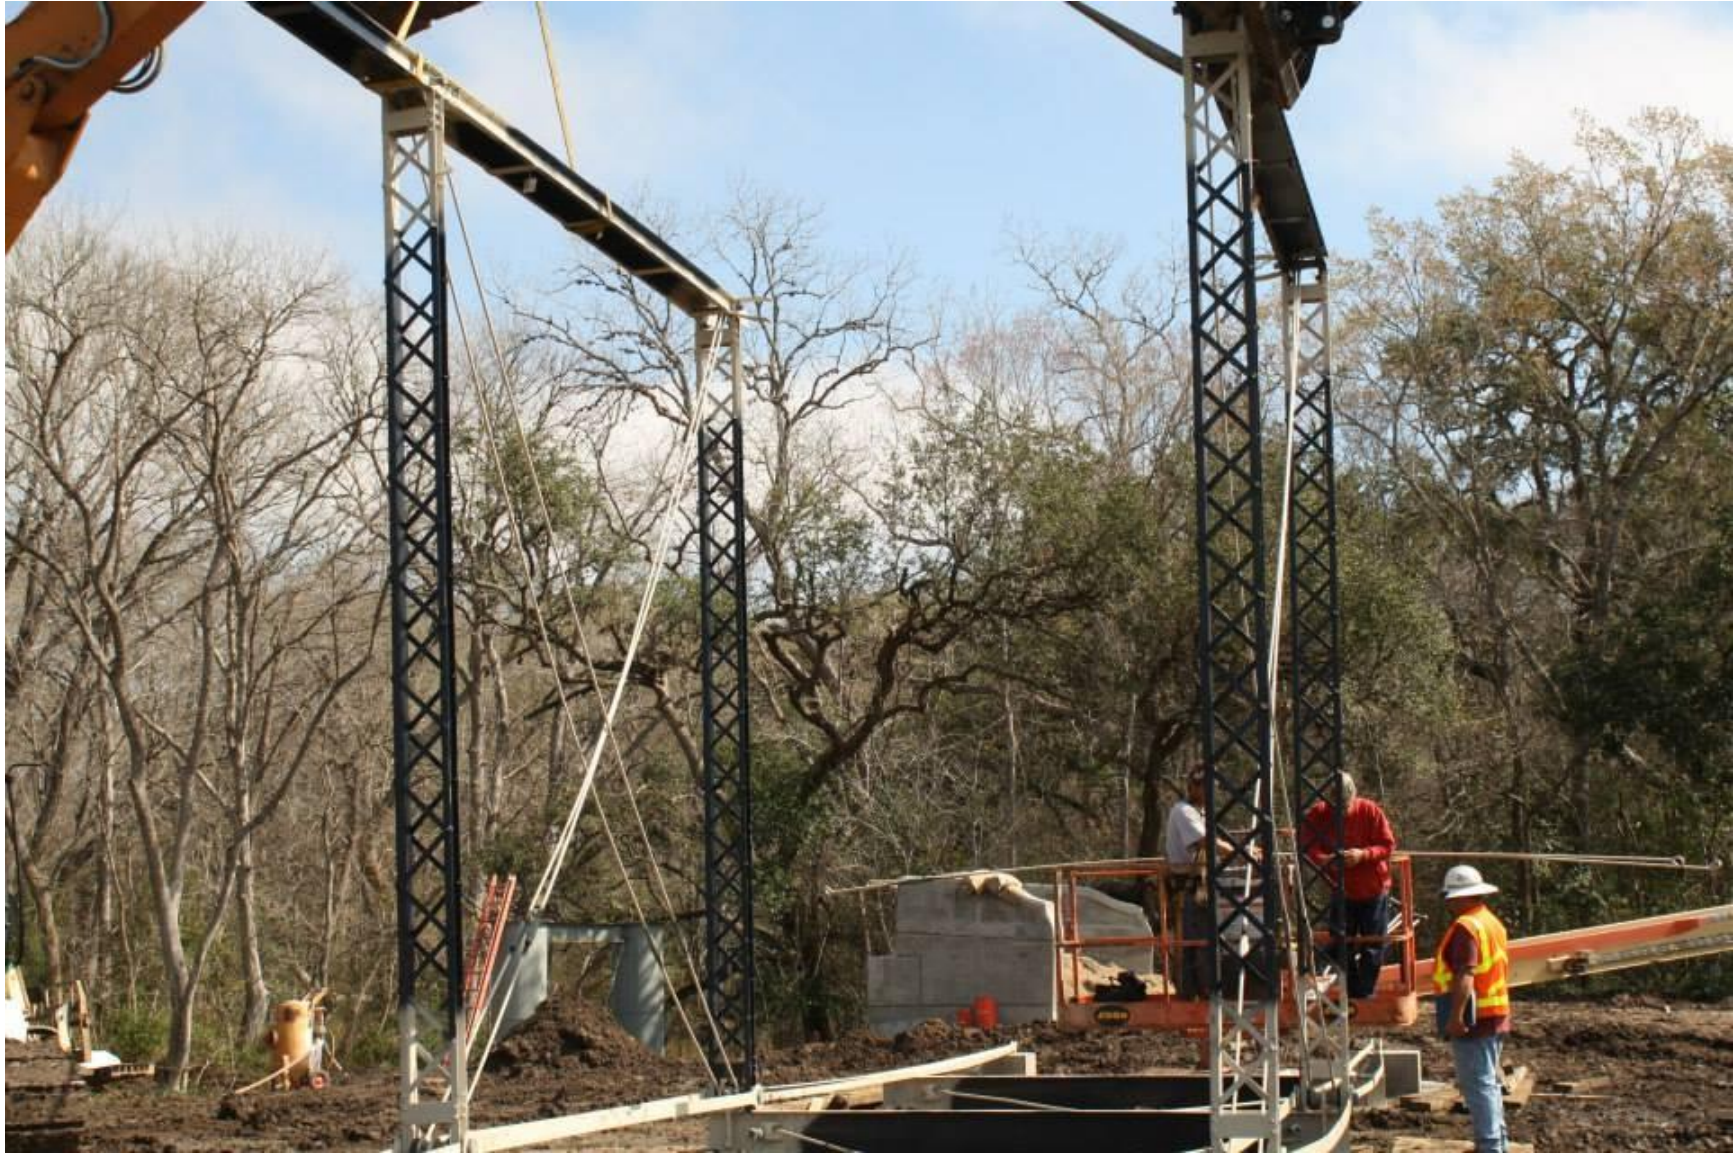
Reassembling the bridge.

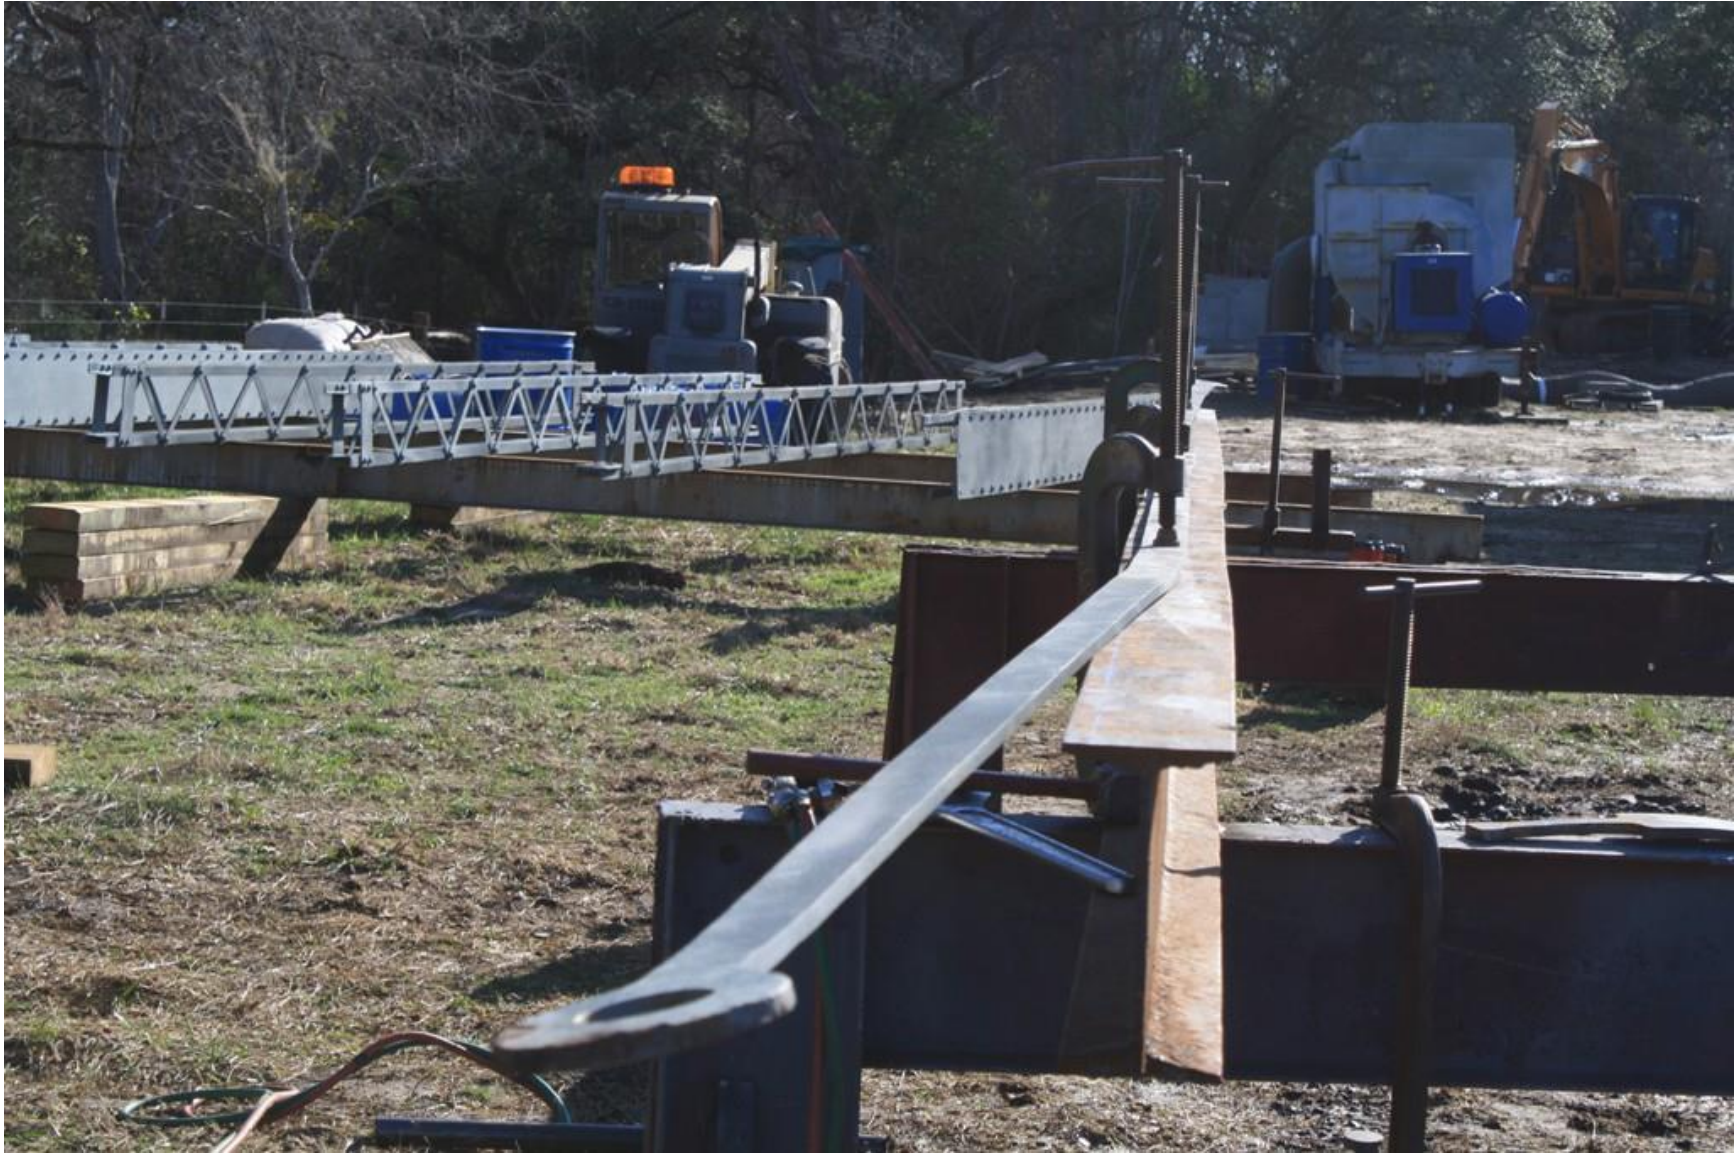
Severely bent eyebar prior to being straightened.

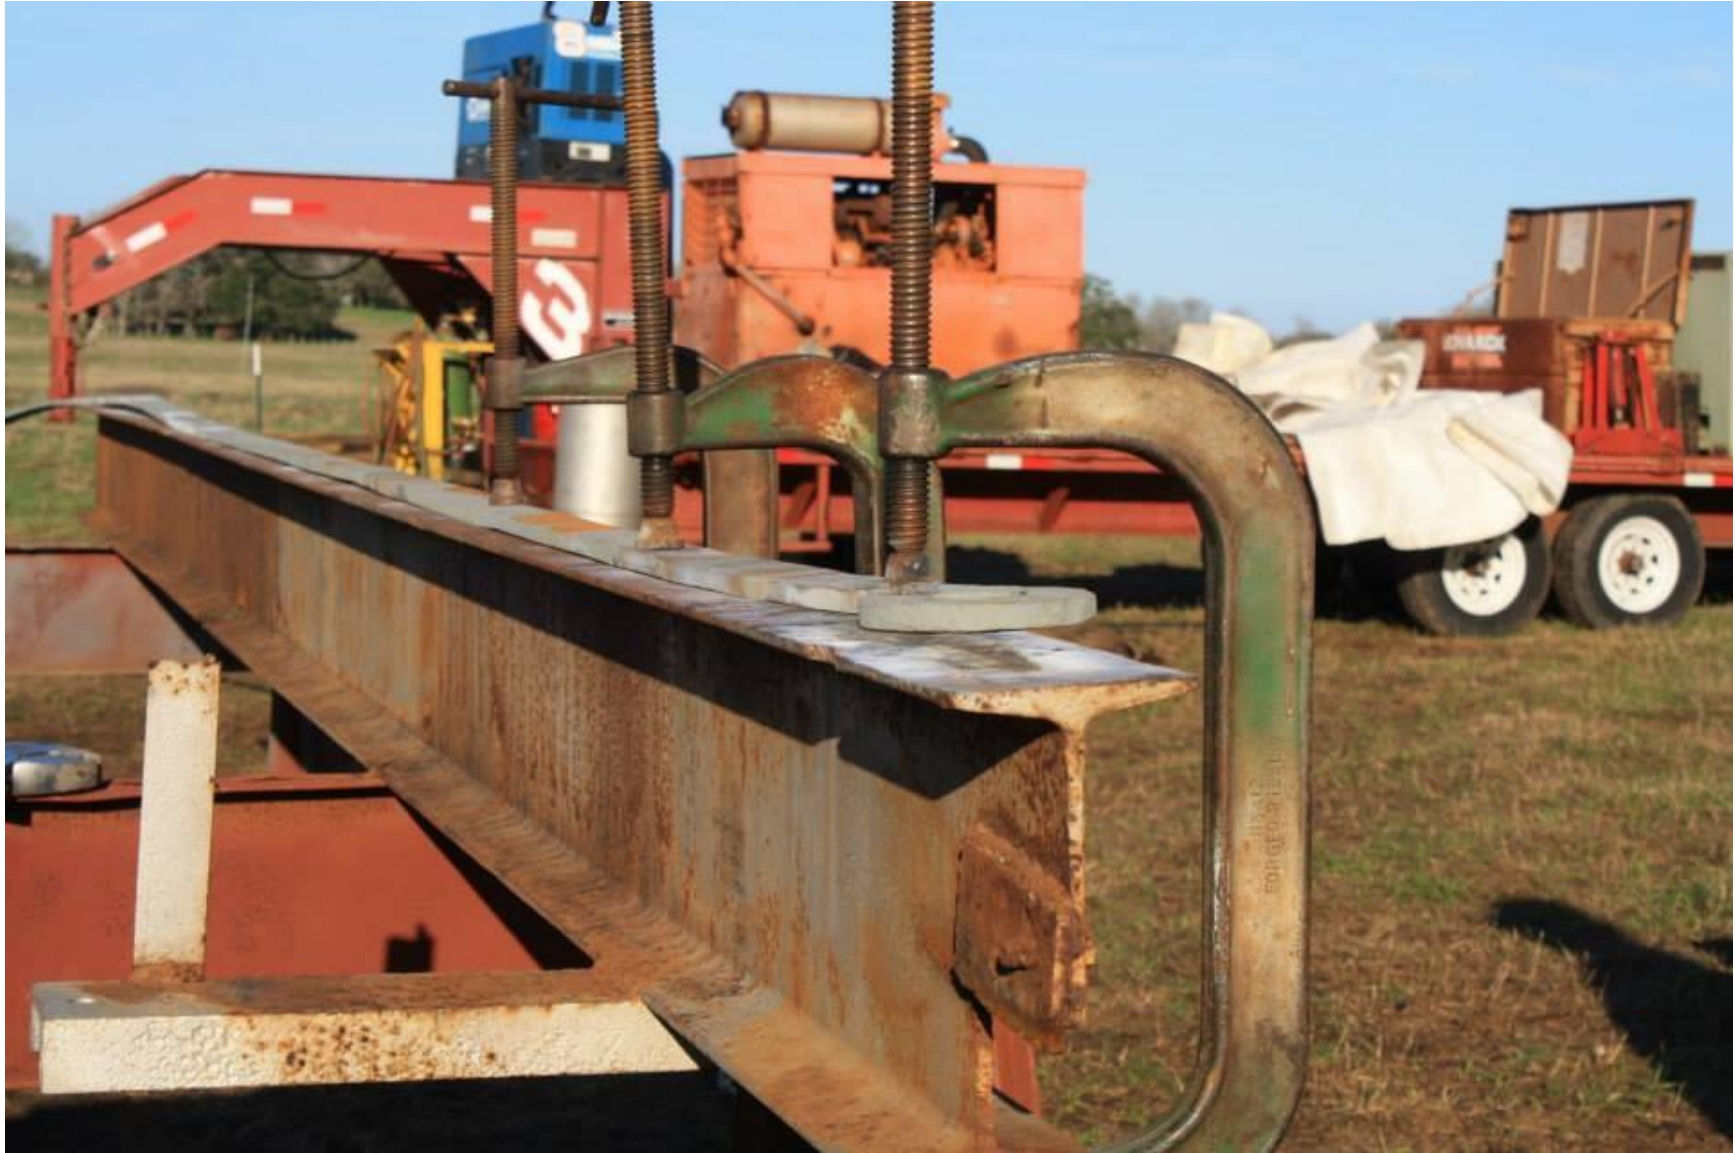
Straightening an eyebar.

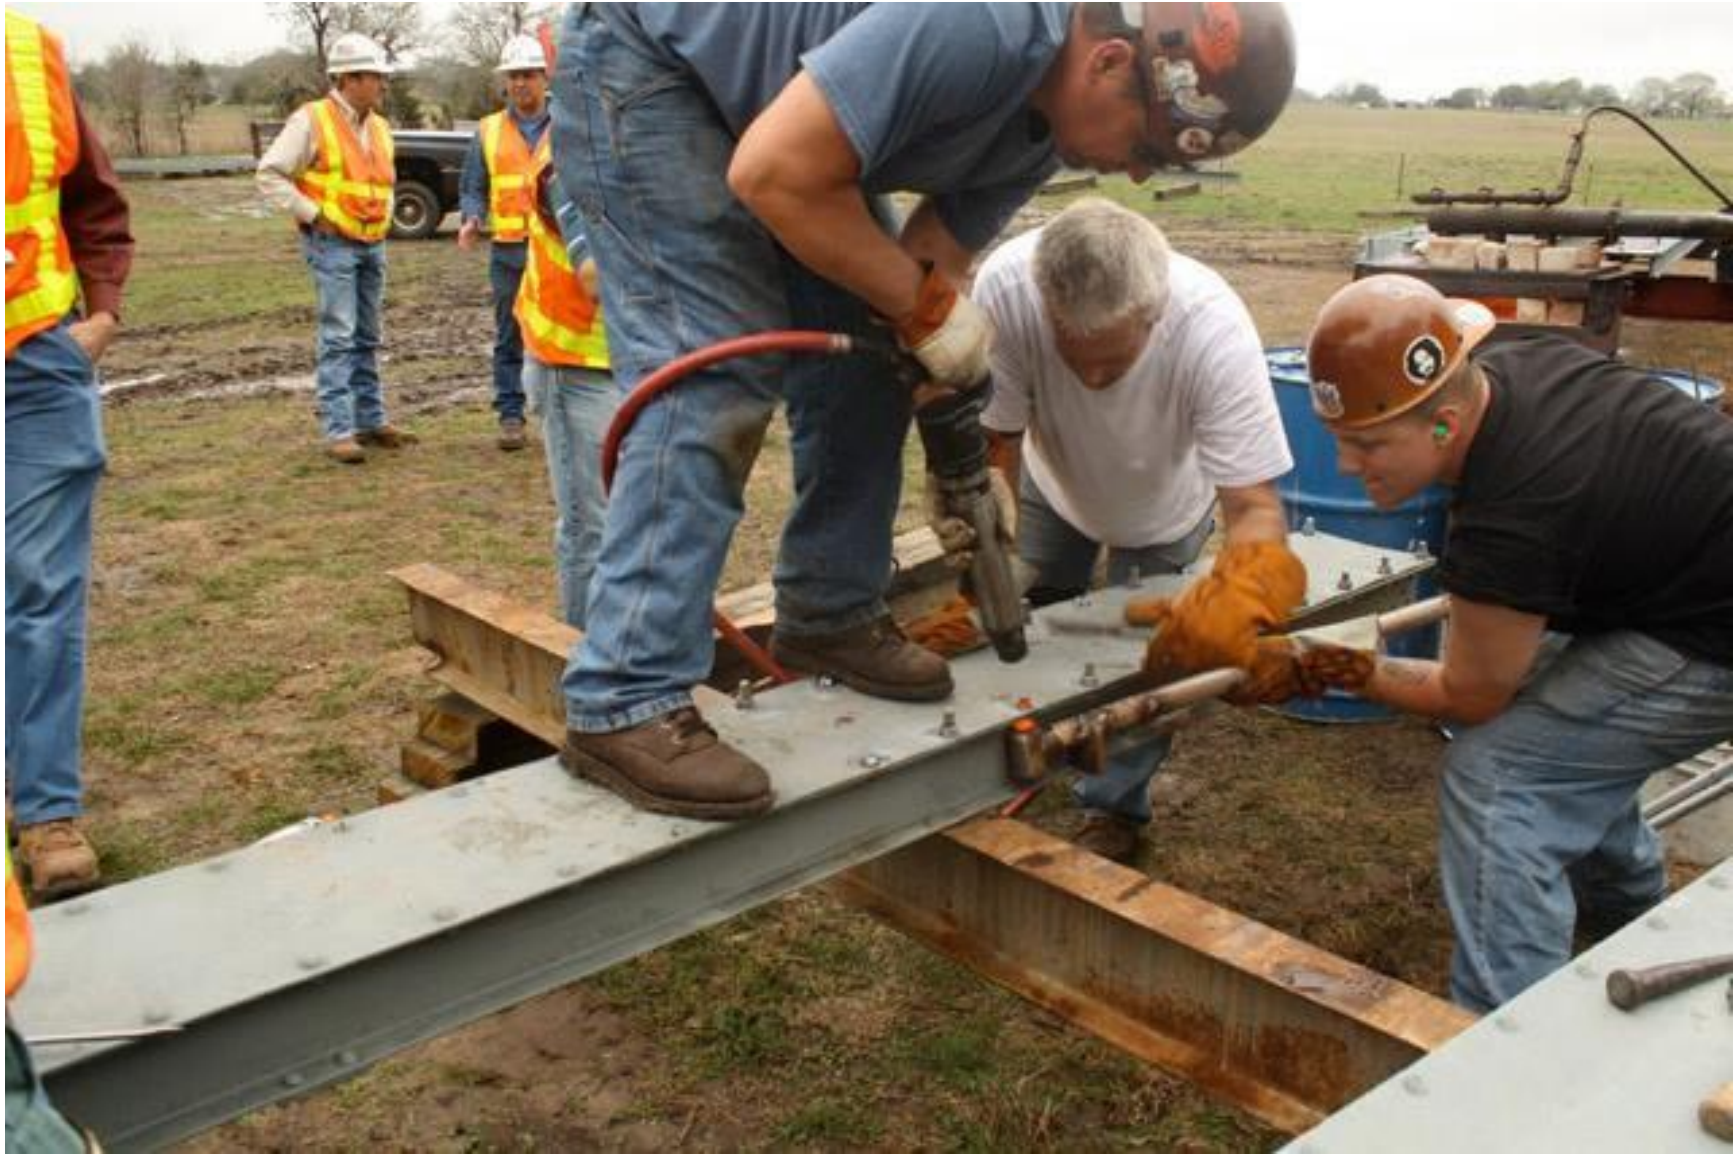
Riveting a cover plate.

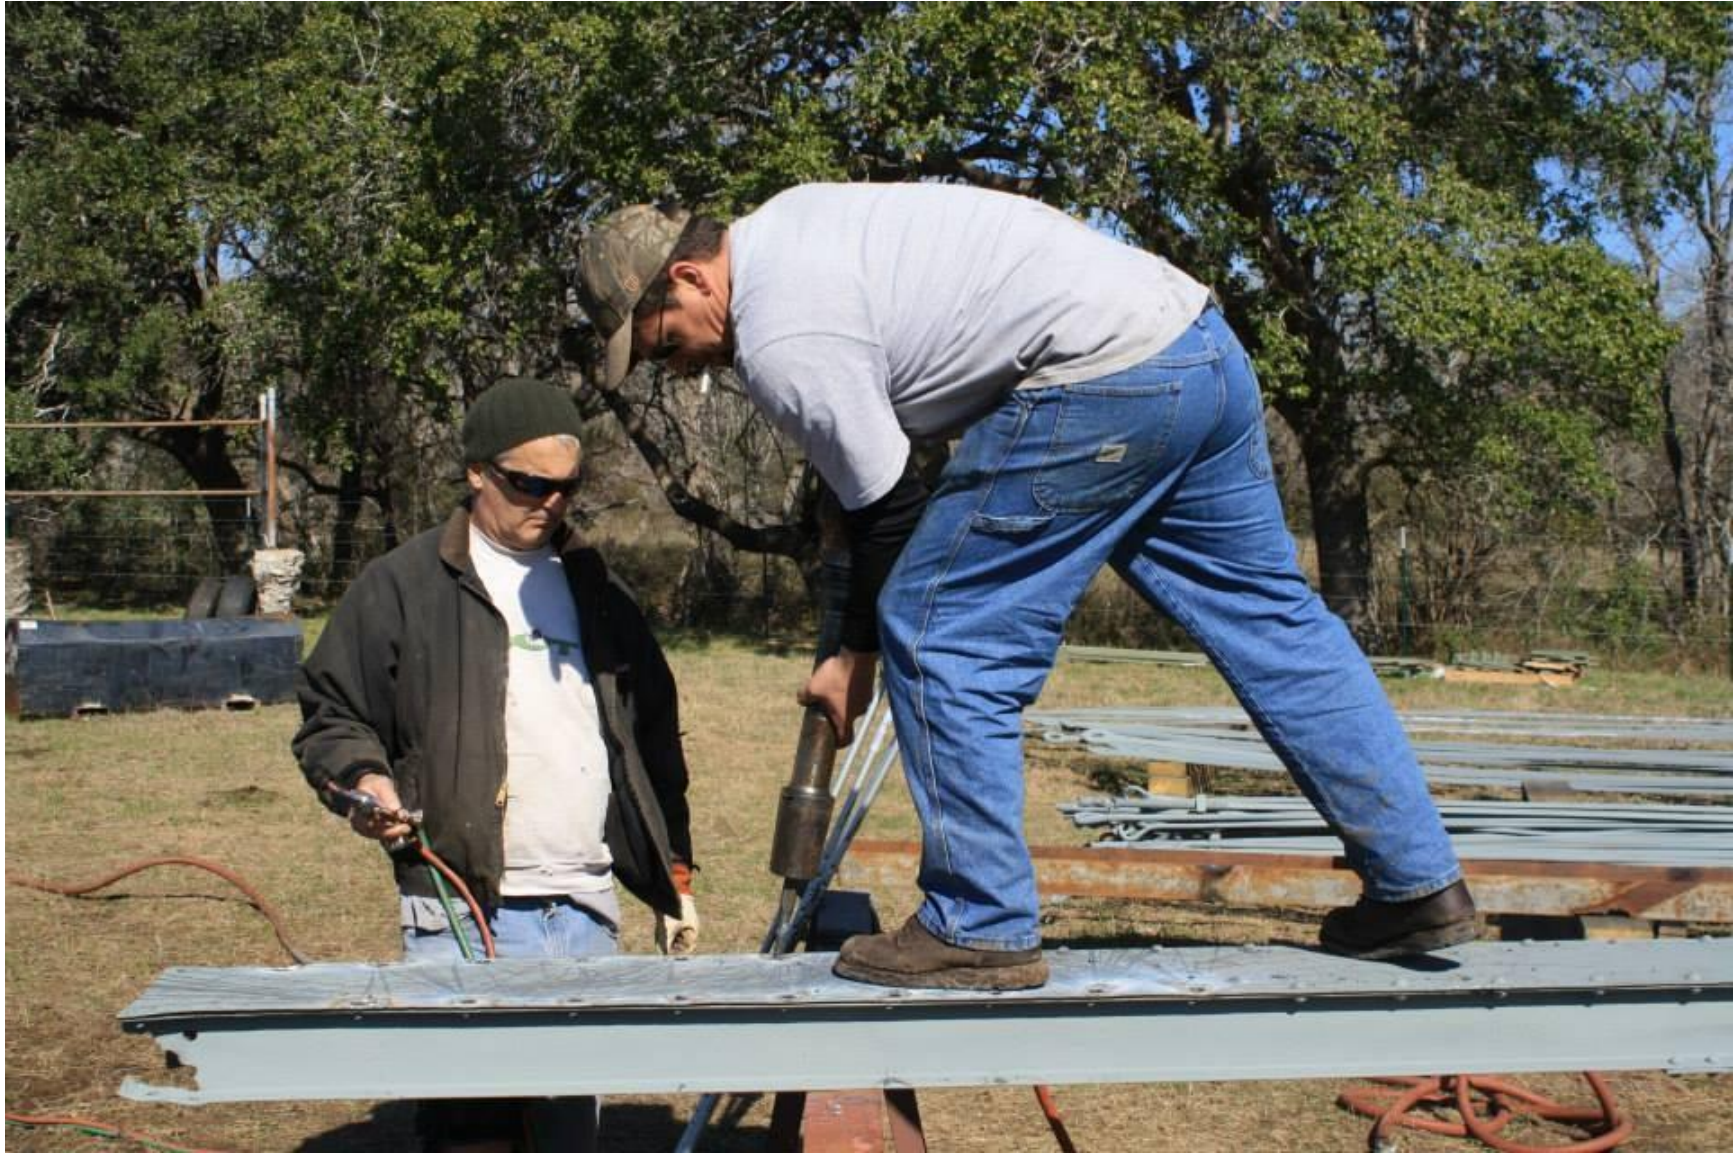
Removing rivets from cover plate.
