Project: Piano Bridge

Project Completed: 2012

Overview: Full in-kind repair and restoration of this historic metal truss bridge for continued vehicular use. Bach Steel was responsible for repair of existing steel, including heat straightening, hot riveting as needed for fasteners, pack rust removal as needed. Heat straightening work included the heavily impact-damaged portal bracing, bent bottom chord eyebars (a fracture critical member), and impact damaged lattice railing.

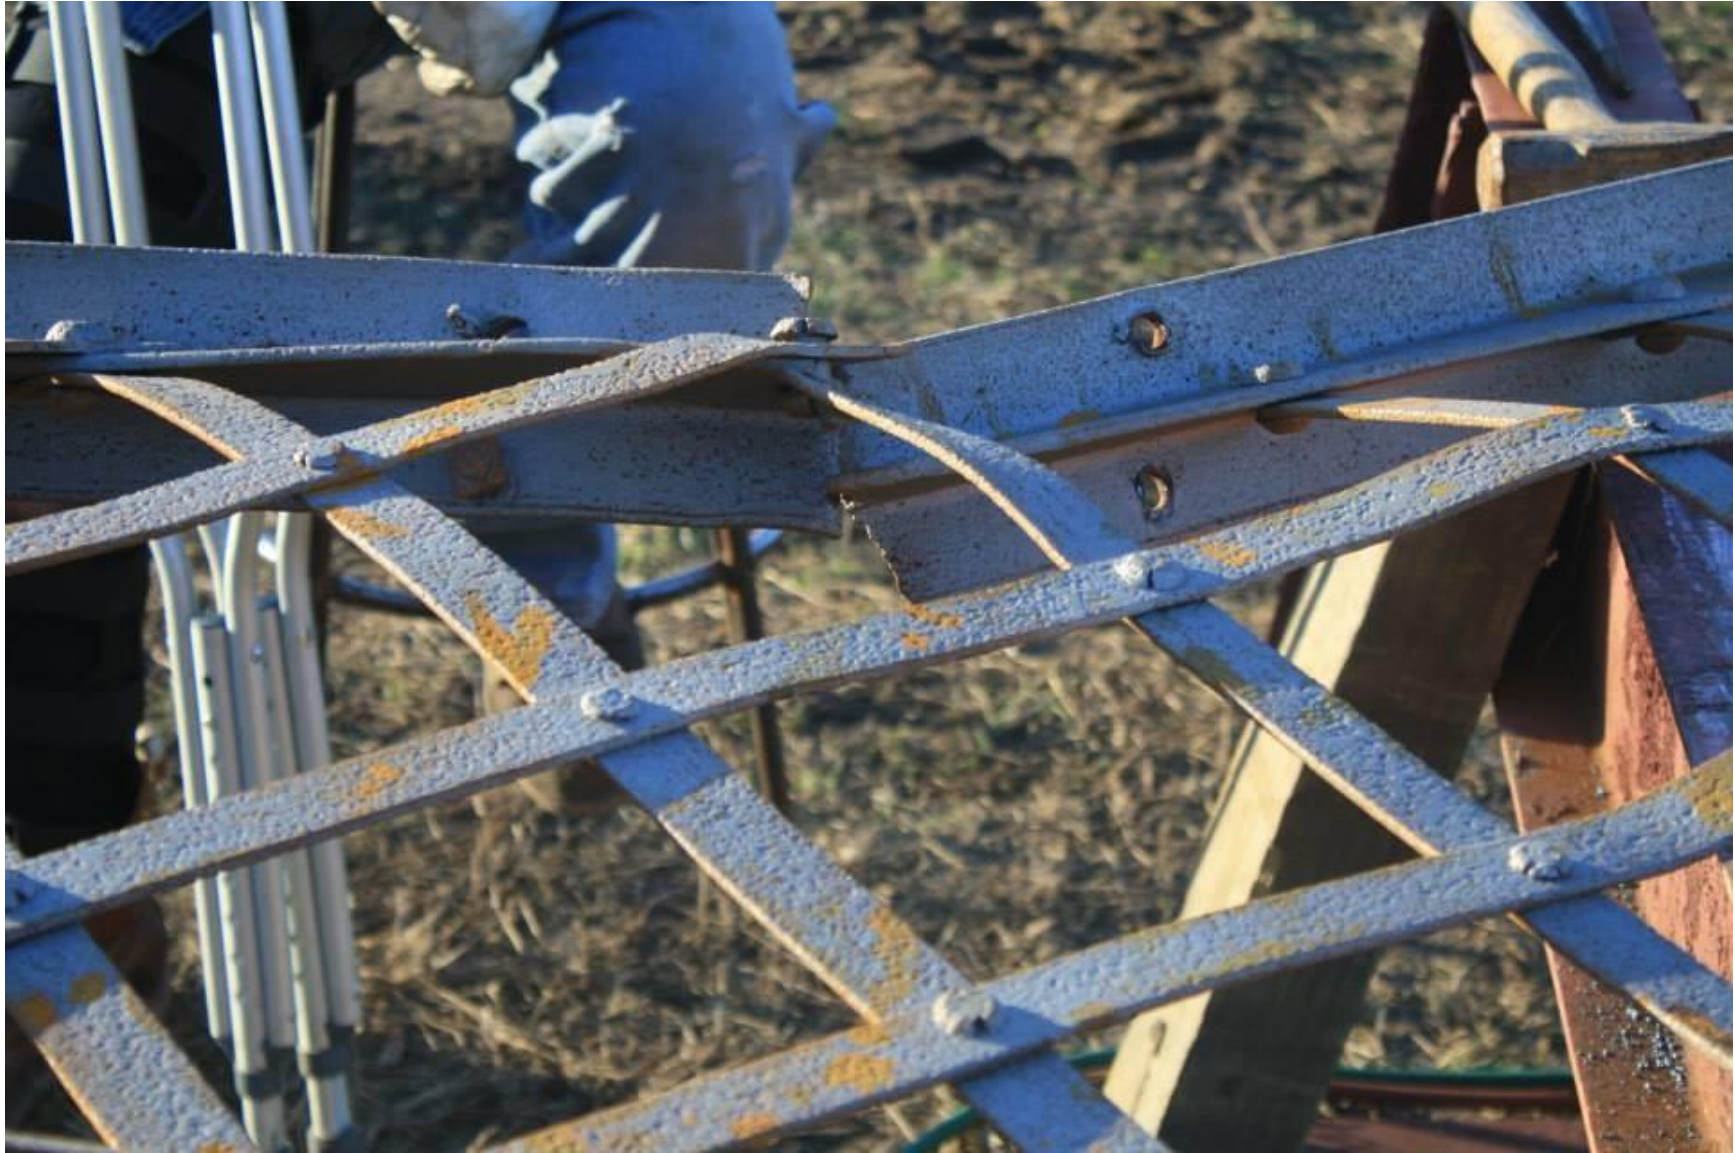
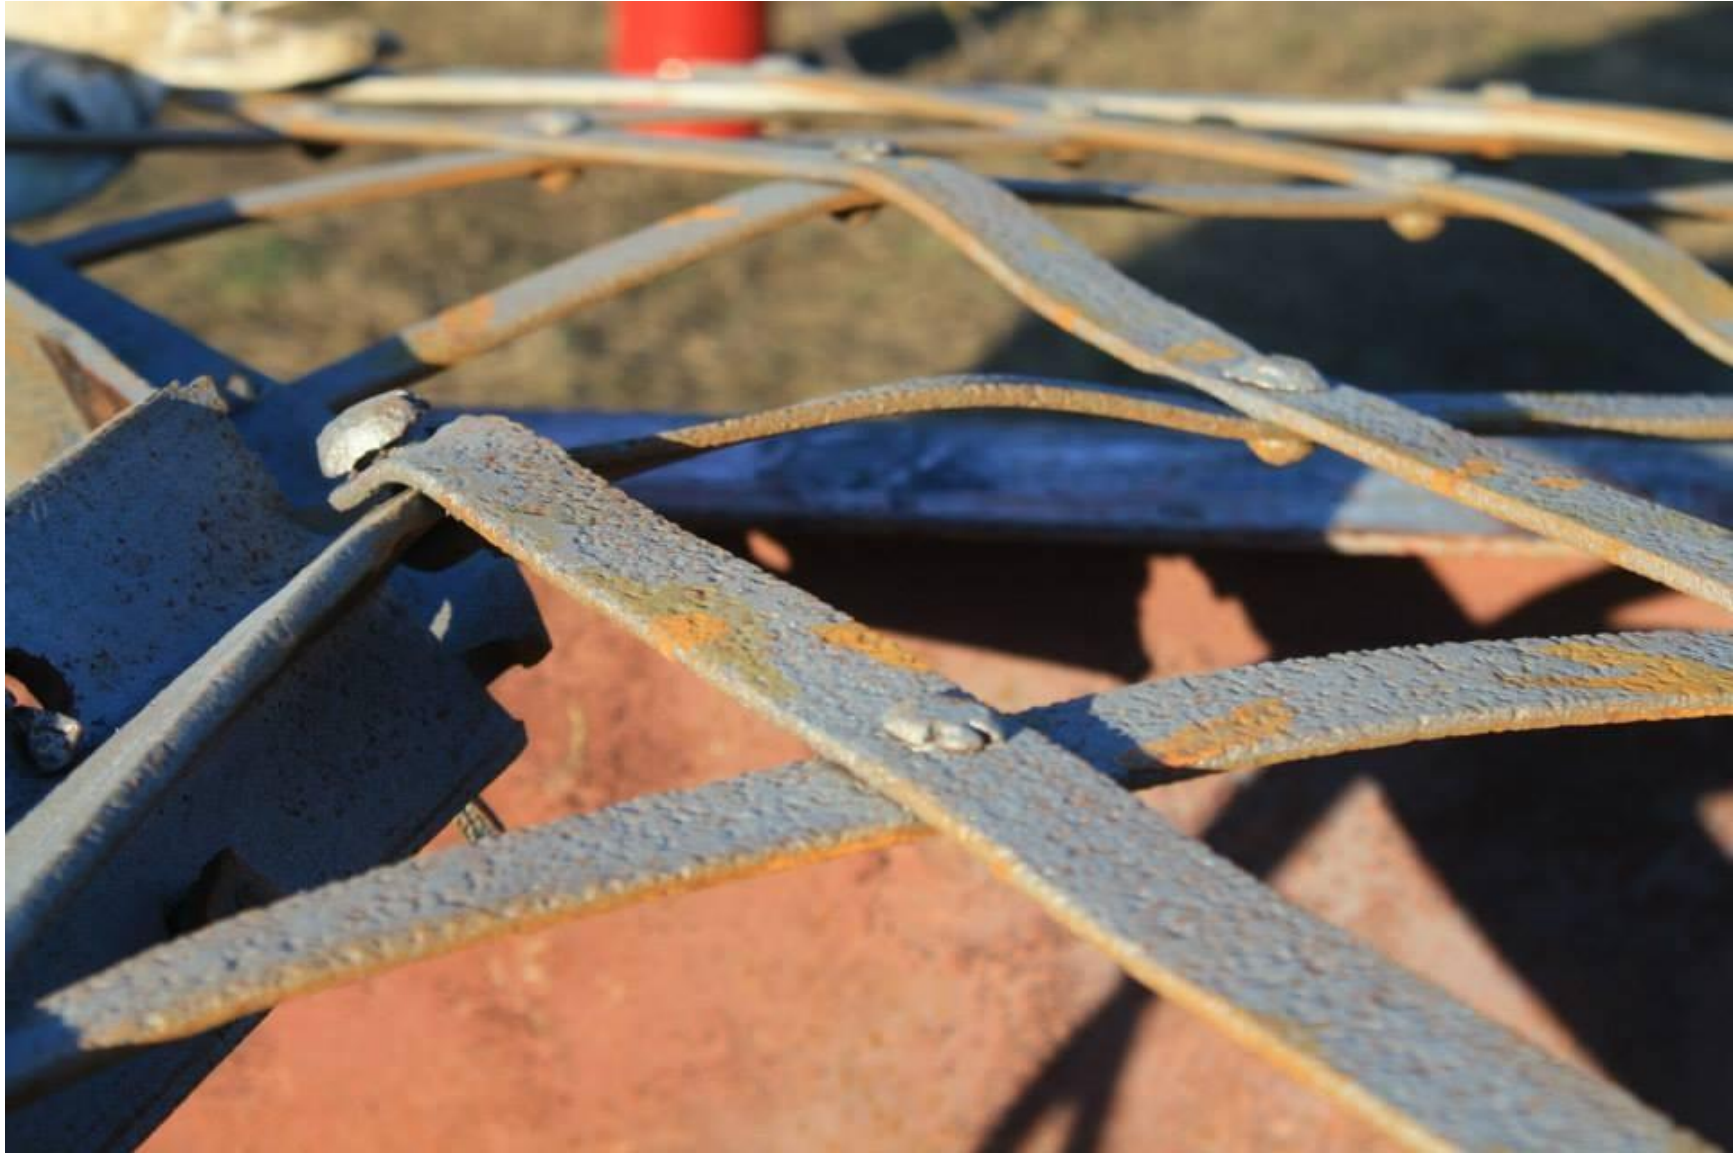
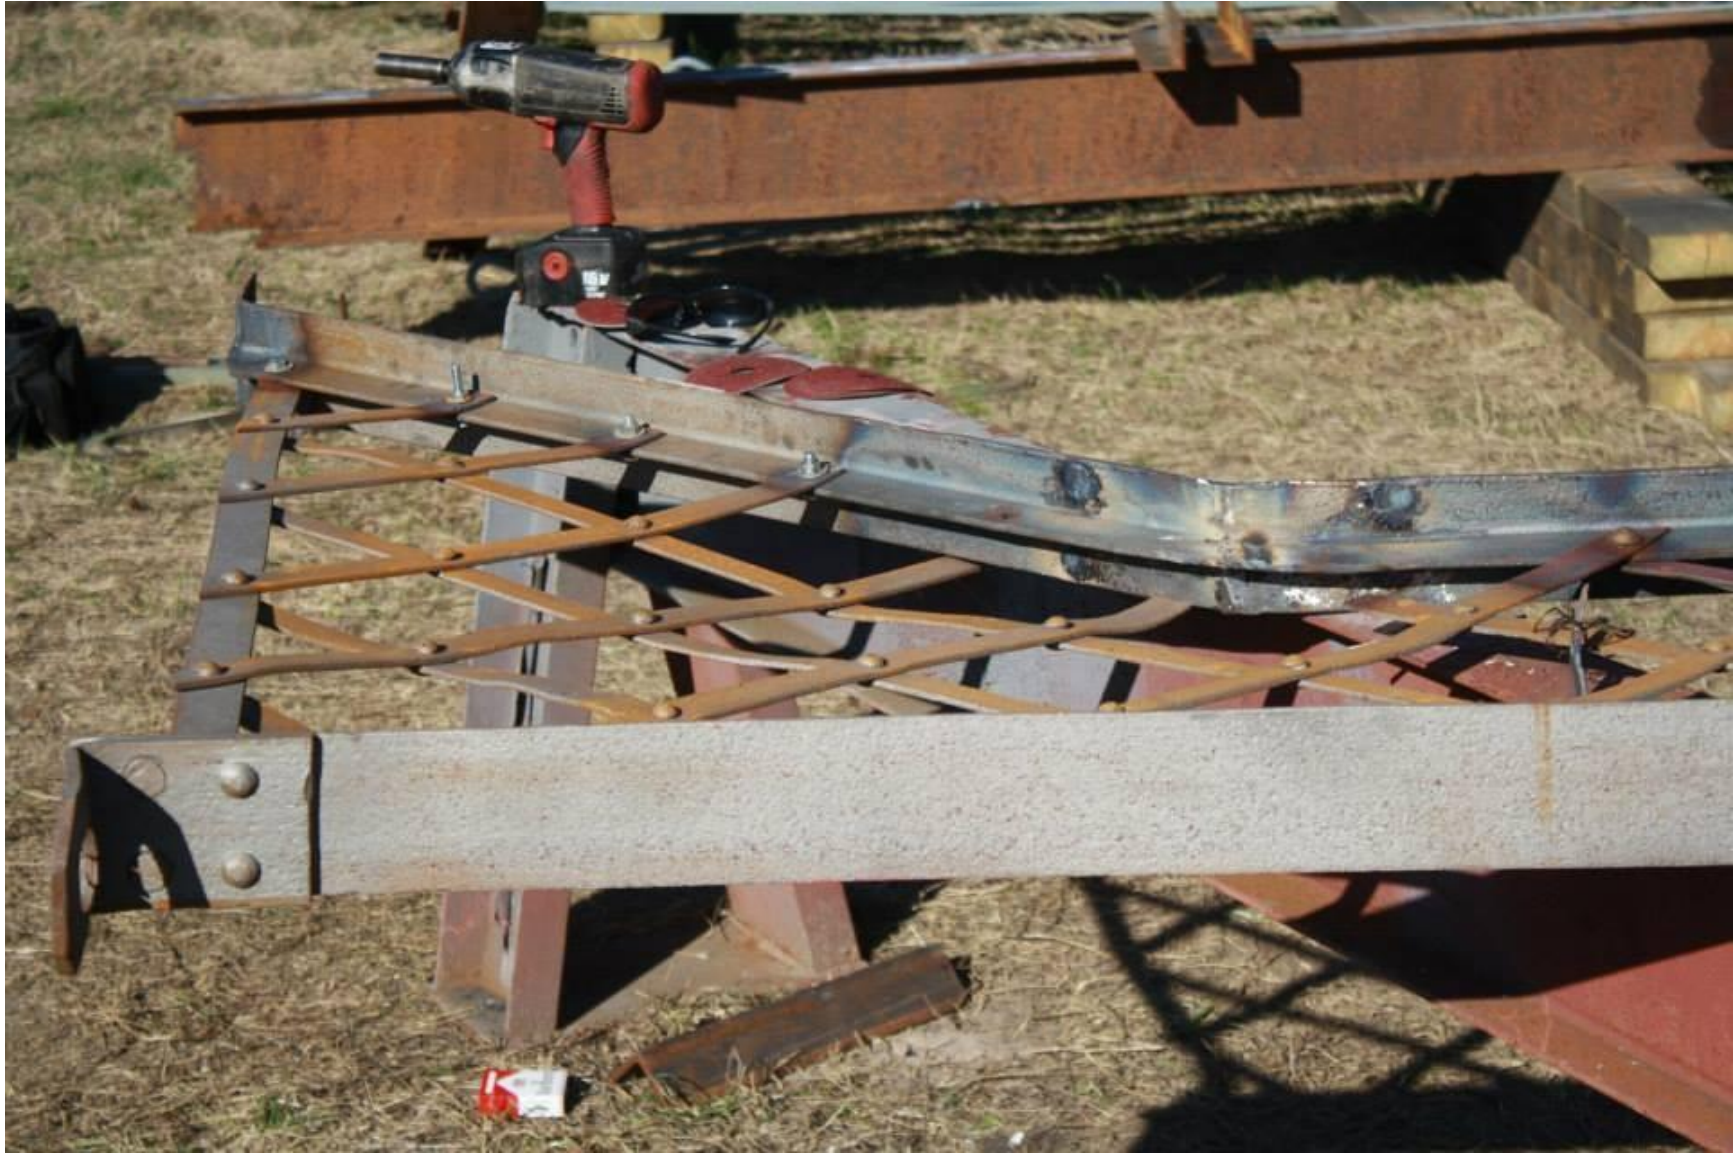
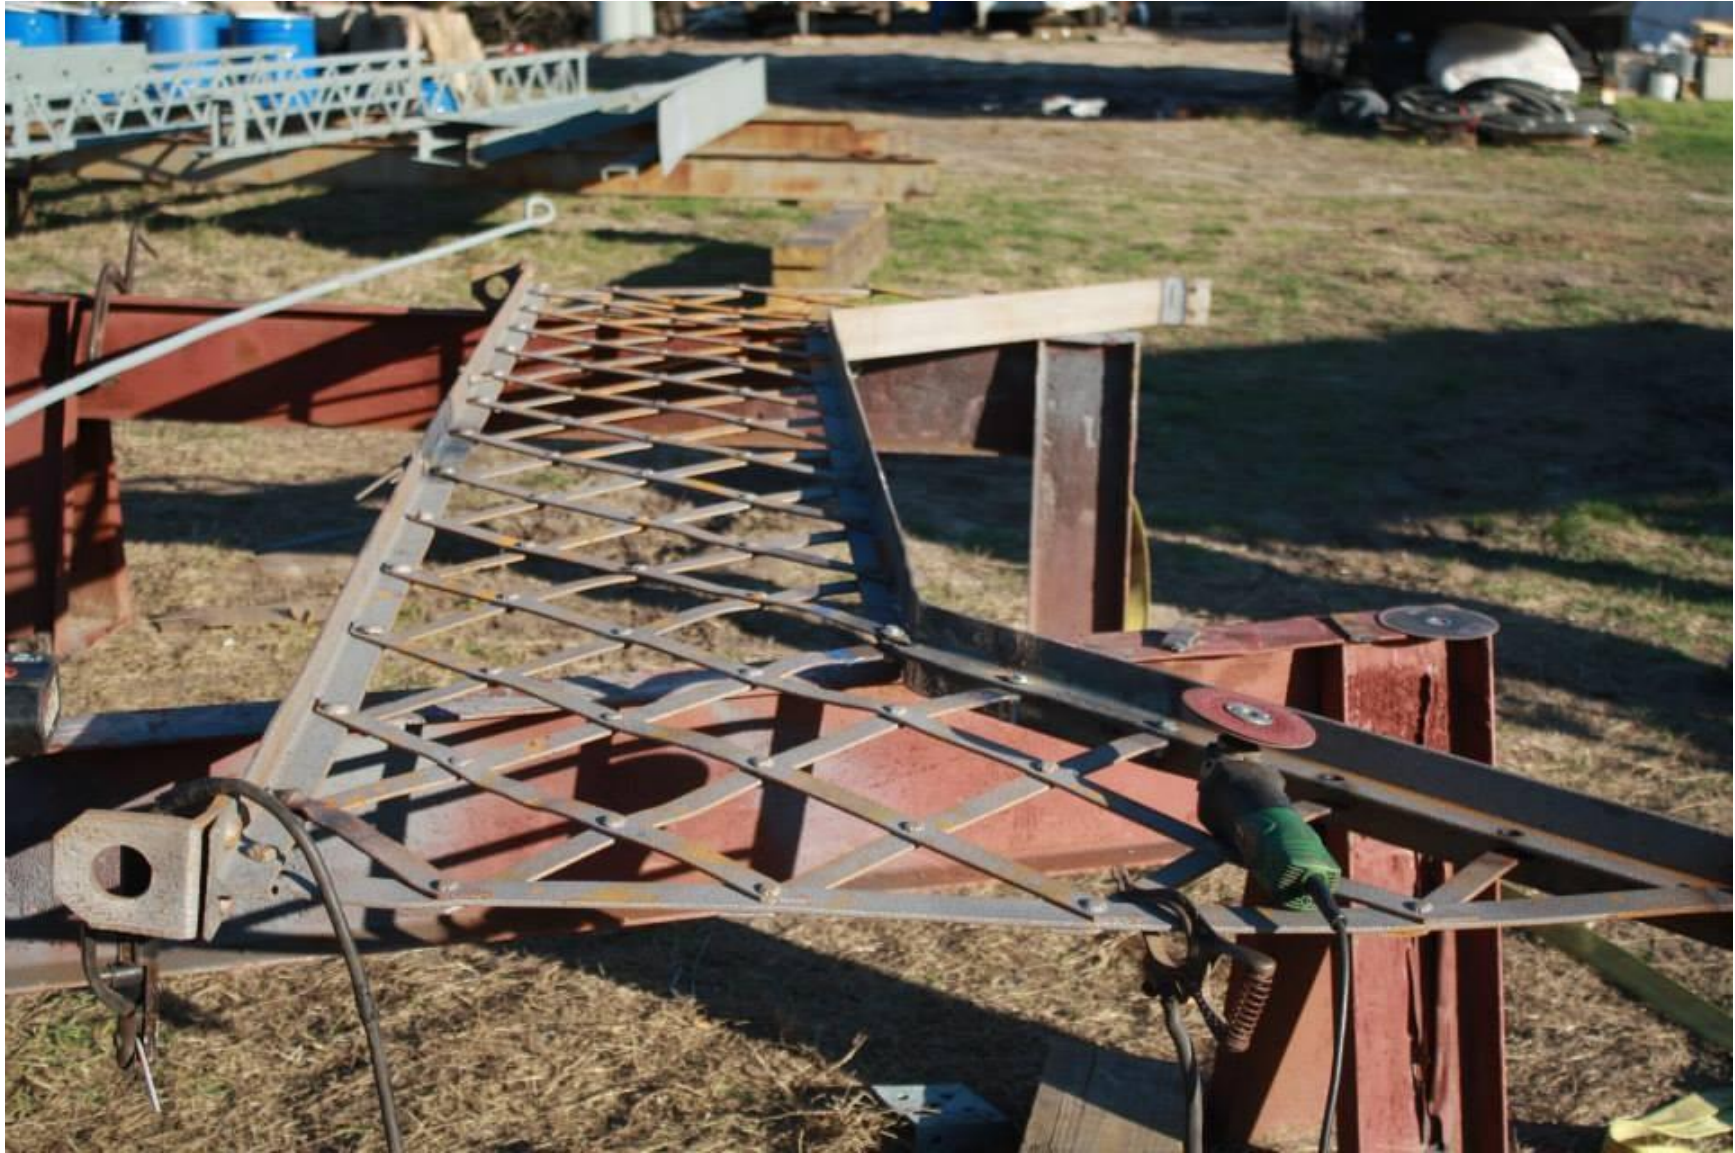
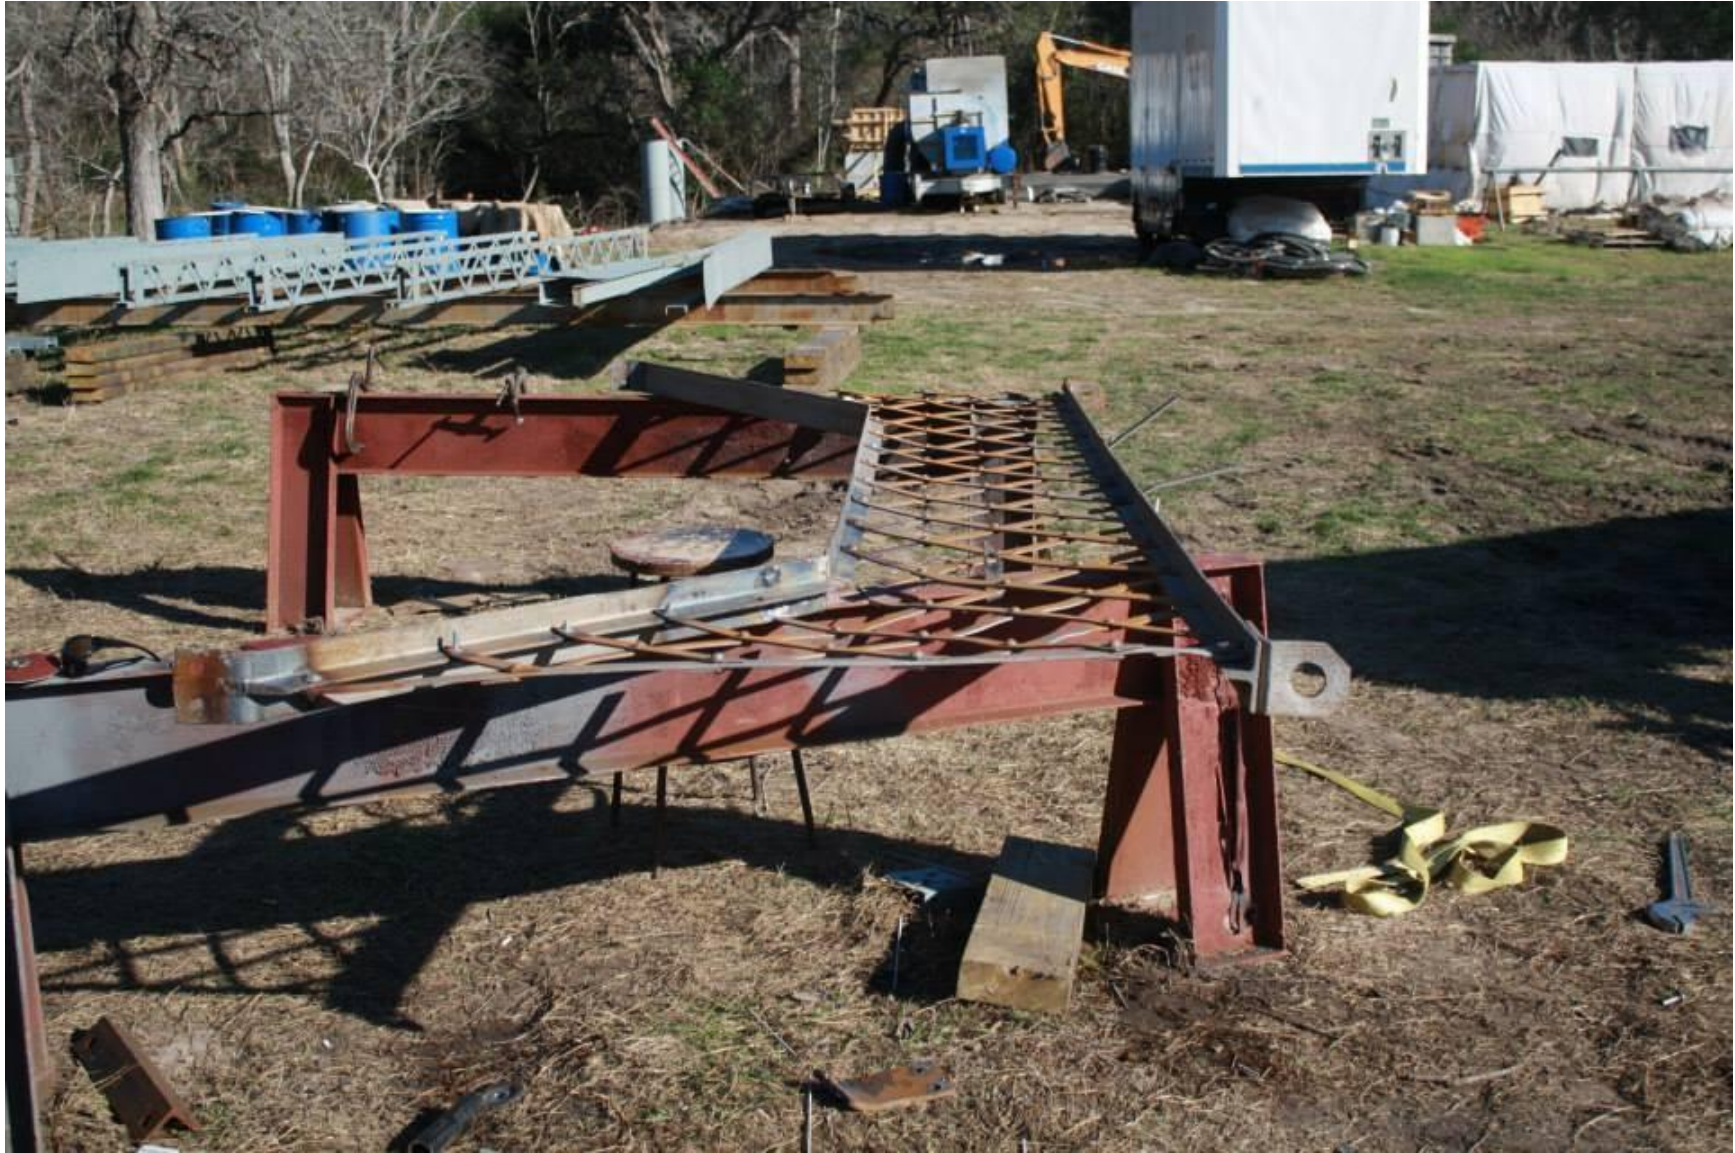
The portal bracing had extensive damage which was repaired.

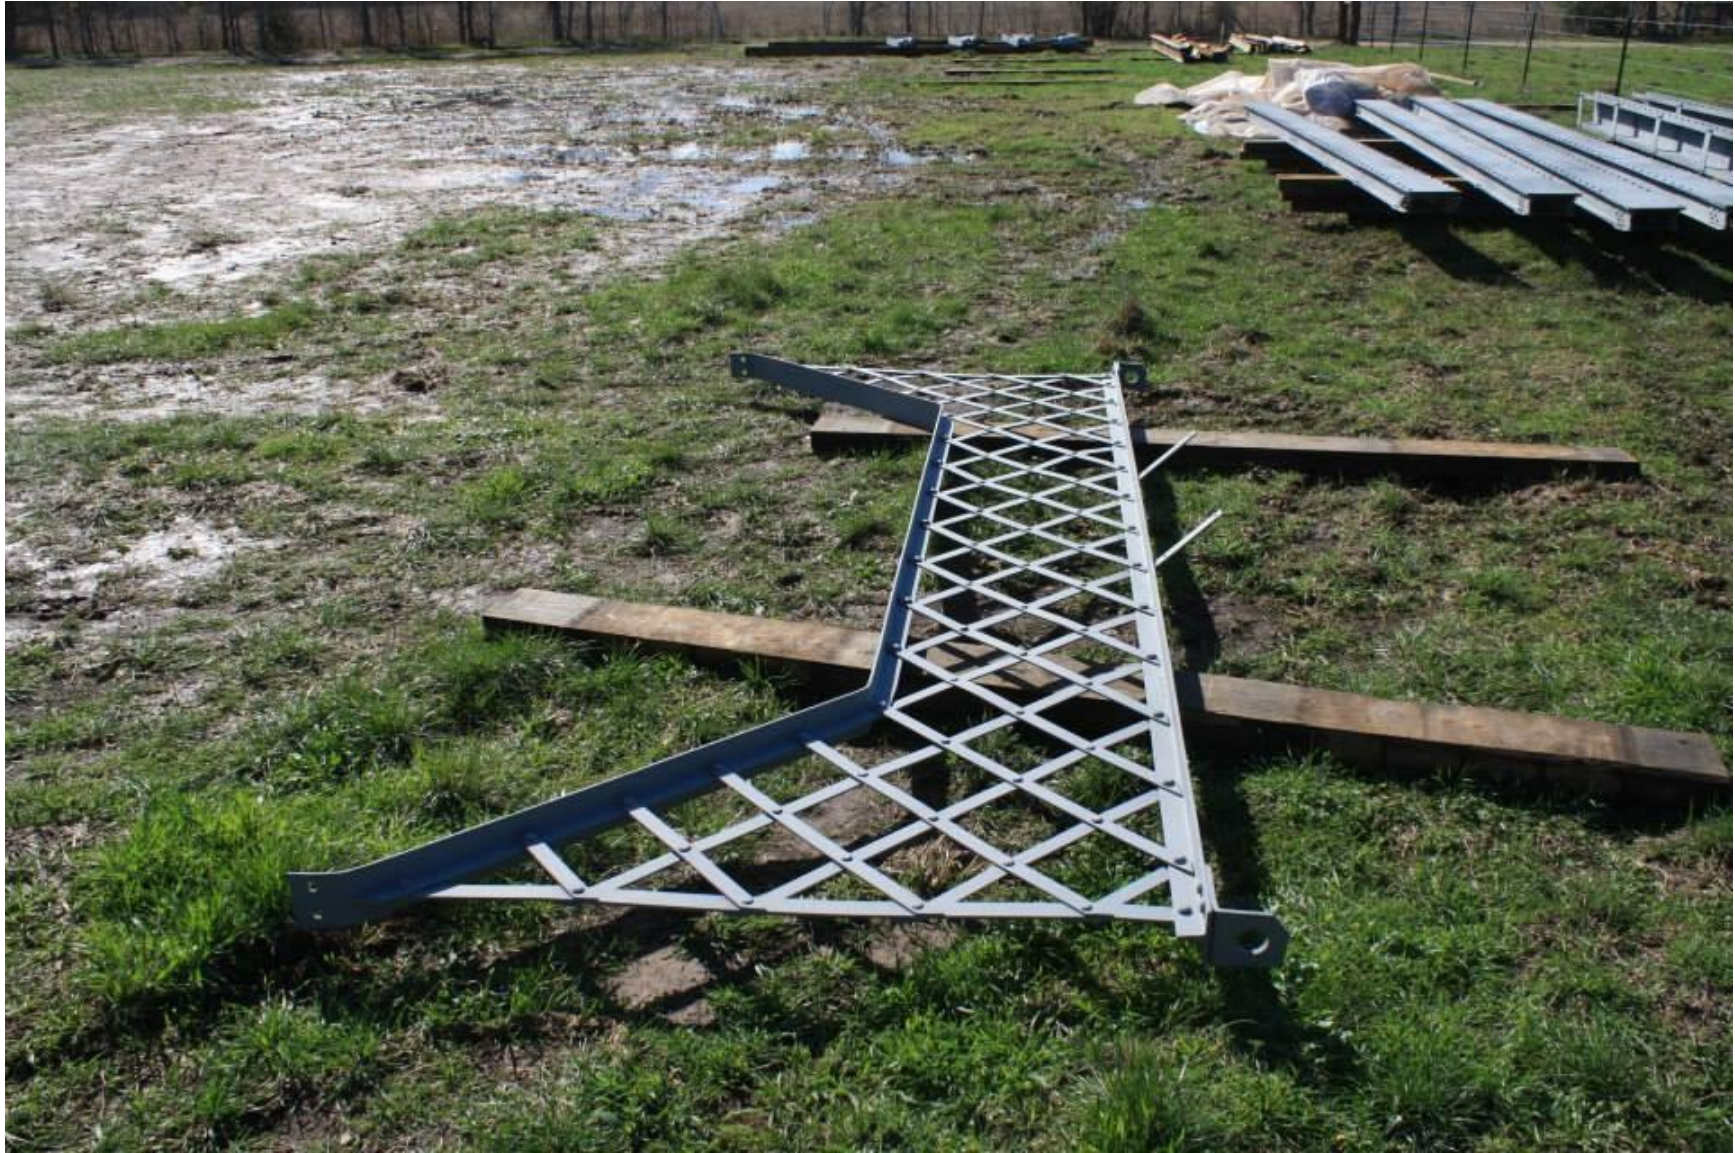
Restored portal bracing.

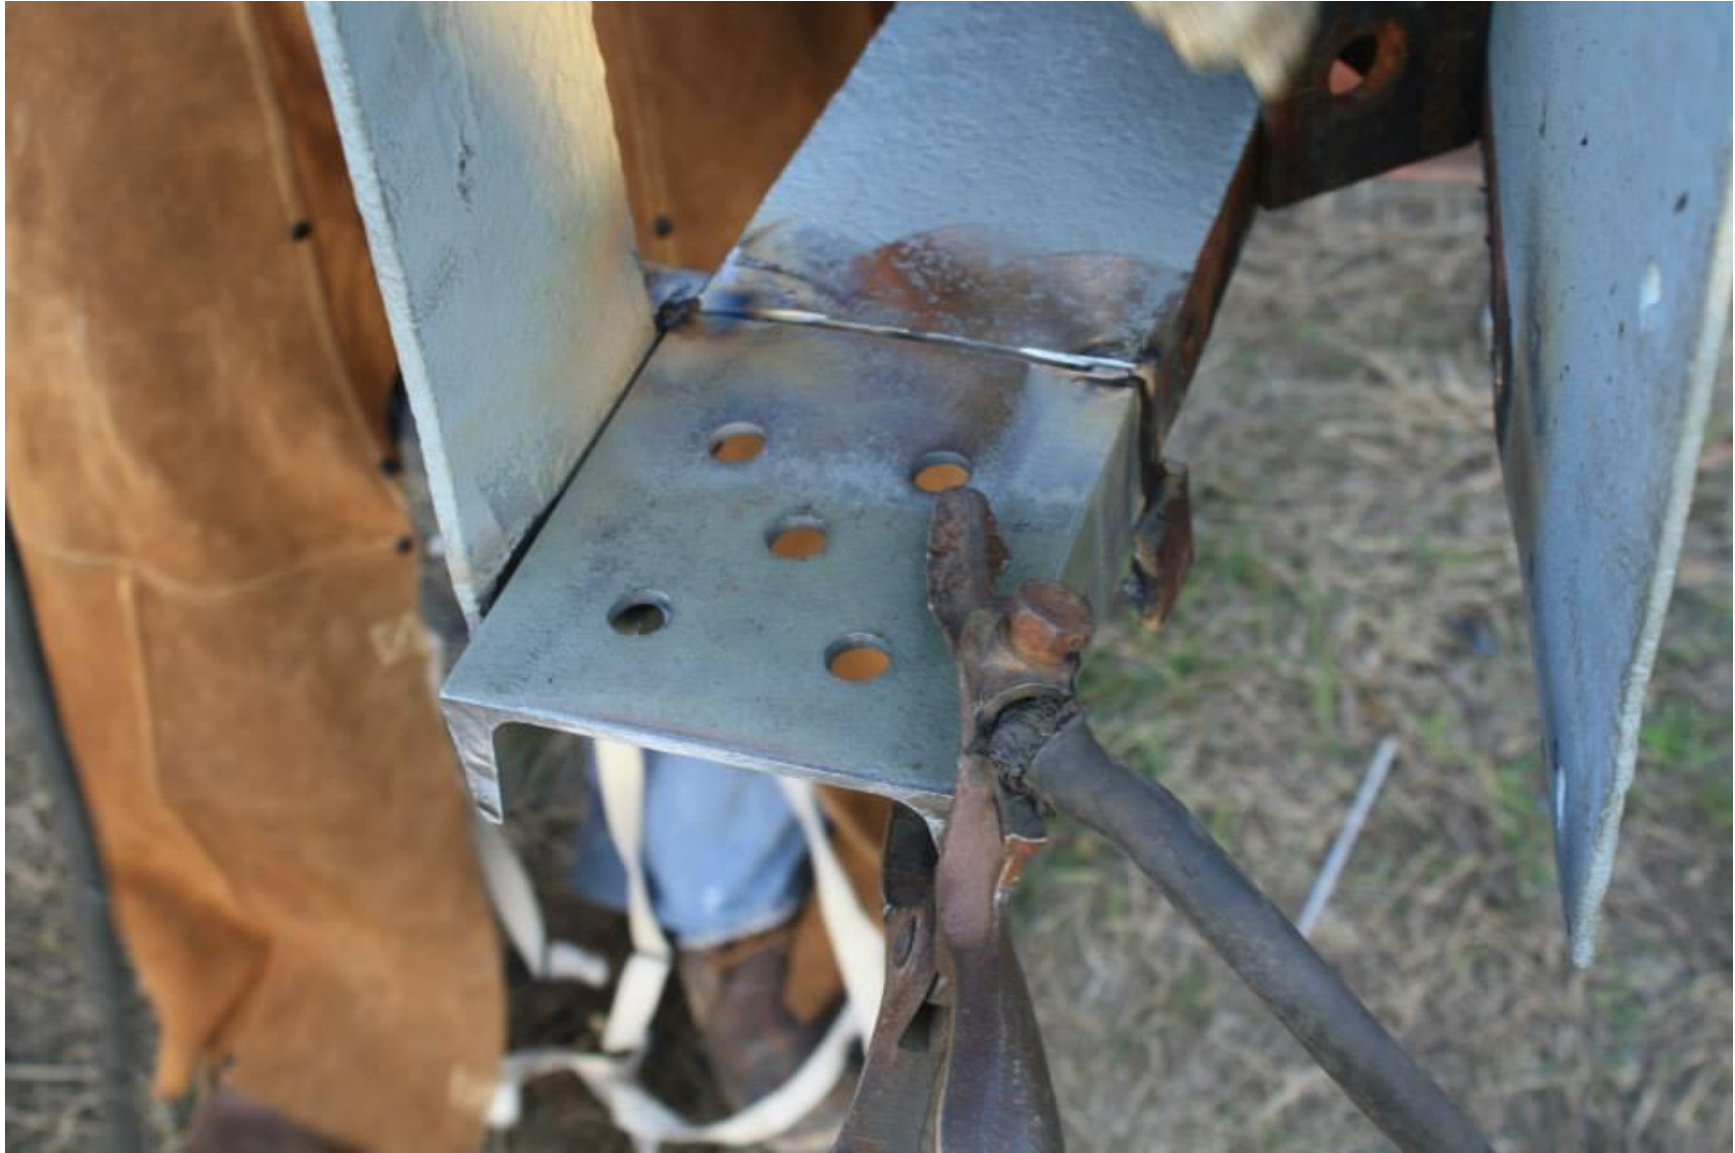
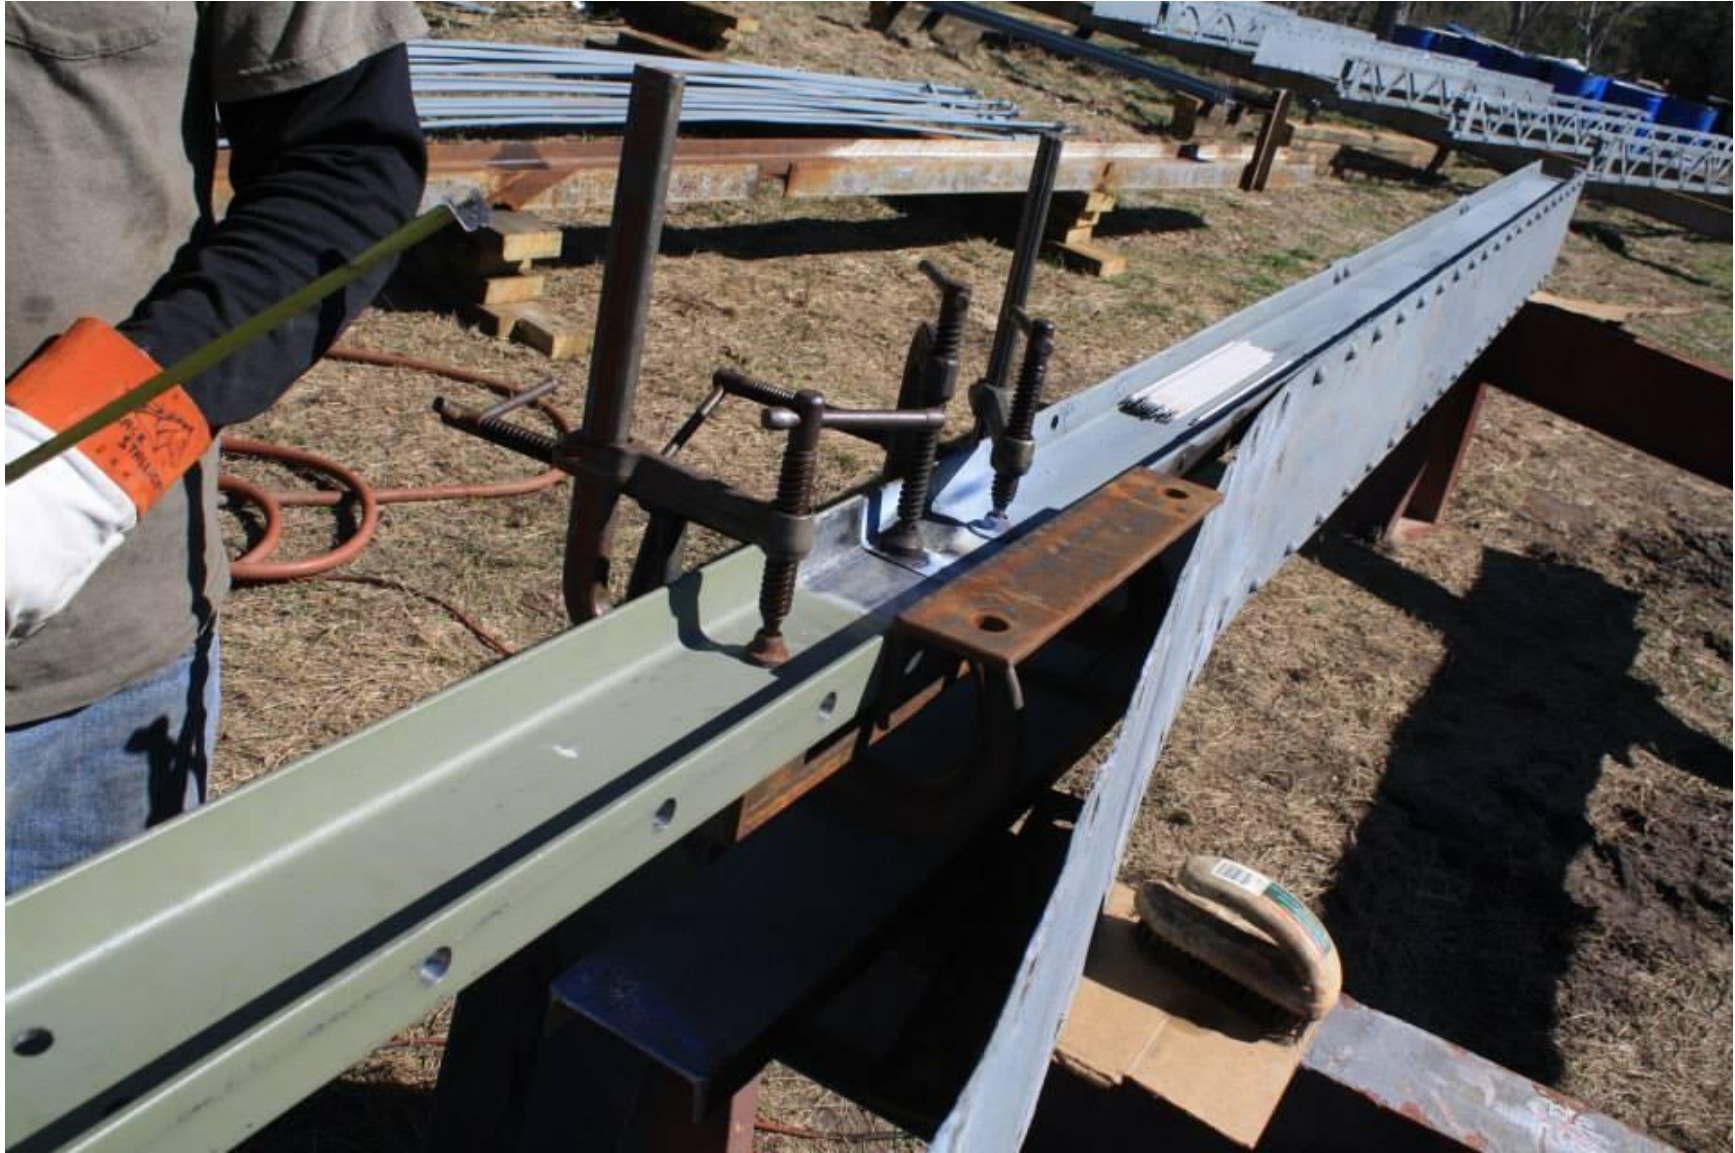
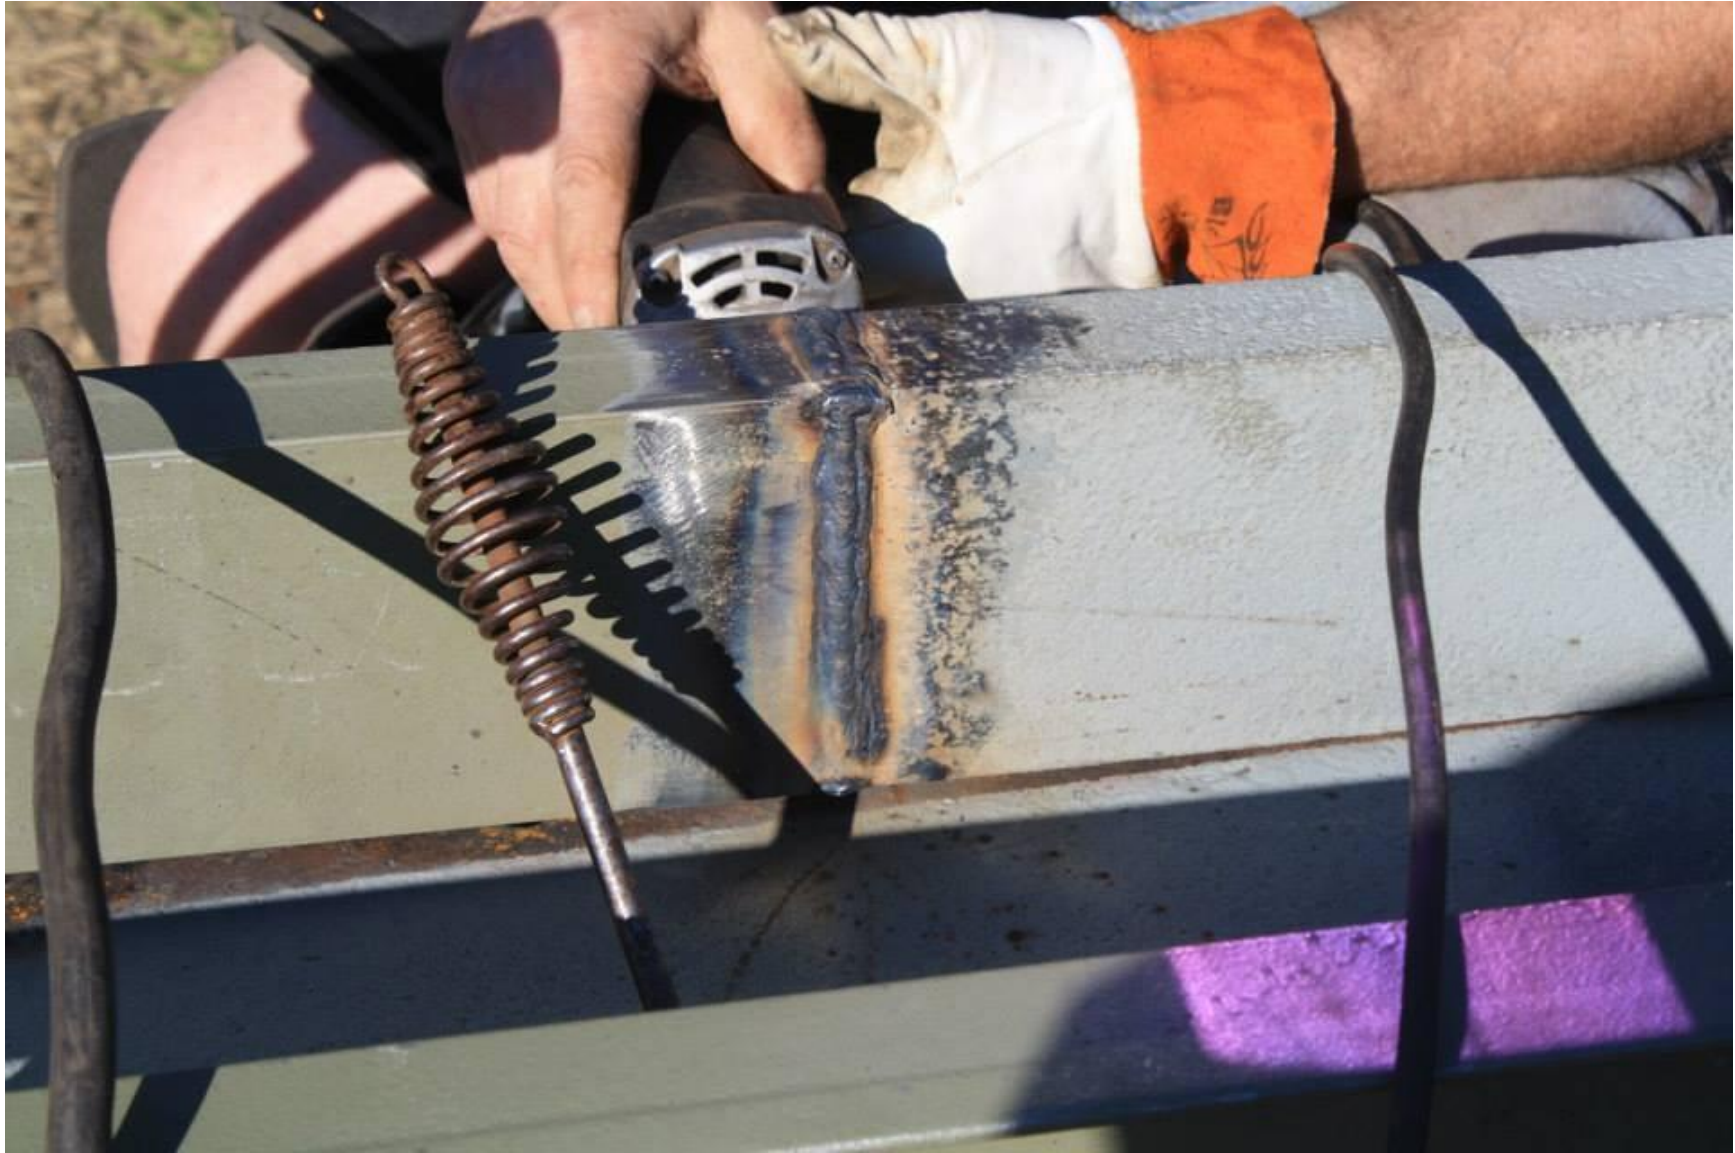
A replicated section of a beam is welded on to an original section of beam.

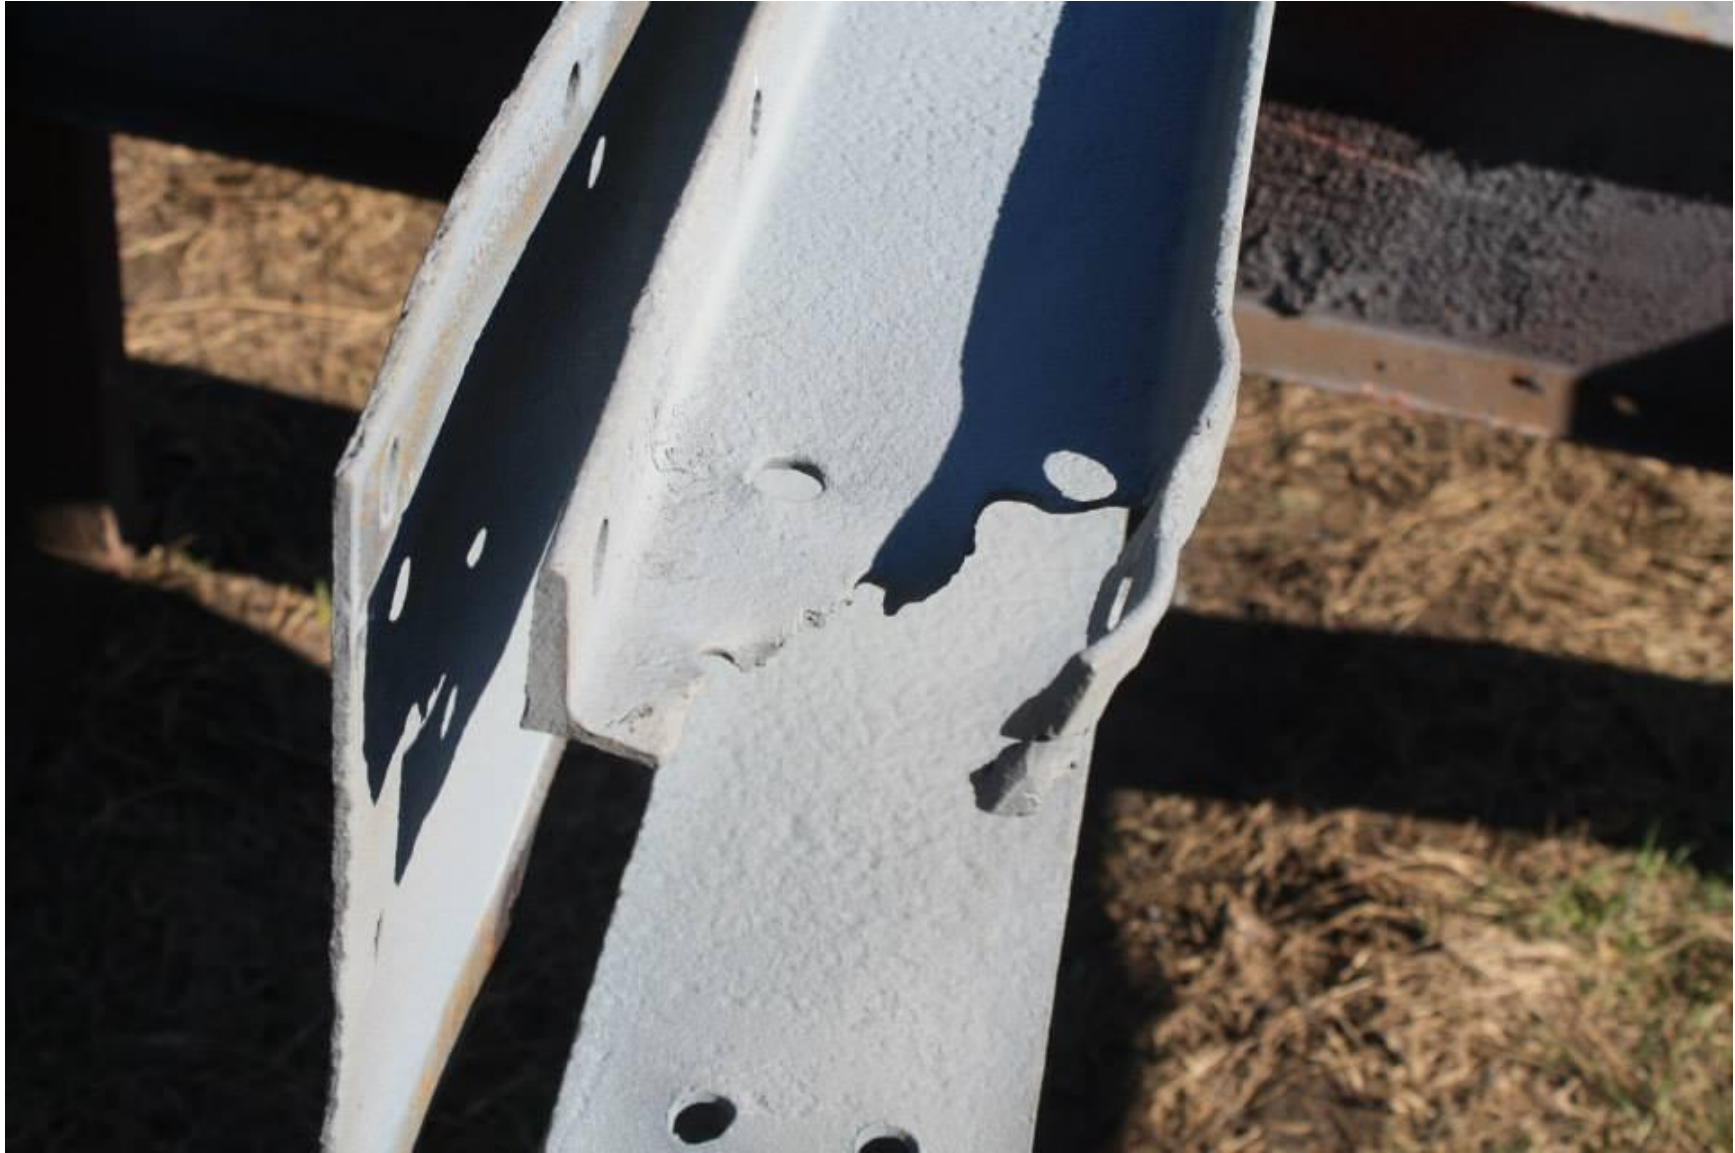
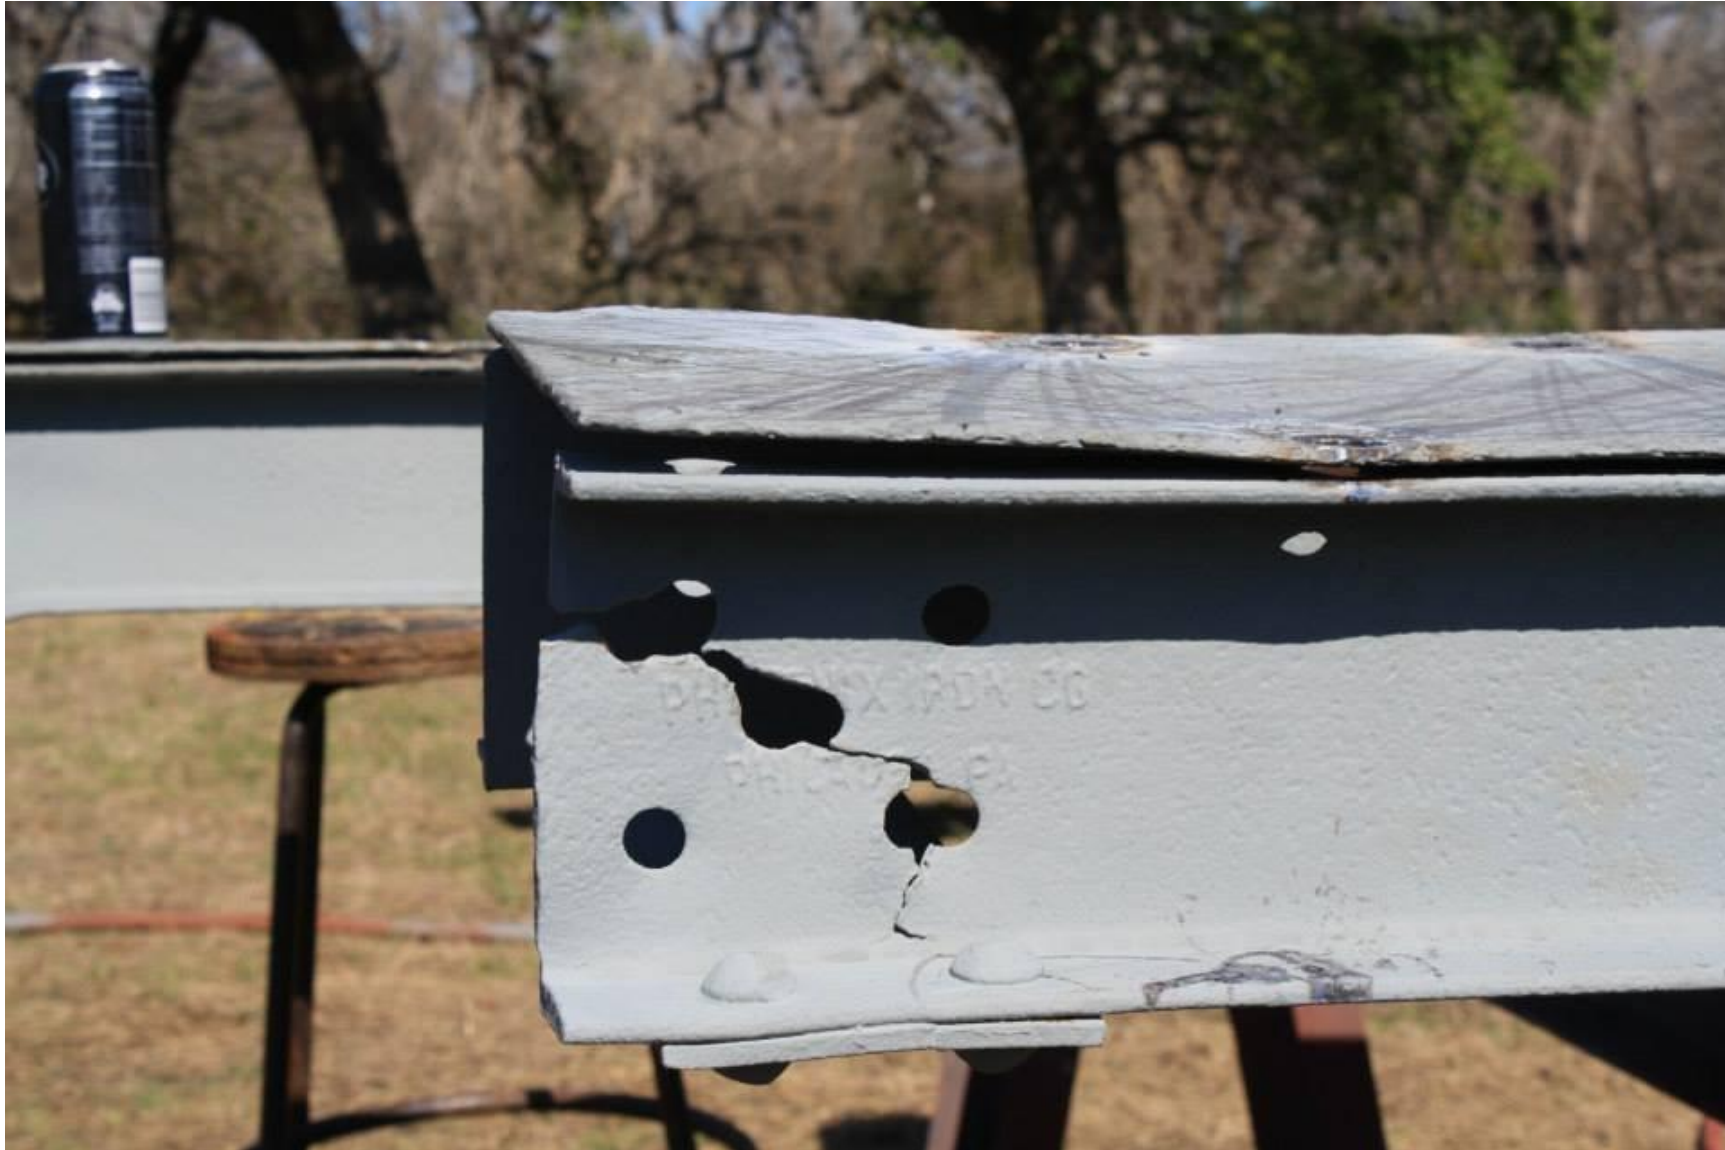
This detail shows a top chord section at the splice point. As originally built, this section was bolted to an adjacent section of top chord. Damage, clearly visible here, was what caused this bridge to be closed to traffic, initiating the restoration effort.
