Project: Piano Bridge

Project Completed: 2012

Overview: Full in-kind repair and restoration of this historic metal truss bridge for continued vehicular use. Bach Steel was responsible for repair of existing steel, including heat straightening, hot riveting as needed for fasteners, pack rust removal as needed. Heat straightening work included the heavily impact-damaged portal bracing, bent bottom chord eyebars (a fracture critical member), and impact damaged lattice railing.

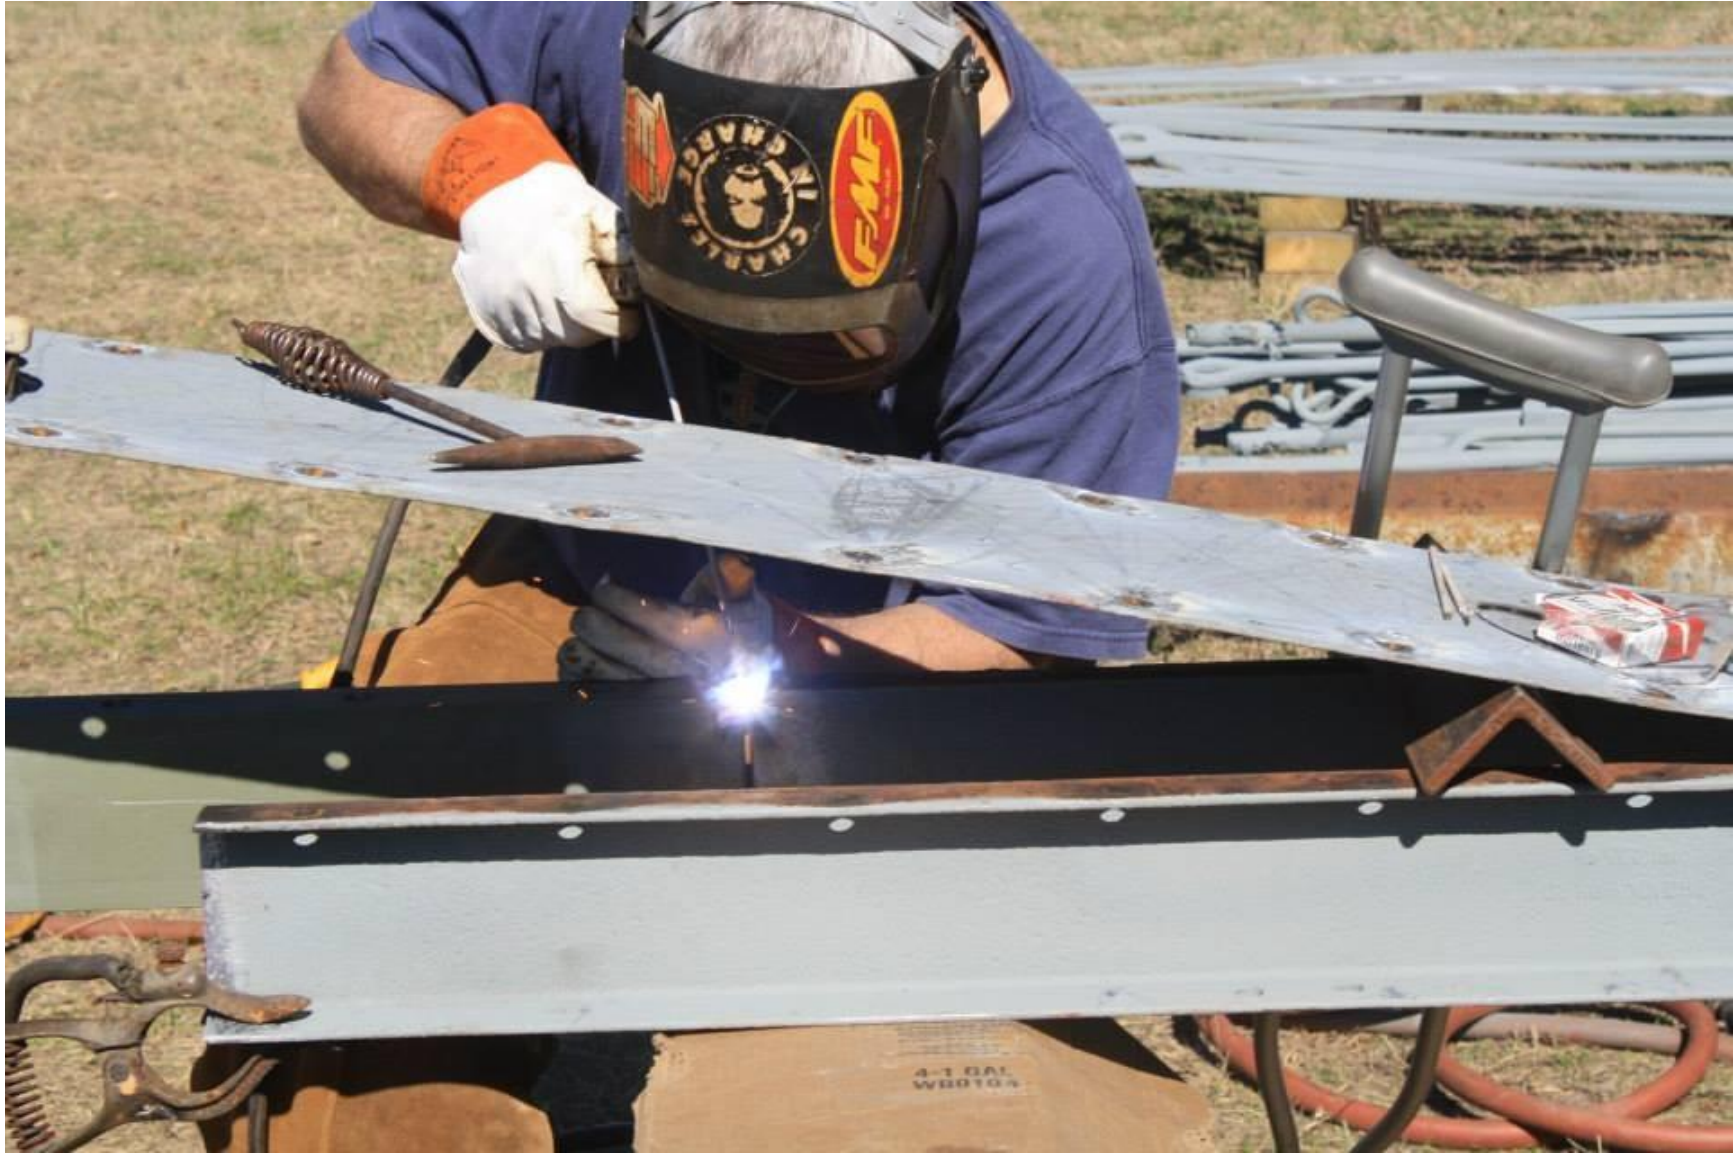
A replicated section of a beam is welded on to an original section of beam.

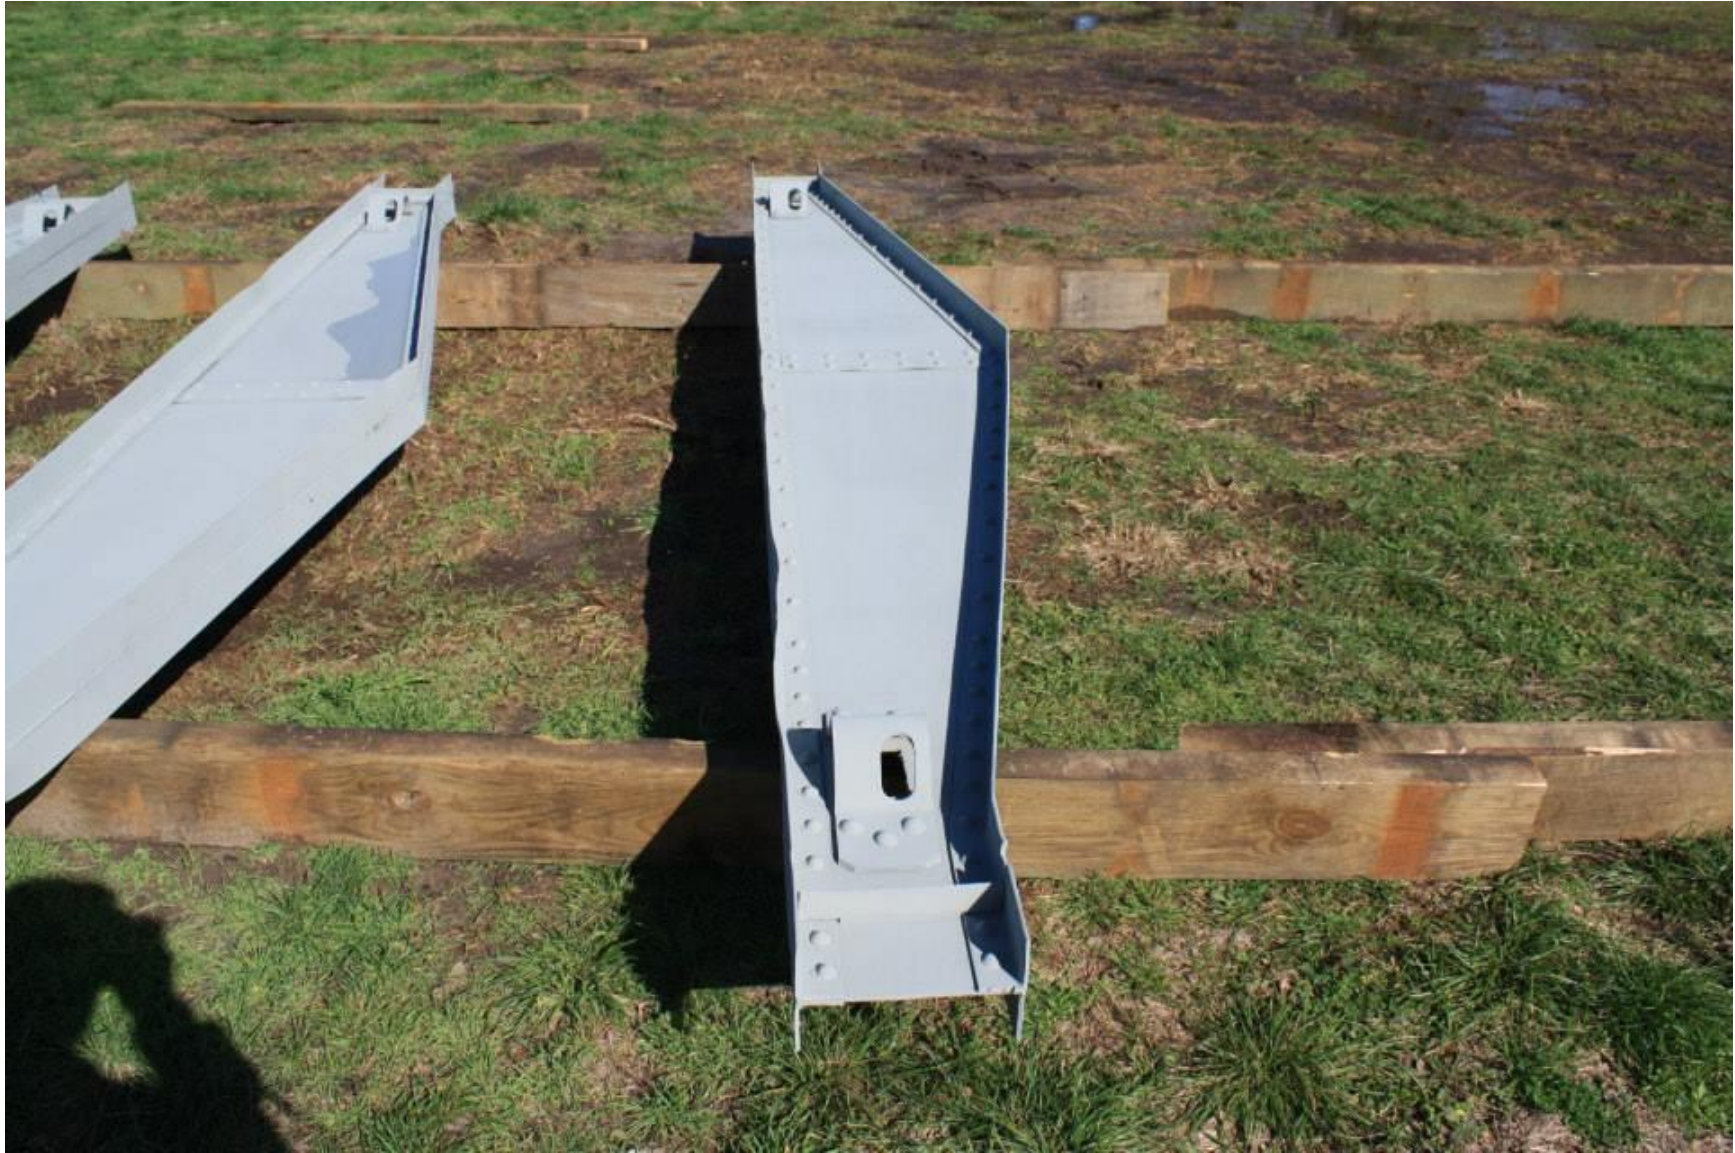
Restored floor beam.

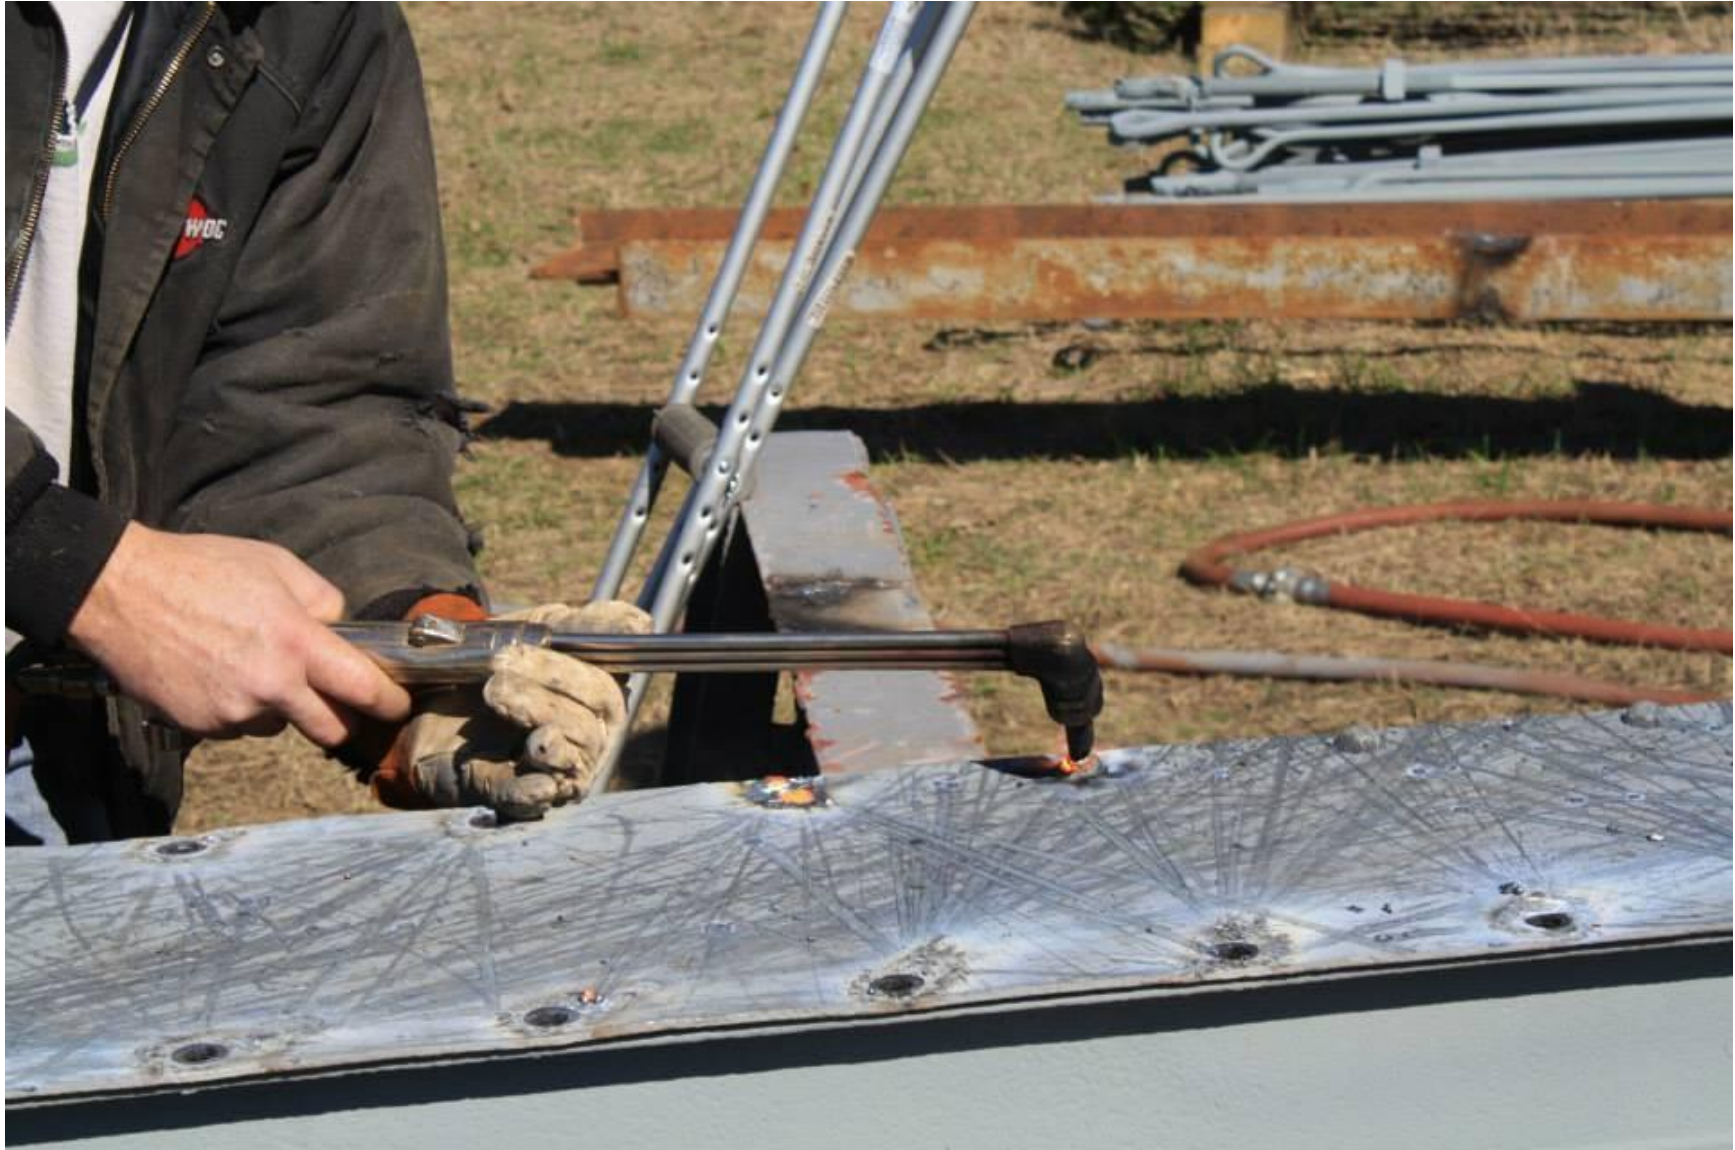
Using a cutting torch to remove rivets from a cover plate. Many contractors would have damaged the cover plate removing rivets in this manner, but Bach Steel knows how to do it without causing damage.

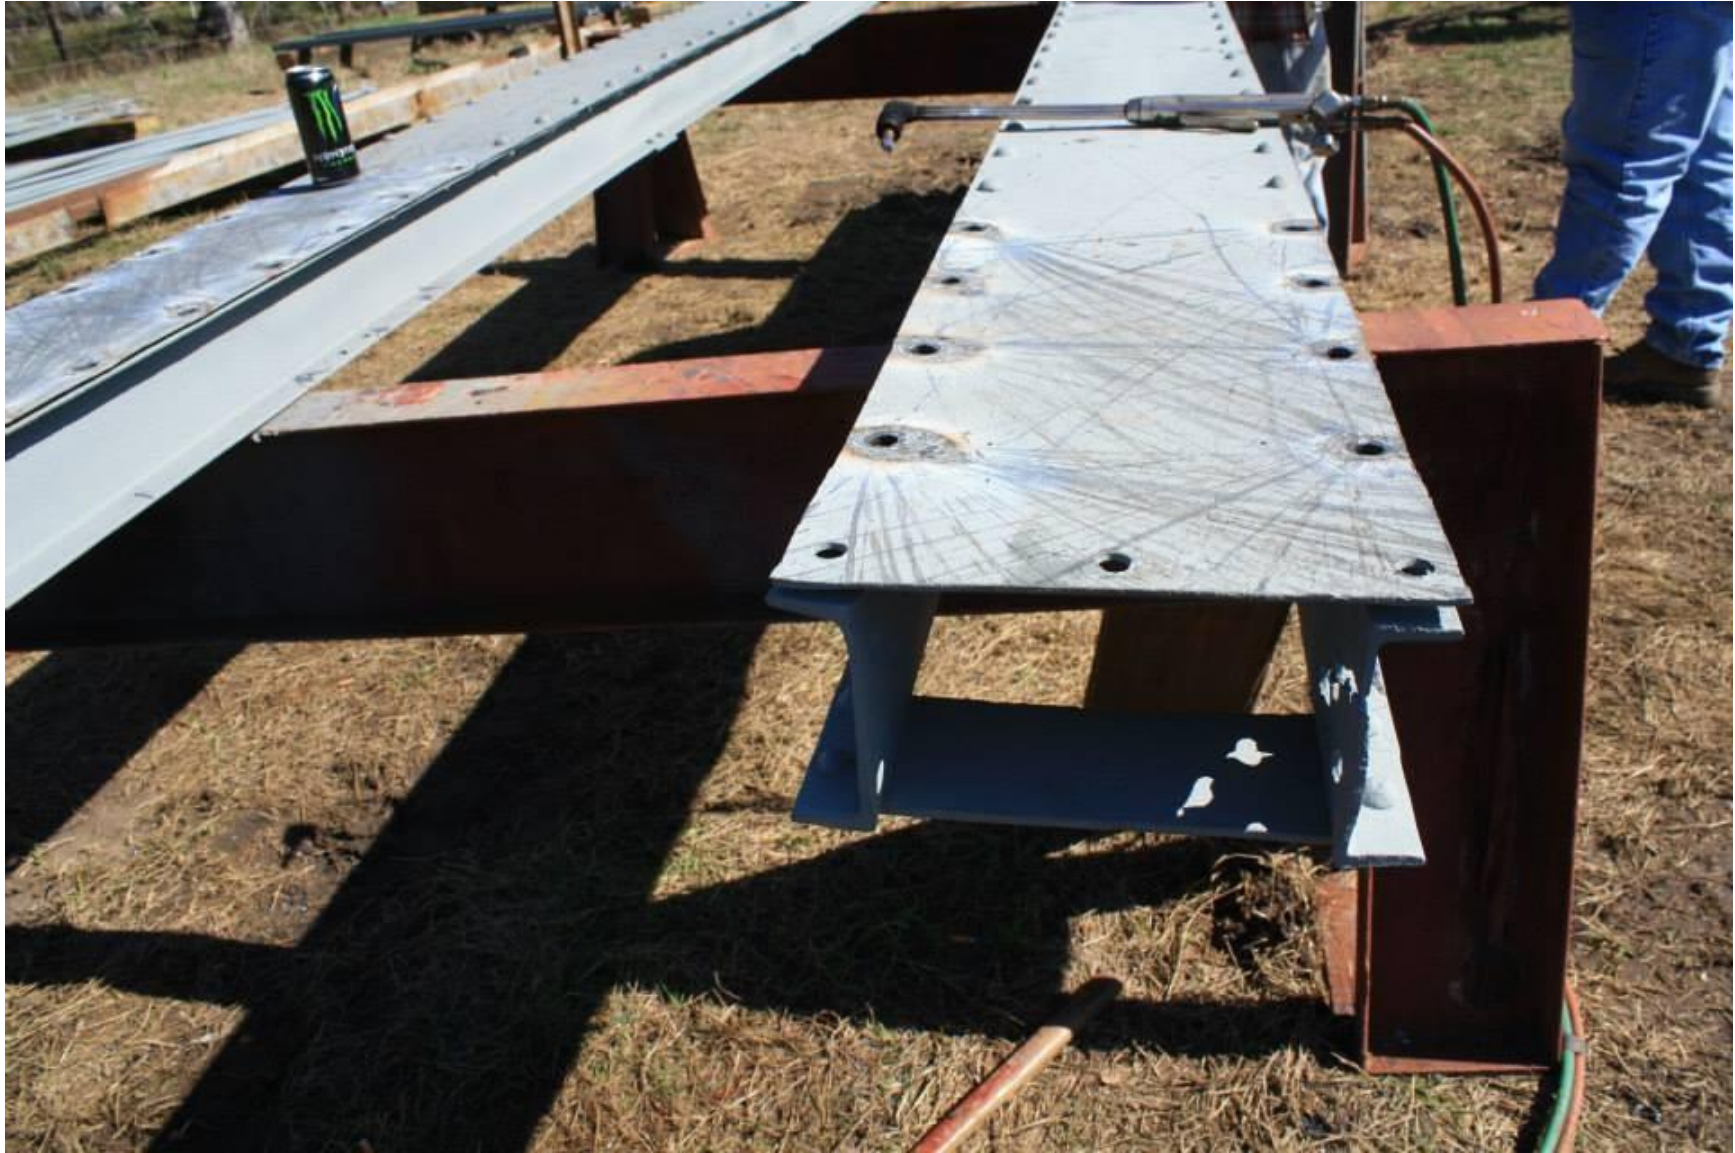
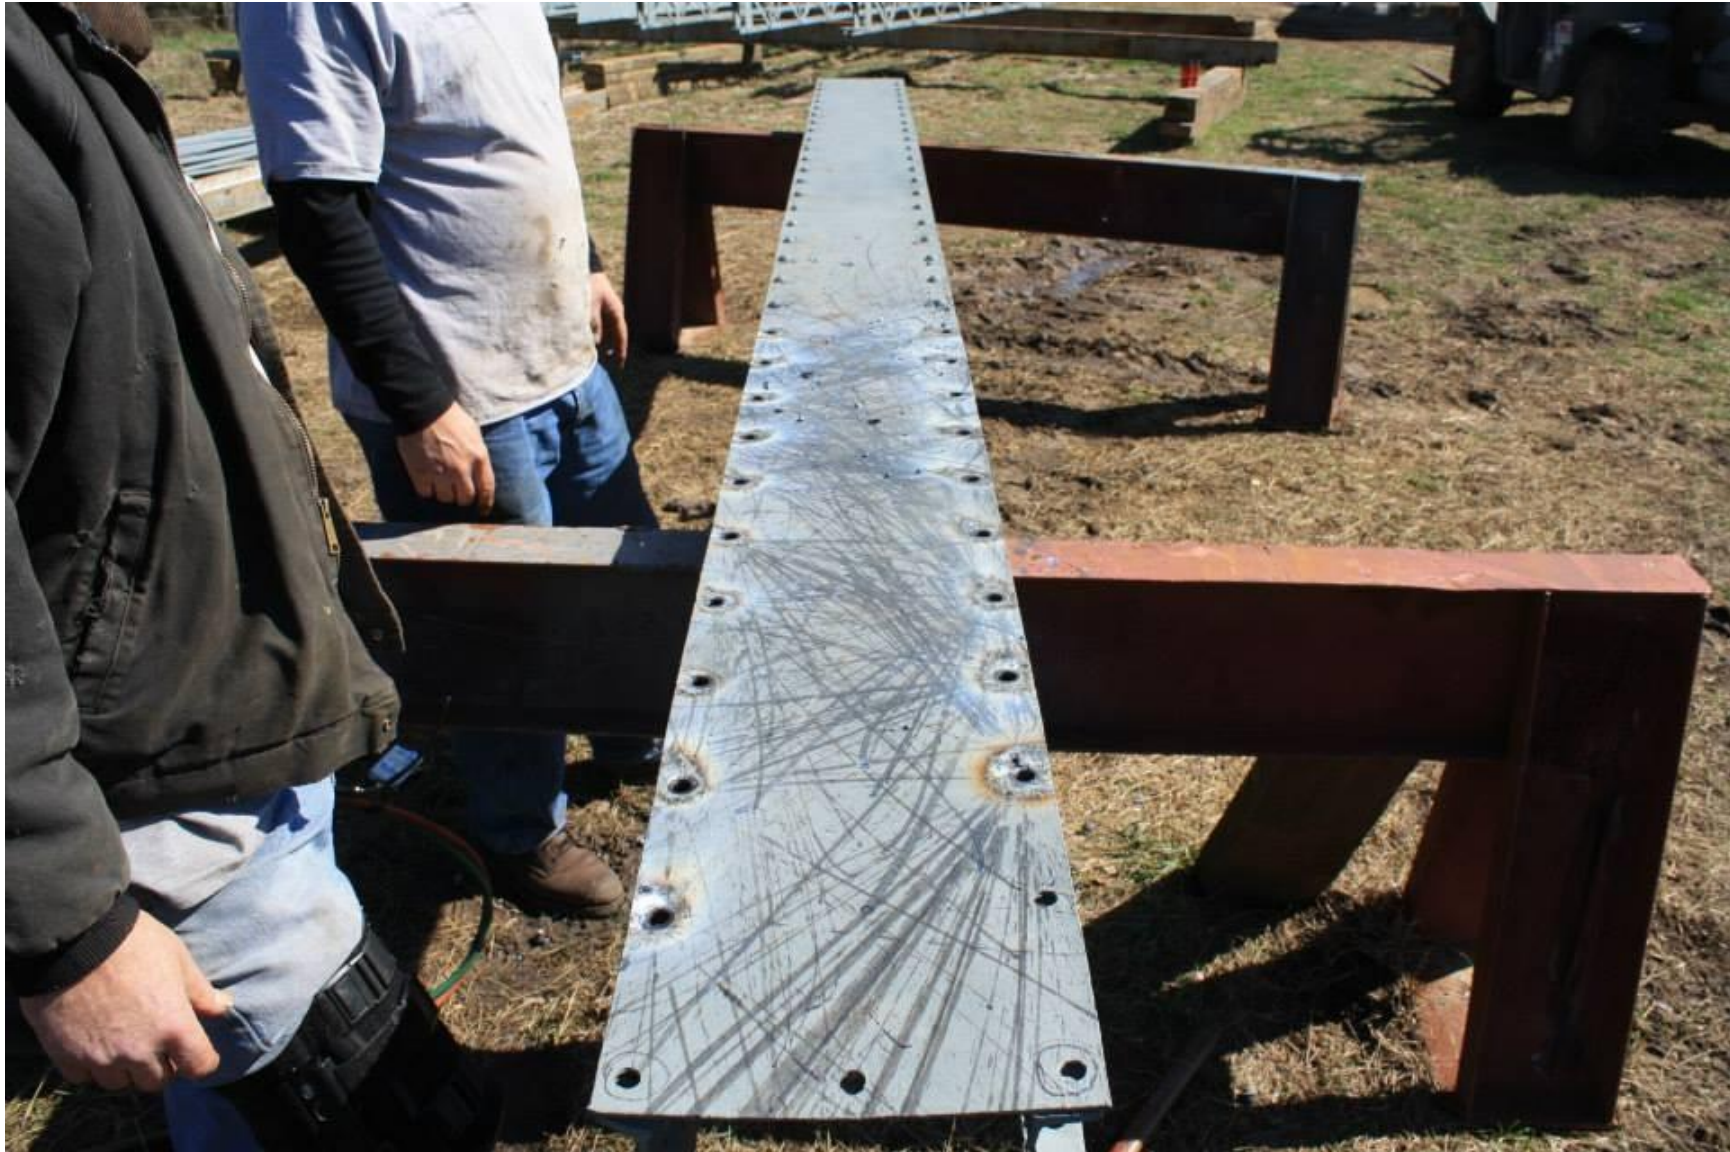
Cover plate after rivets were removed. Many contractors would have damaged the cover plate removing rivets in this manner, but Bach Steel knows how to do it without causing damage.

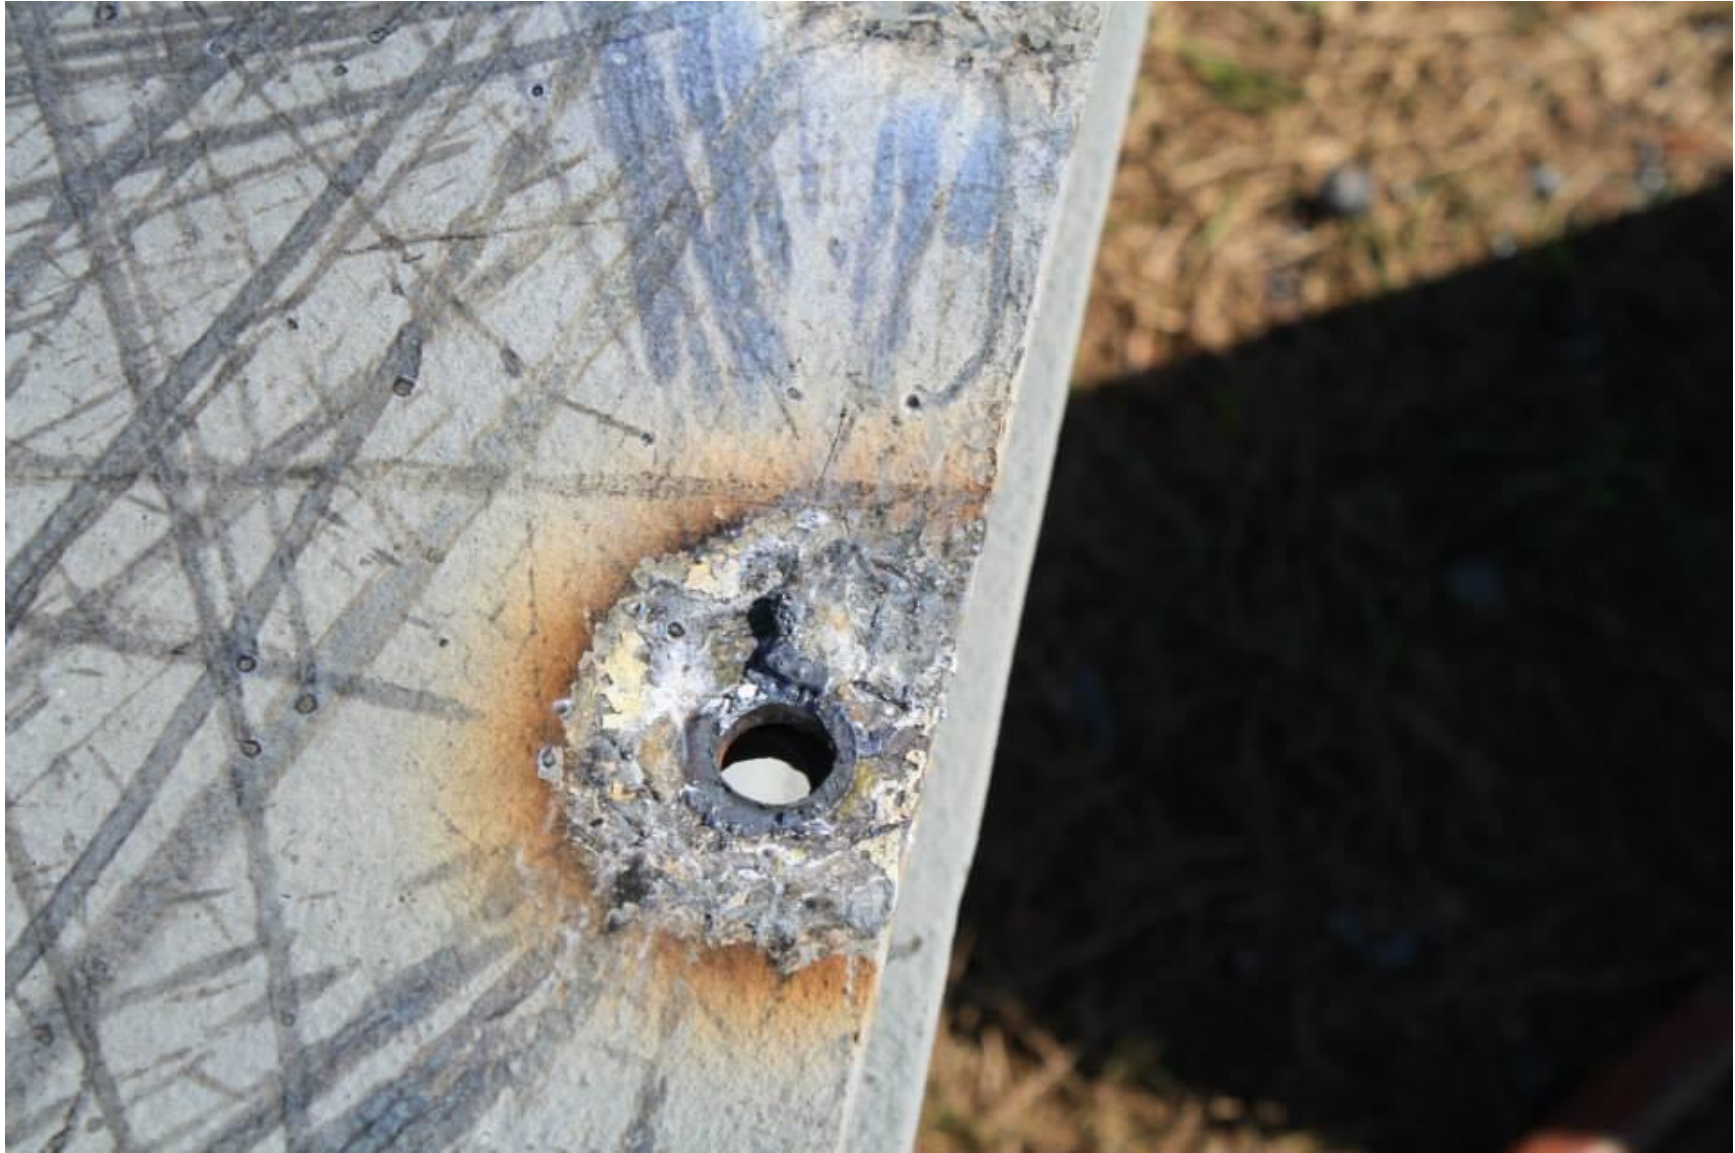
Cover plate after a rivet was removed. Many contractors would have damaged the cover plate removing rivets in this manner, but Bach Steel knows how to do it without causing damage.
