# Project: Sterling Road Bridge

Project Completed: 2004

Overview: Complete restoration of the truss parts for this bridge which was relocated to Morenci, Michigan for pedestrian use. The extensive deterioration on the bridge required hot metal riveting, and replication of deteriorated sections of truss members, and welding plate to address areas of section loss. Eyebars with section loss were pad welded to repair them. Bach also did selected repairs to the existing floor beams and installed new rivets where needed.

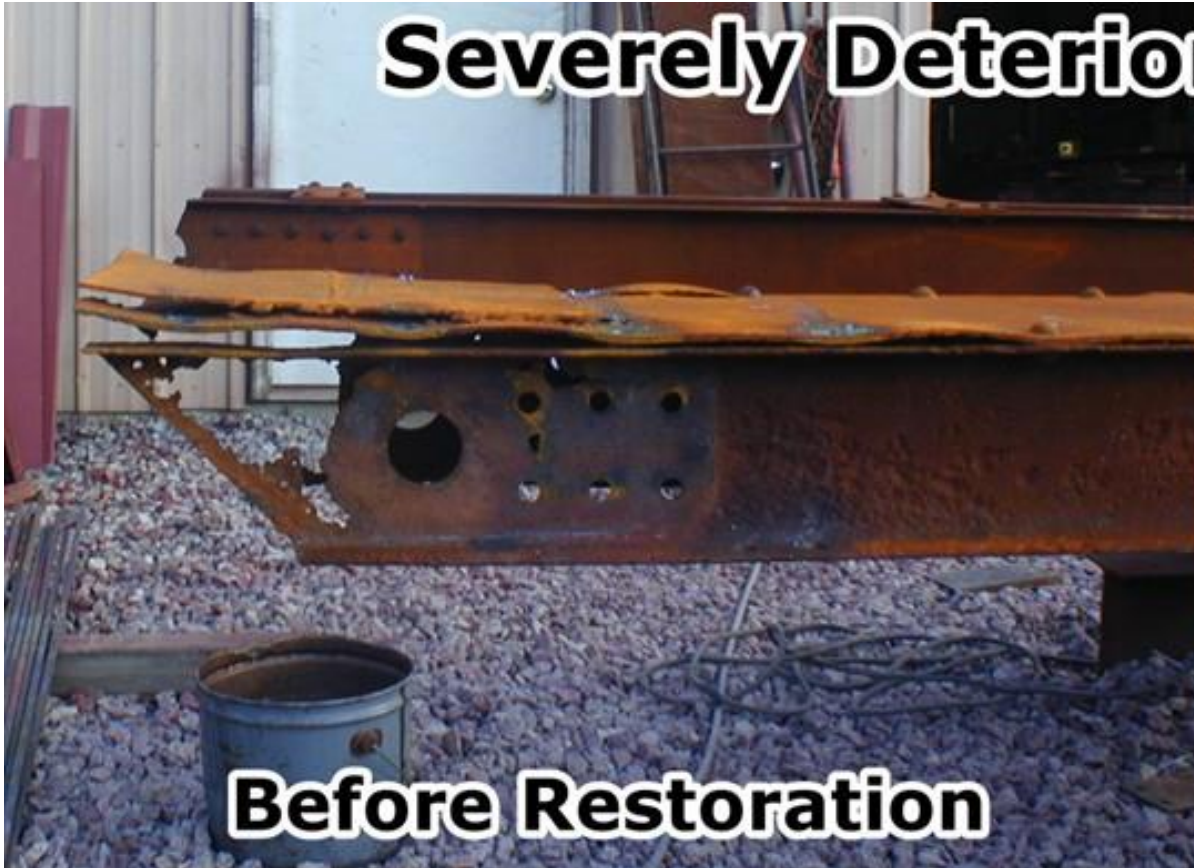
**Before Restoration**

# Severely Deteriorated End Post

These photos show the horrible condition of the end posts before restoration, and after we replicated the deteriorated portion. Hot metal riveting was used to assemble the replicated parts.

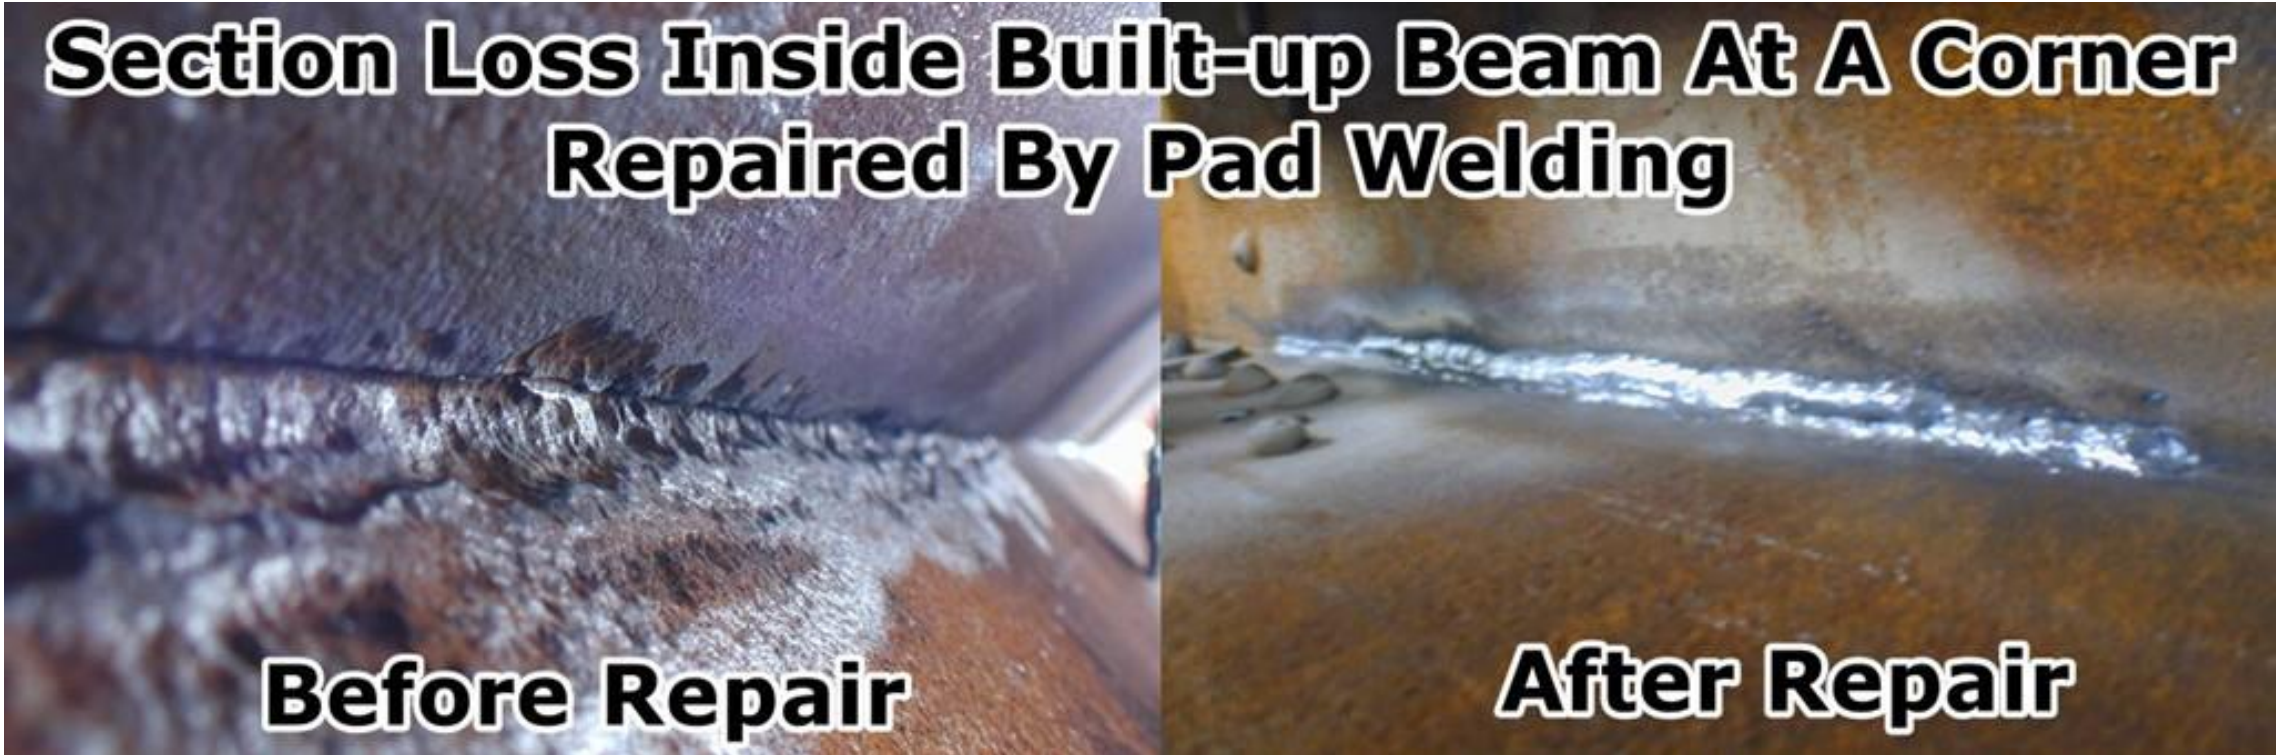
# Section Loss Inside Built-up Beam At A Corner Repaired By Pad Welding

**Before Repair**

**After Repair**

Section loss hidden on the inside of a built-up beam was repaired with pad welding.

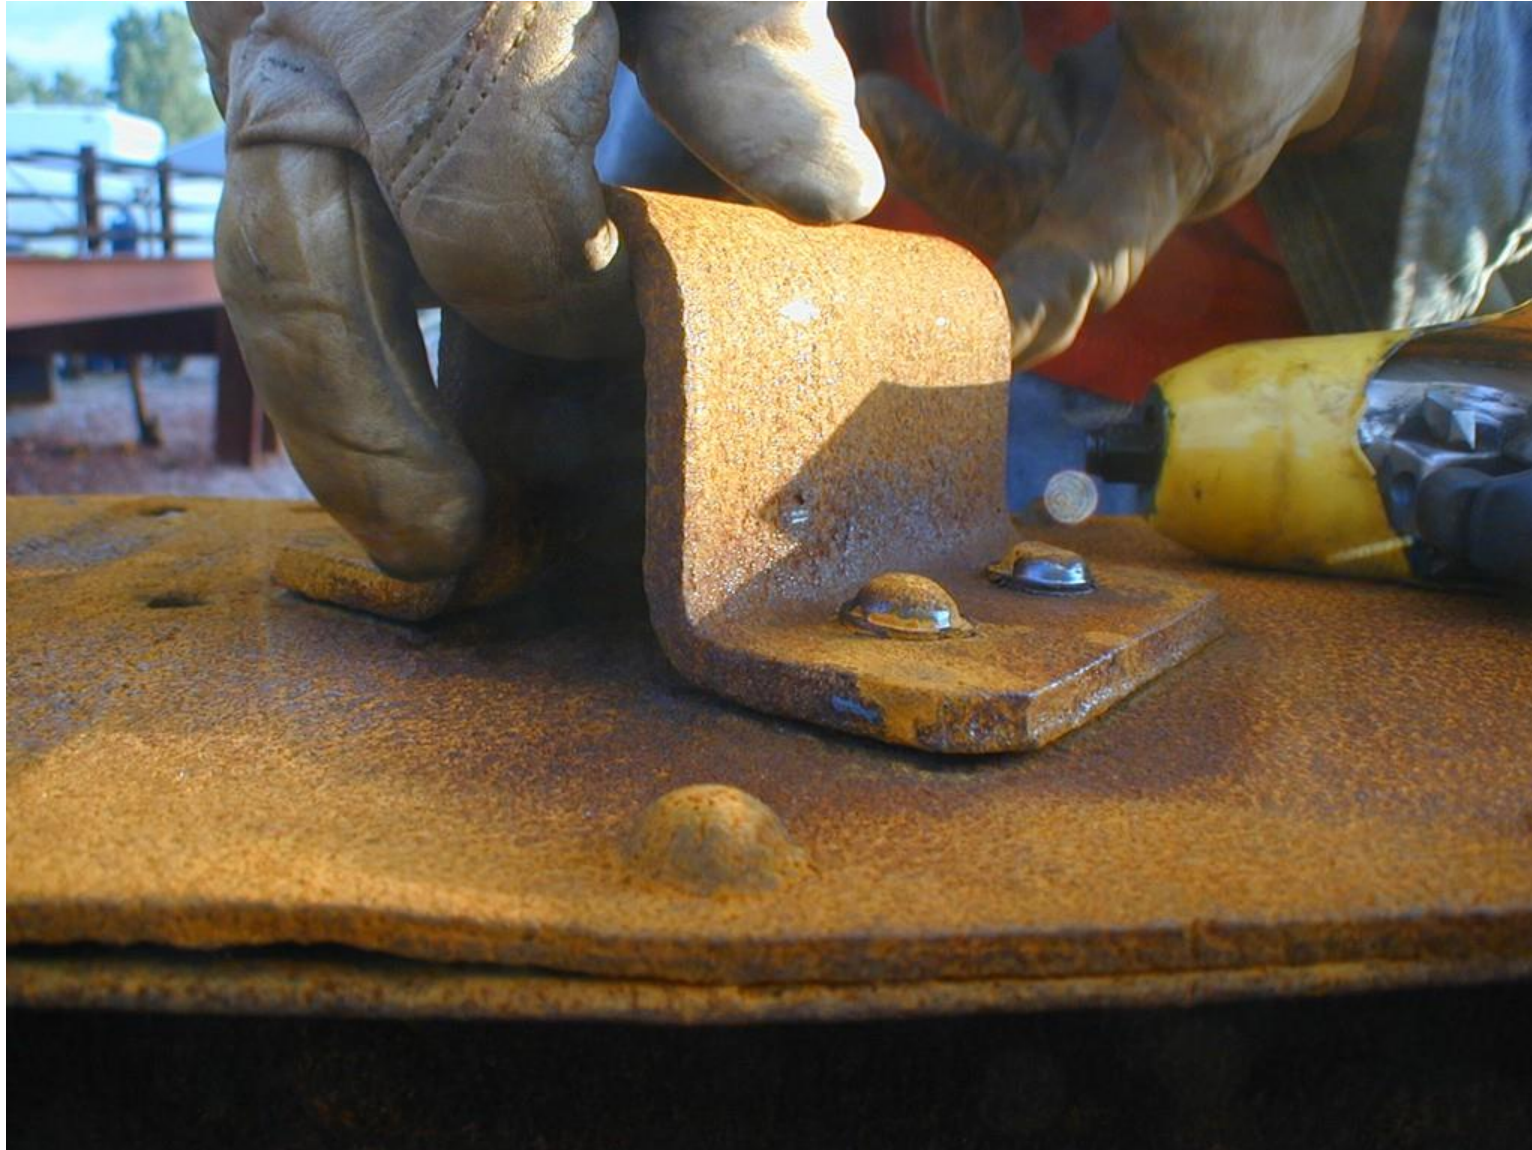
Newly riveted lateral bracing attachment on top chord.

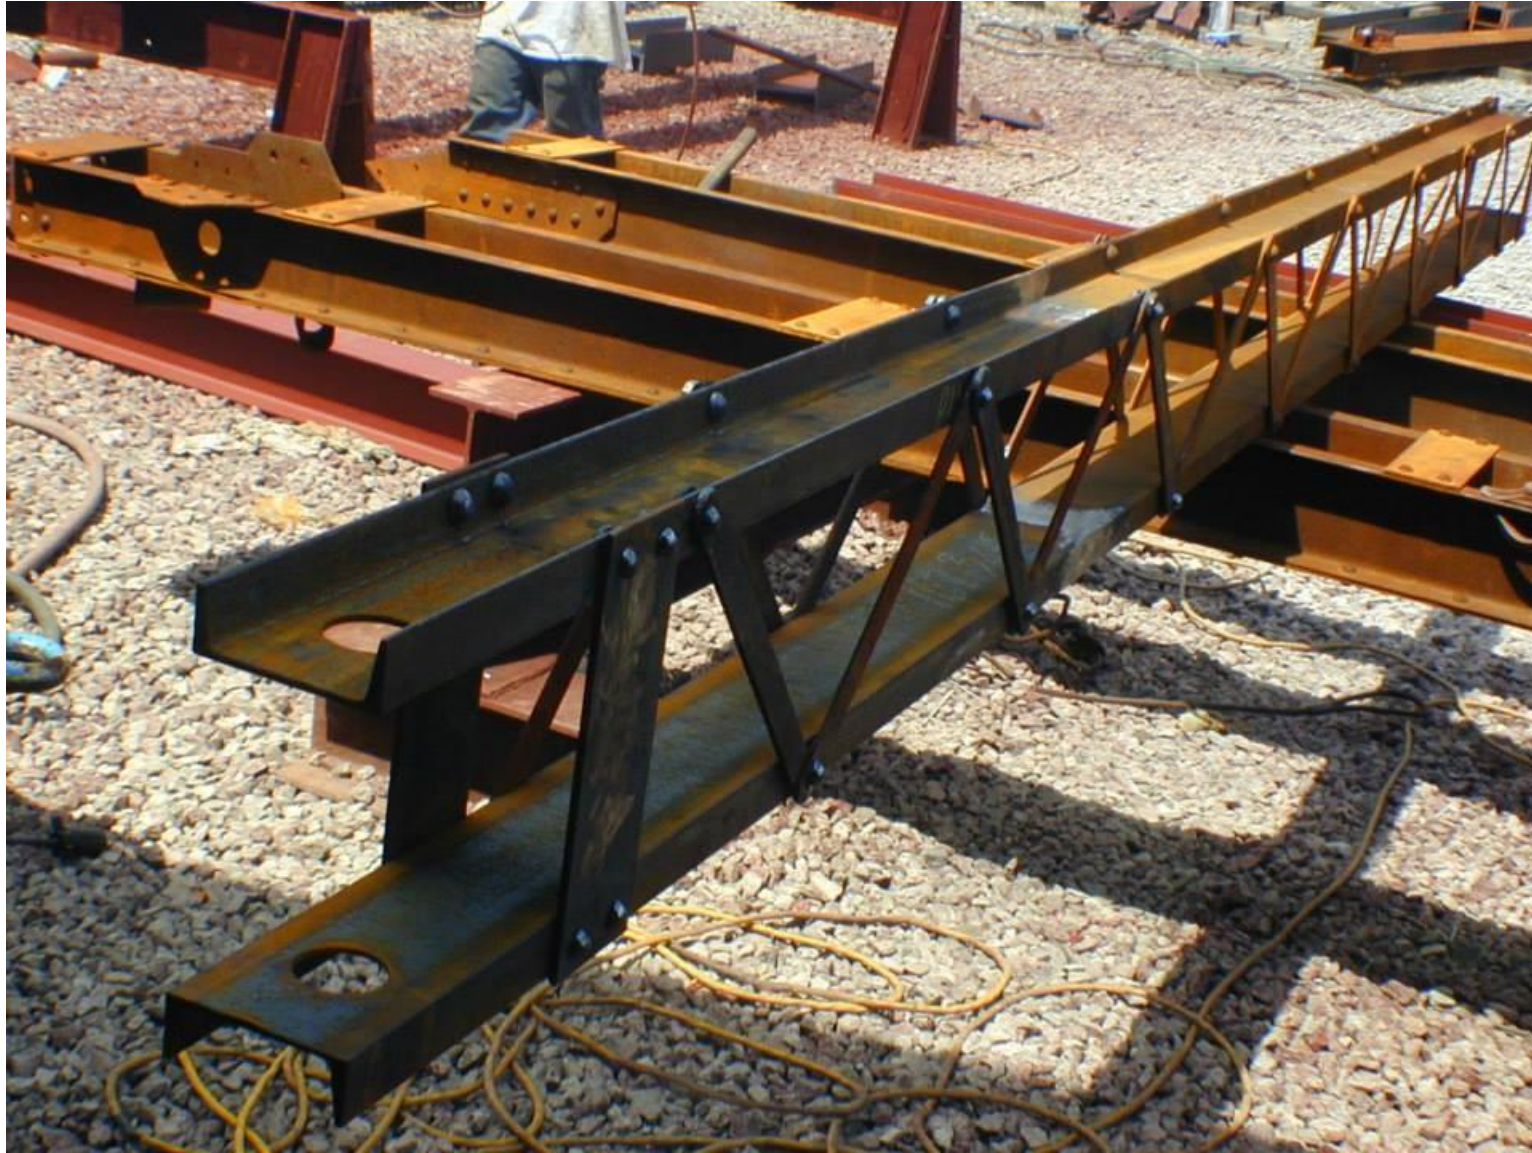
Restored vertical member. The left half is replicated, while the right half is original material.

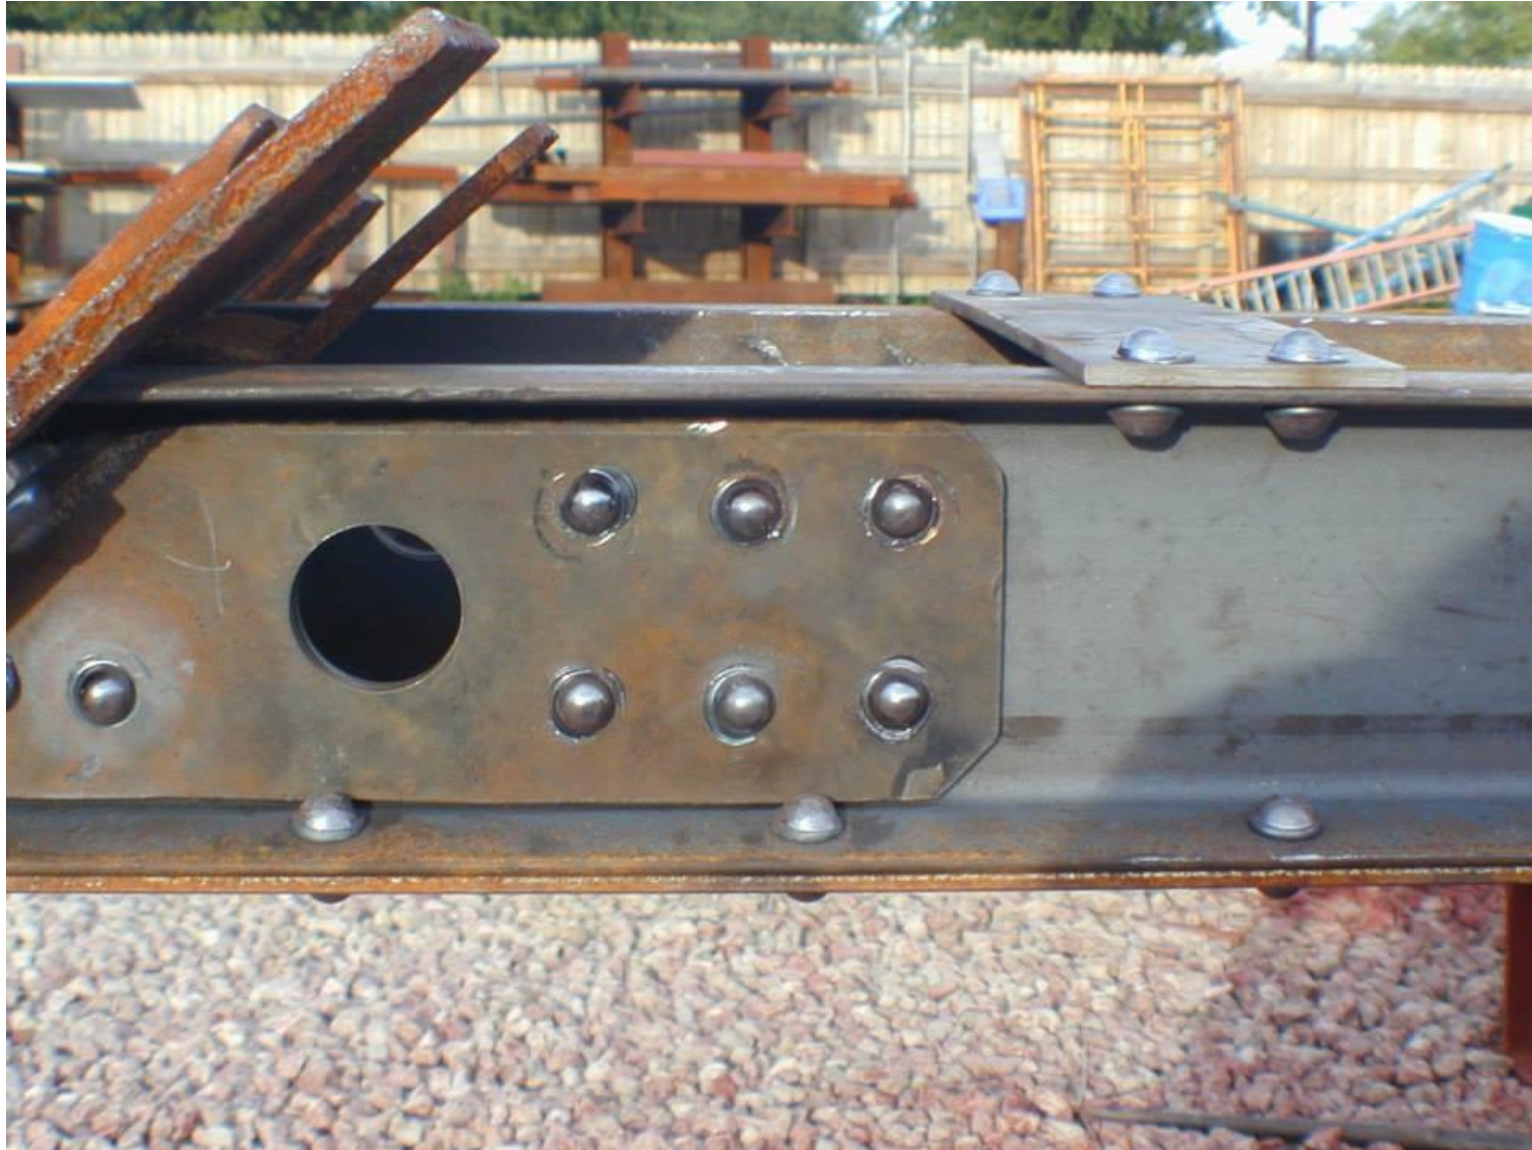
Restored end post showing newly driven rivets by Bach Steel.

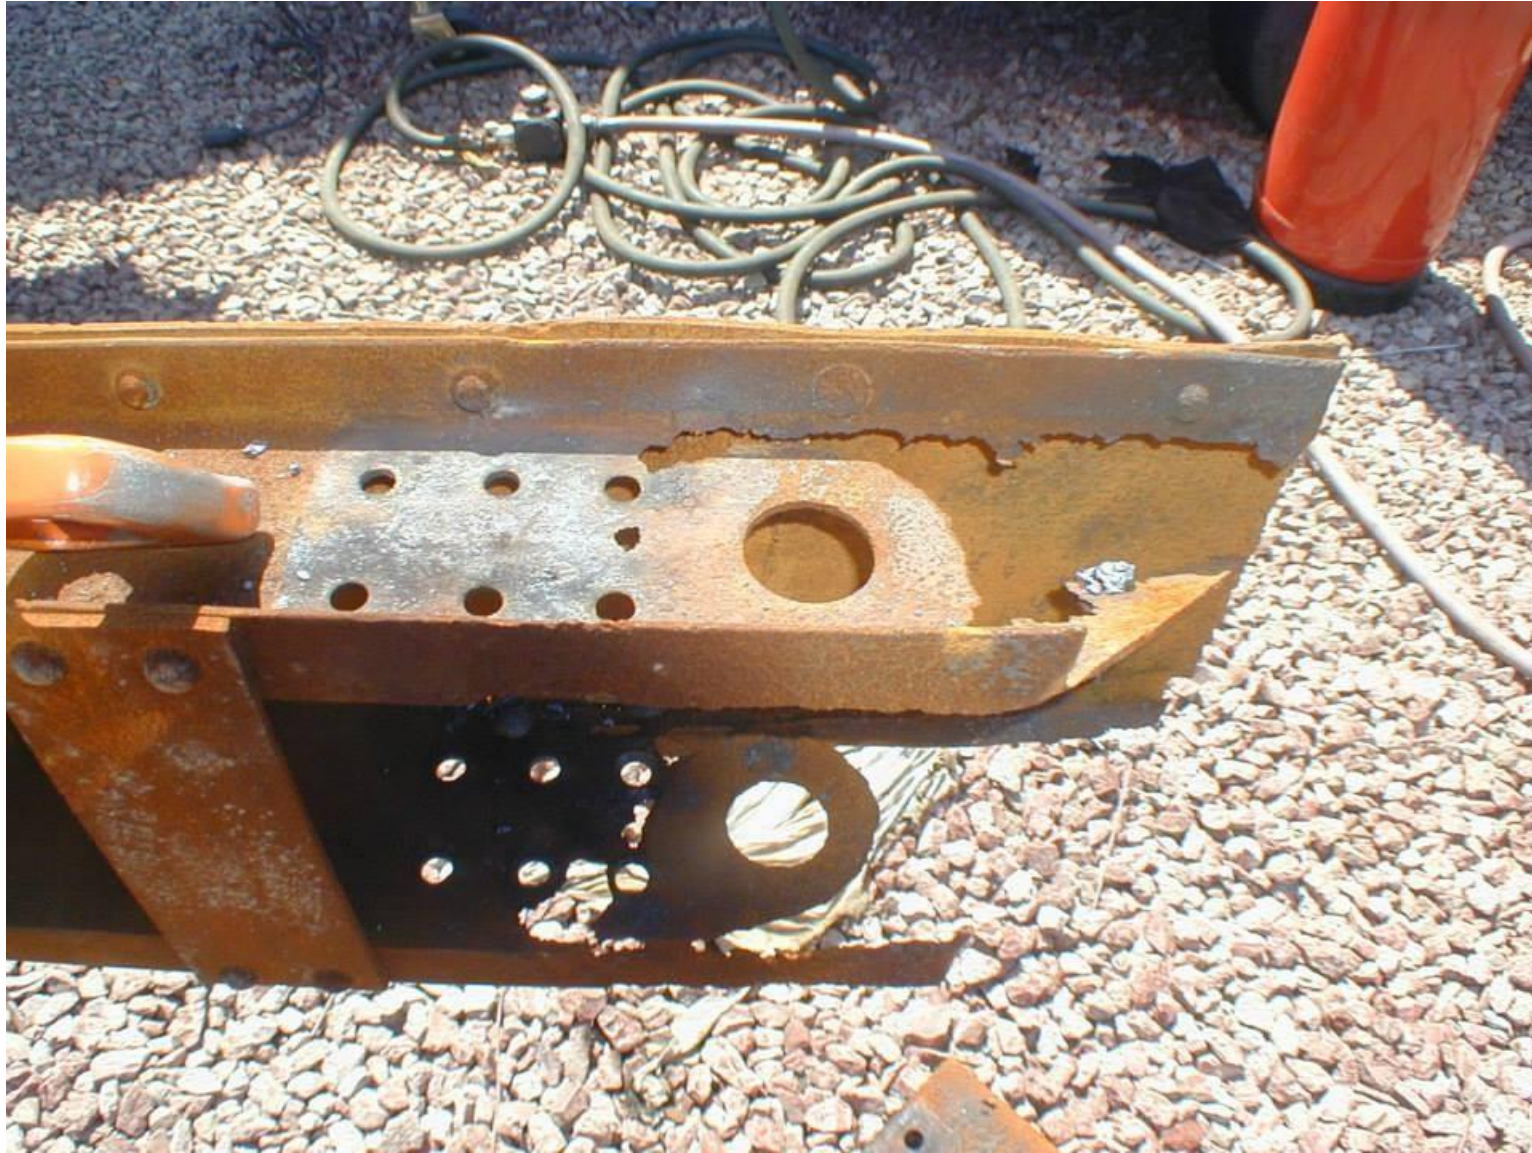
Condition of end post before restoration showing severe deterioration.

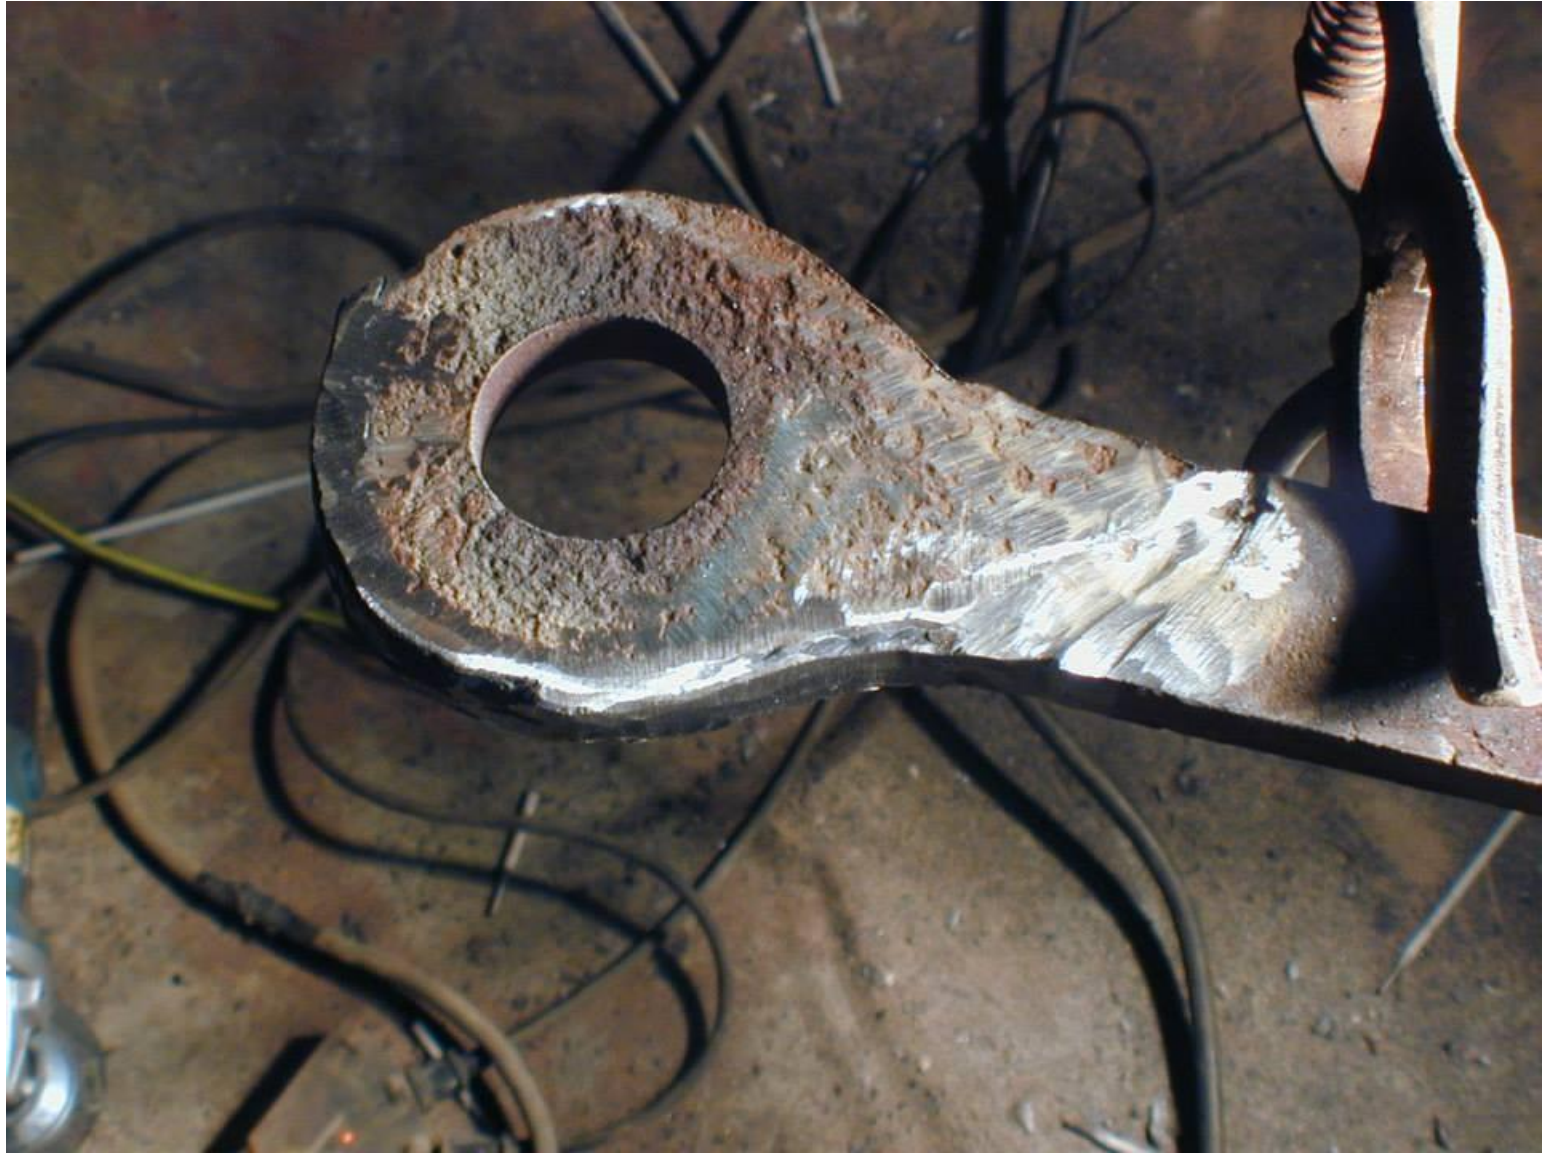
Pad welding repair in progress for deteriorated eyebar.

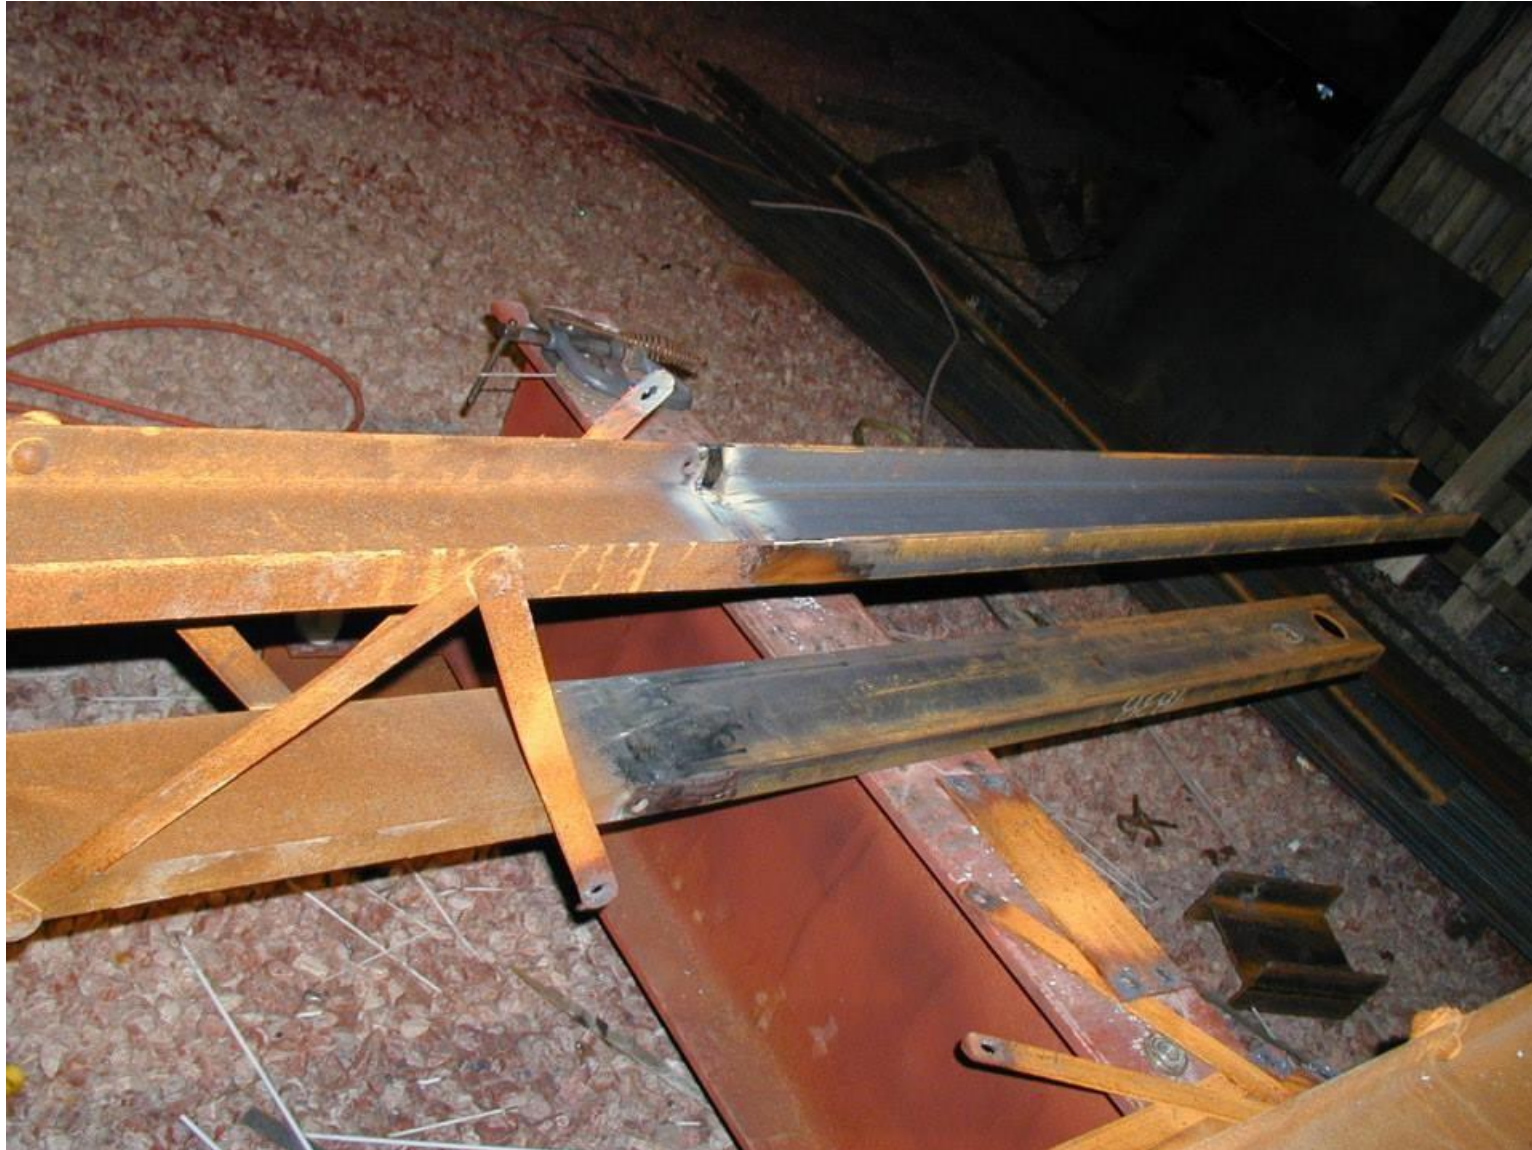
Repair in progress of a vertical member. Work included replication (including rivets) of a section of deteriorated vertical member which was welded on to the remaining original portion.

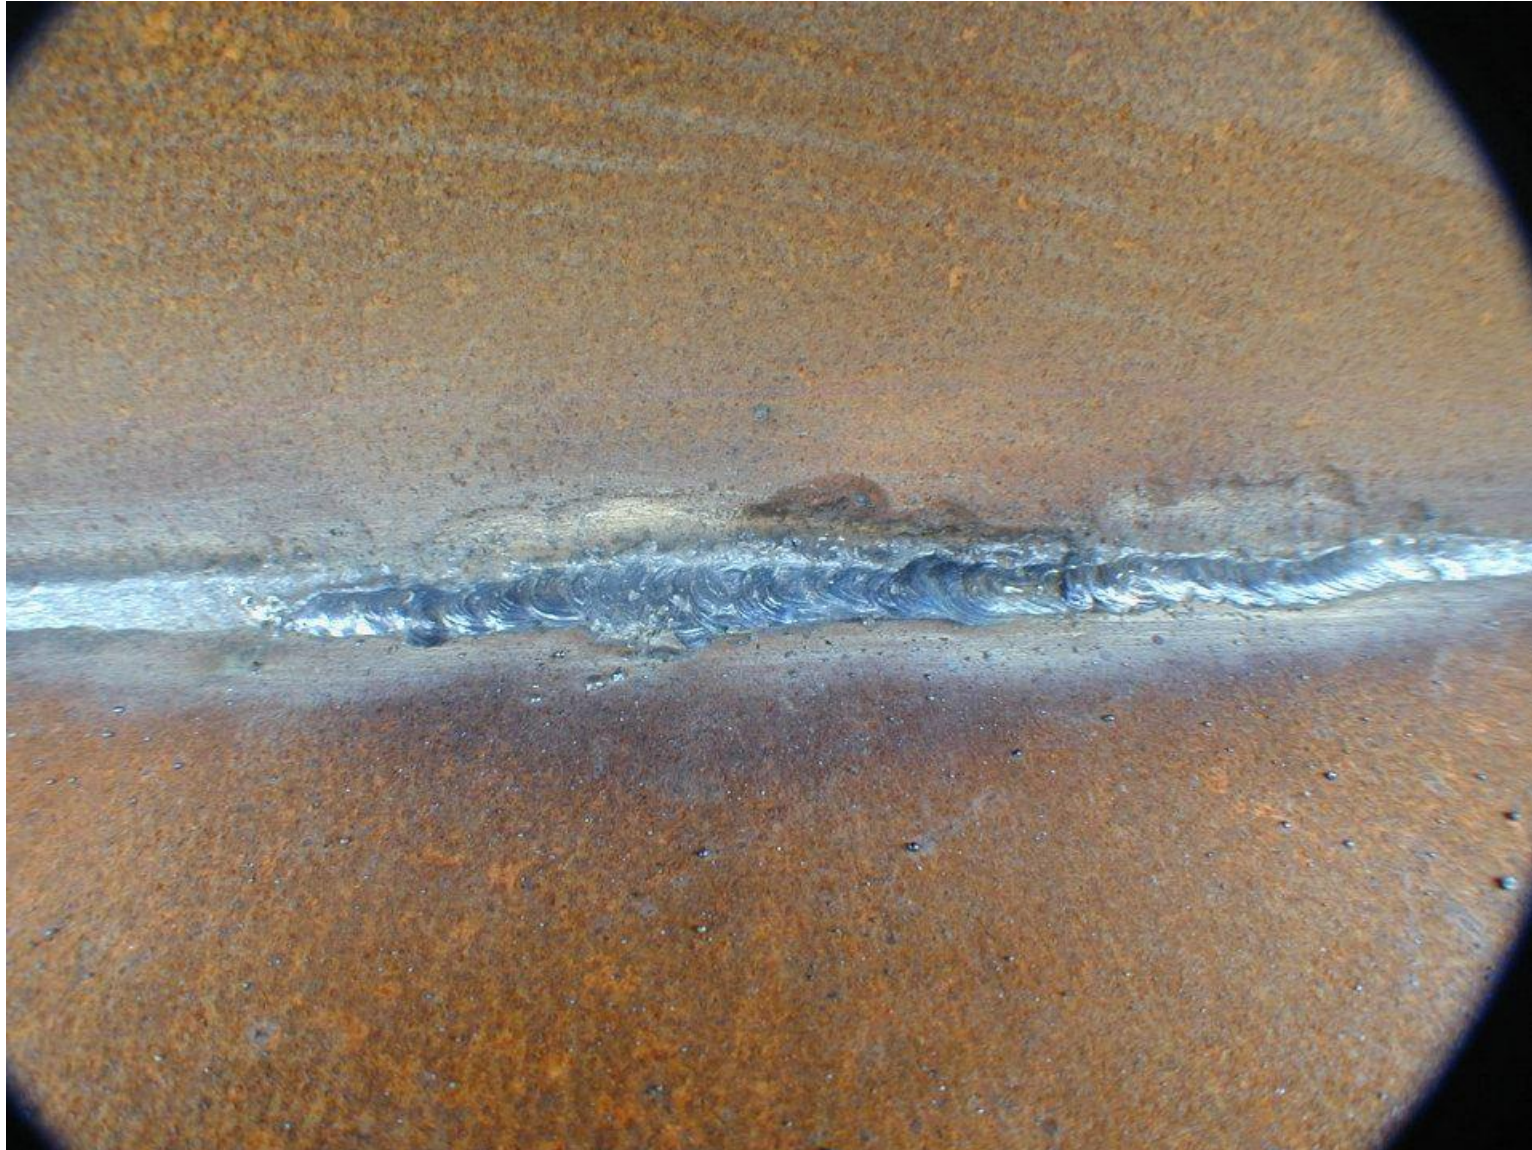
Pad welding repair in progress for section loss hidden inside a built-up beam at a corner.

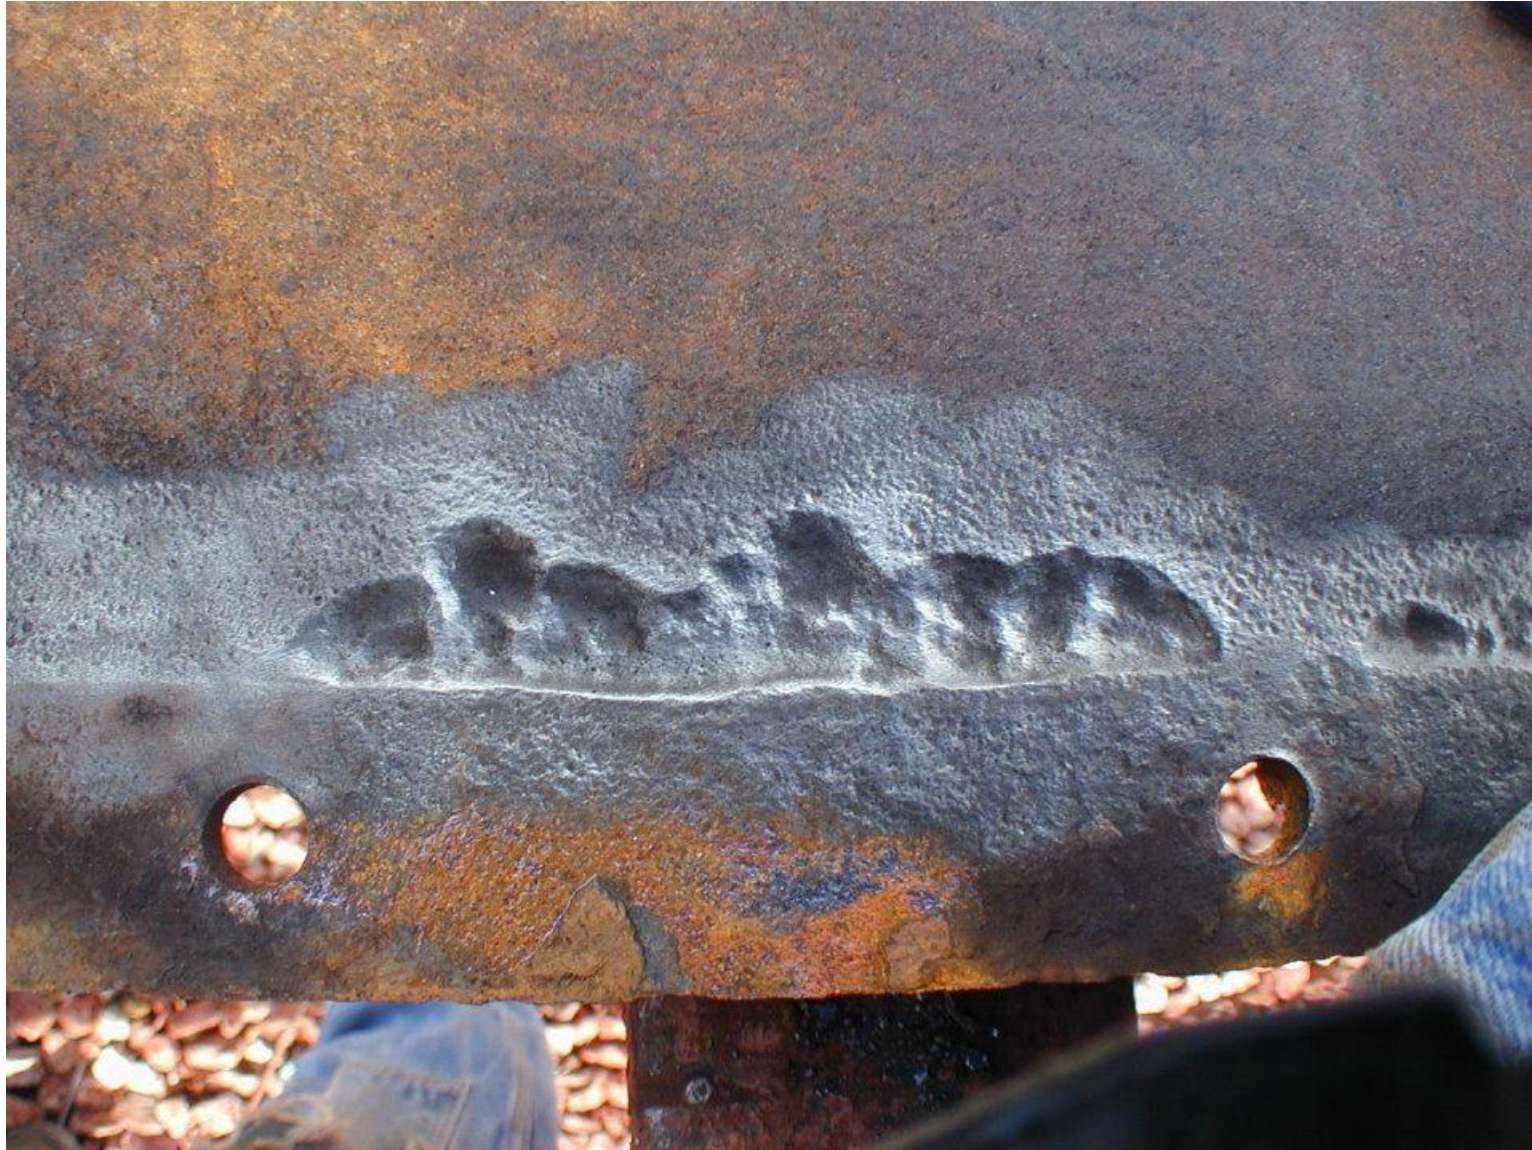
Section loss on floor beam, cleaned and ready for pad weld repair.

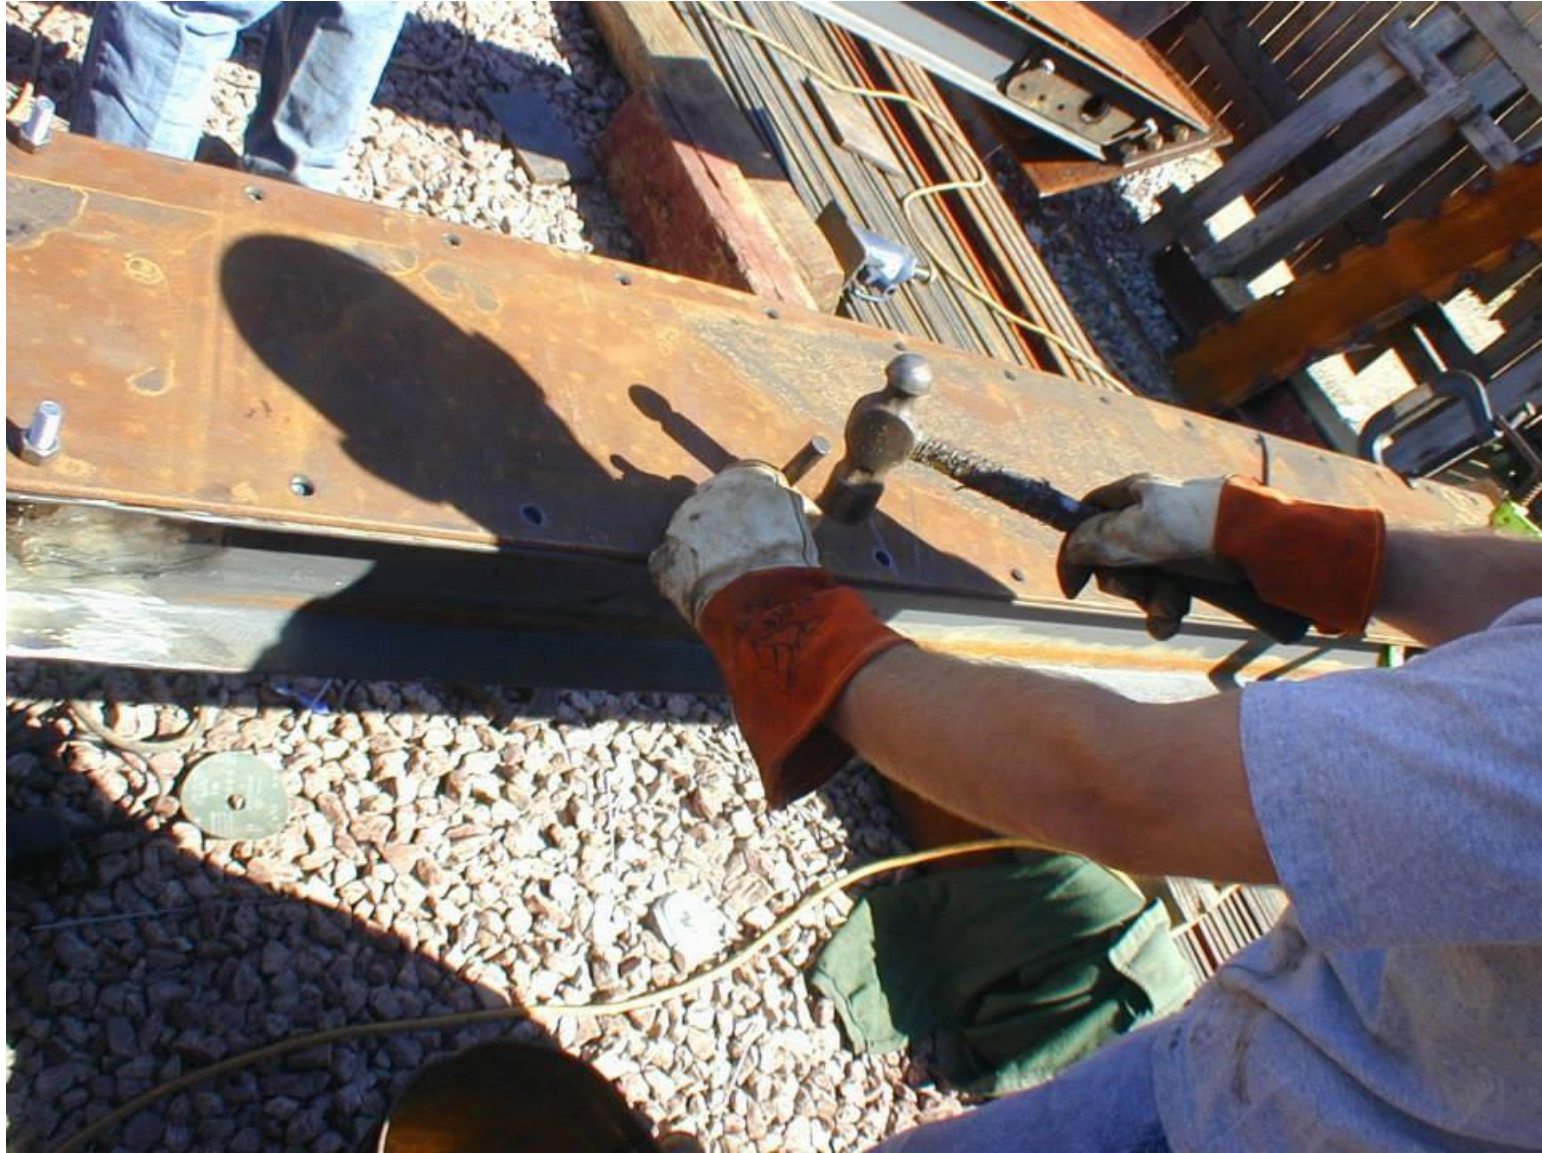
Using a locator punch to mark holes for drilling.

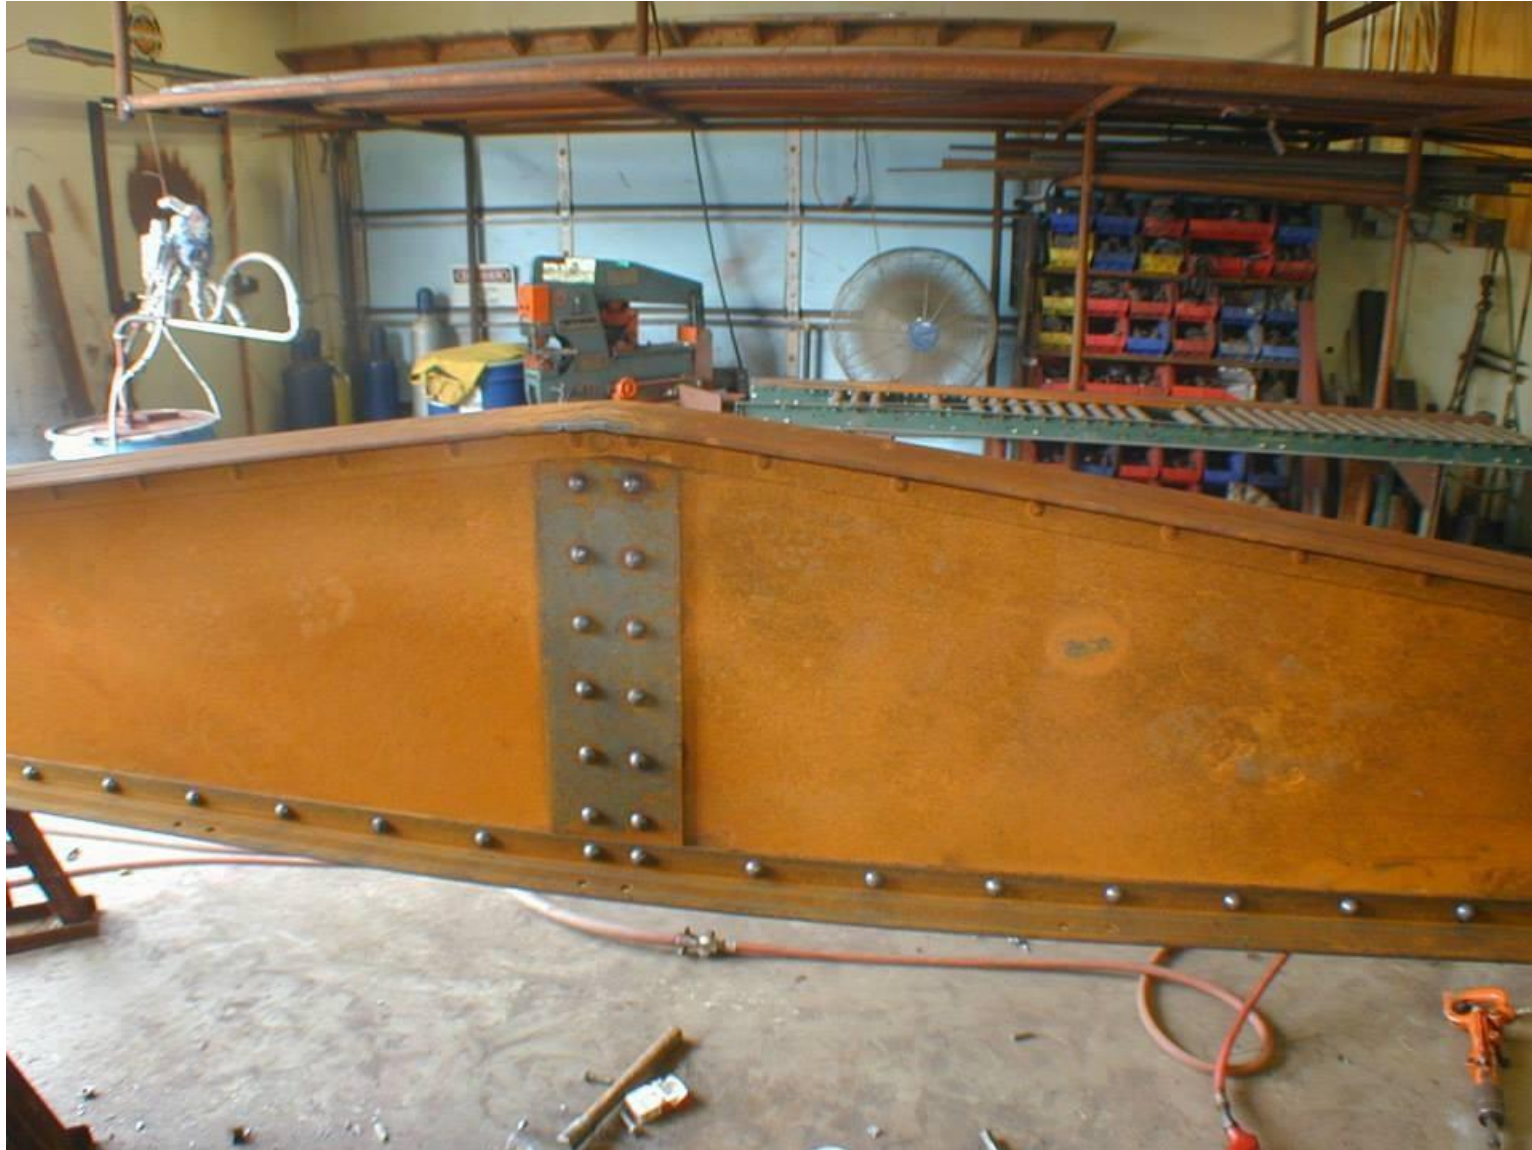
Repair of floor beam. The shiny rivets in the middle and on the lower portion of the photo are new rivets driven by Bach Steel.
