Project: Repairs to Historic NM-395 Lincoln County Bridge, New Mexico

Project Completed: October 2017

Overview: Heat straightening of vertical members, portal bracing, and sway bracing of historic riveted through truss damaged by over-height truck. The bridge was built in 1927 and consists of a 140 foot span. Bach Steel completed shop riveting of replica lower sway and portal bracing beams. This was followed by field riveting of the replica beams in place onto the bridge, with heat straightening also being completed to correct members to remain in place. This project was completed (including painting work by the Prime Contractor) in the 30 day period as required by contract.

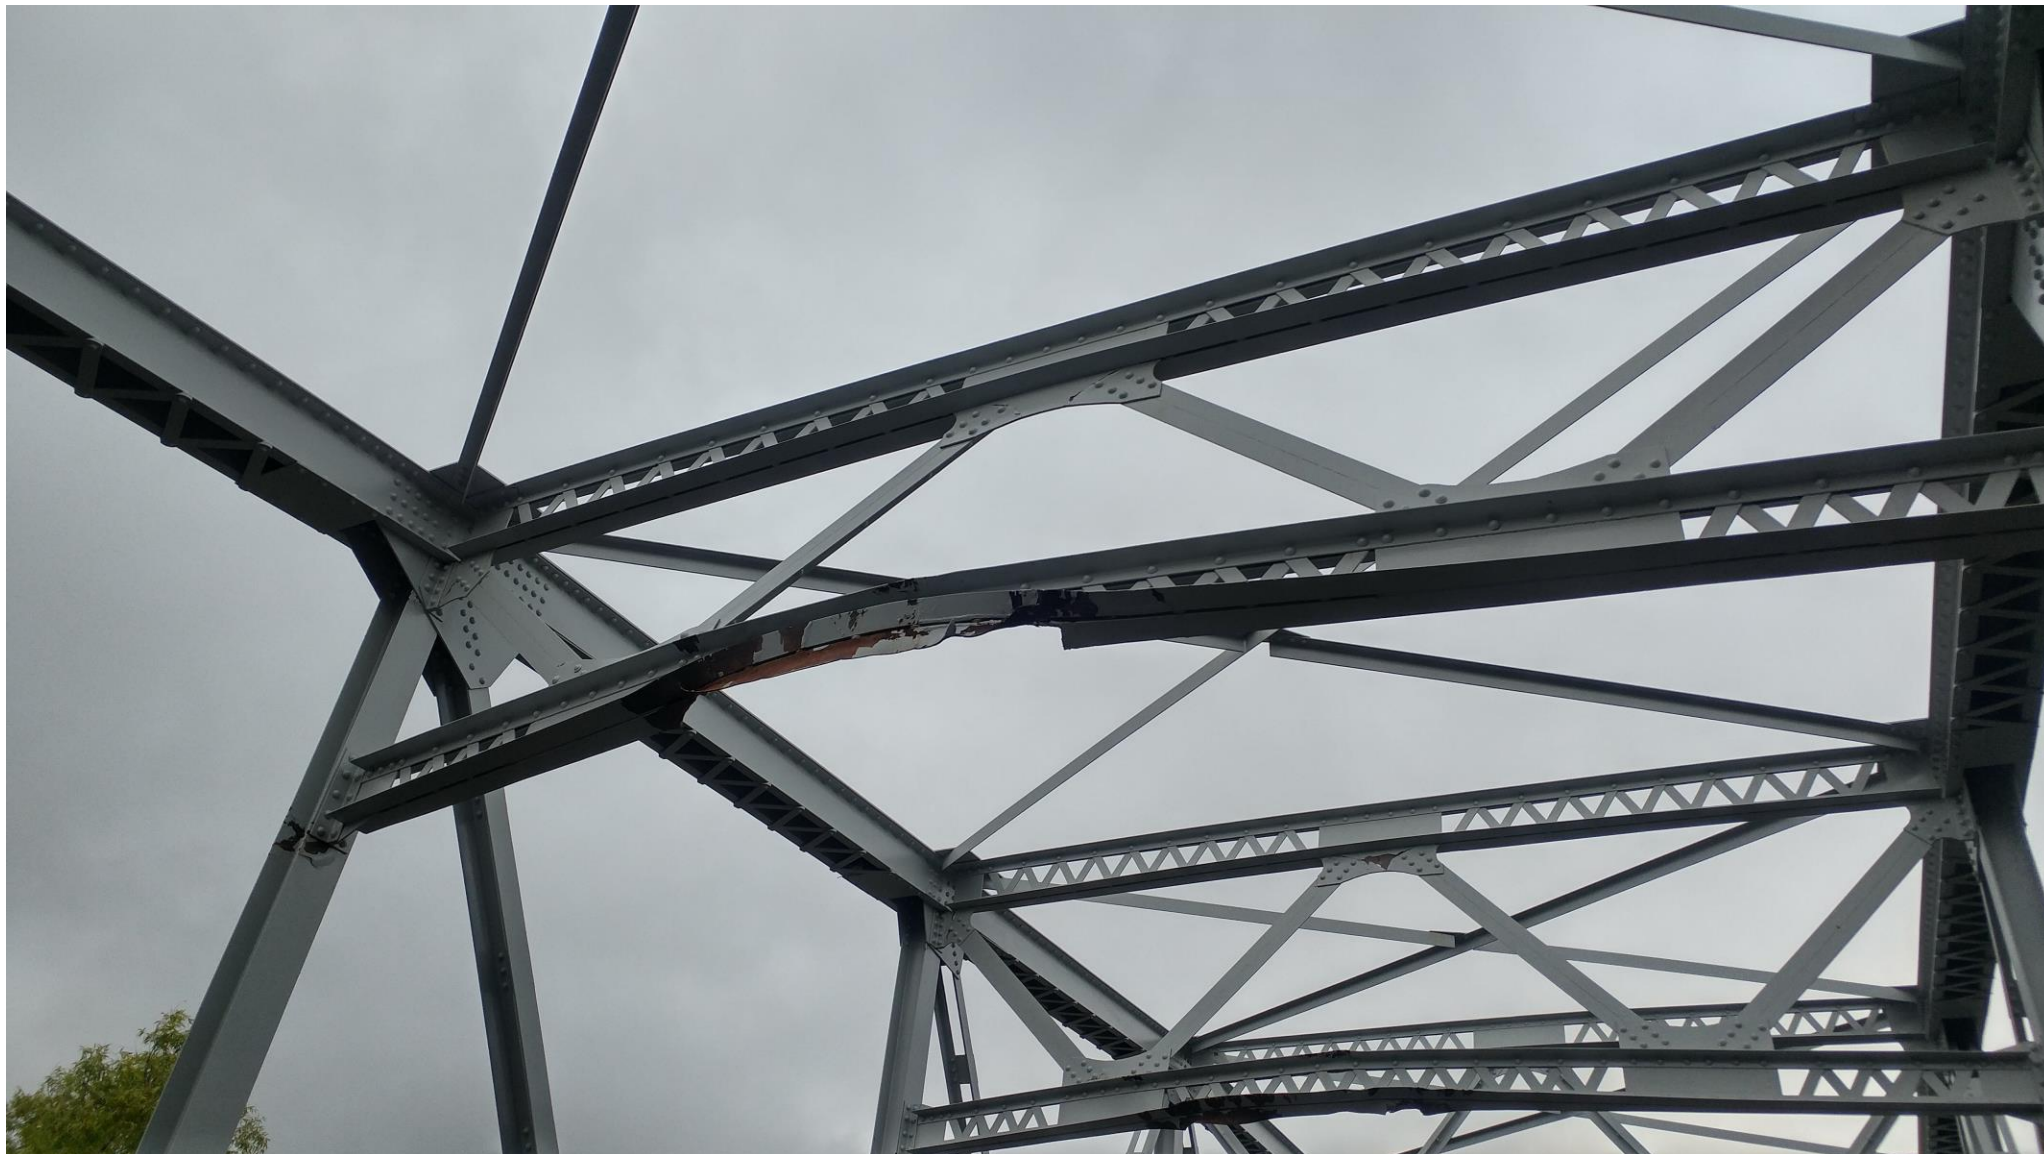
Bridge before repairs showing bracing damage.

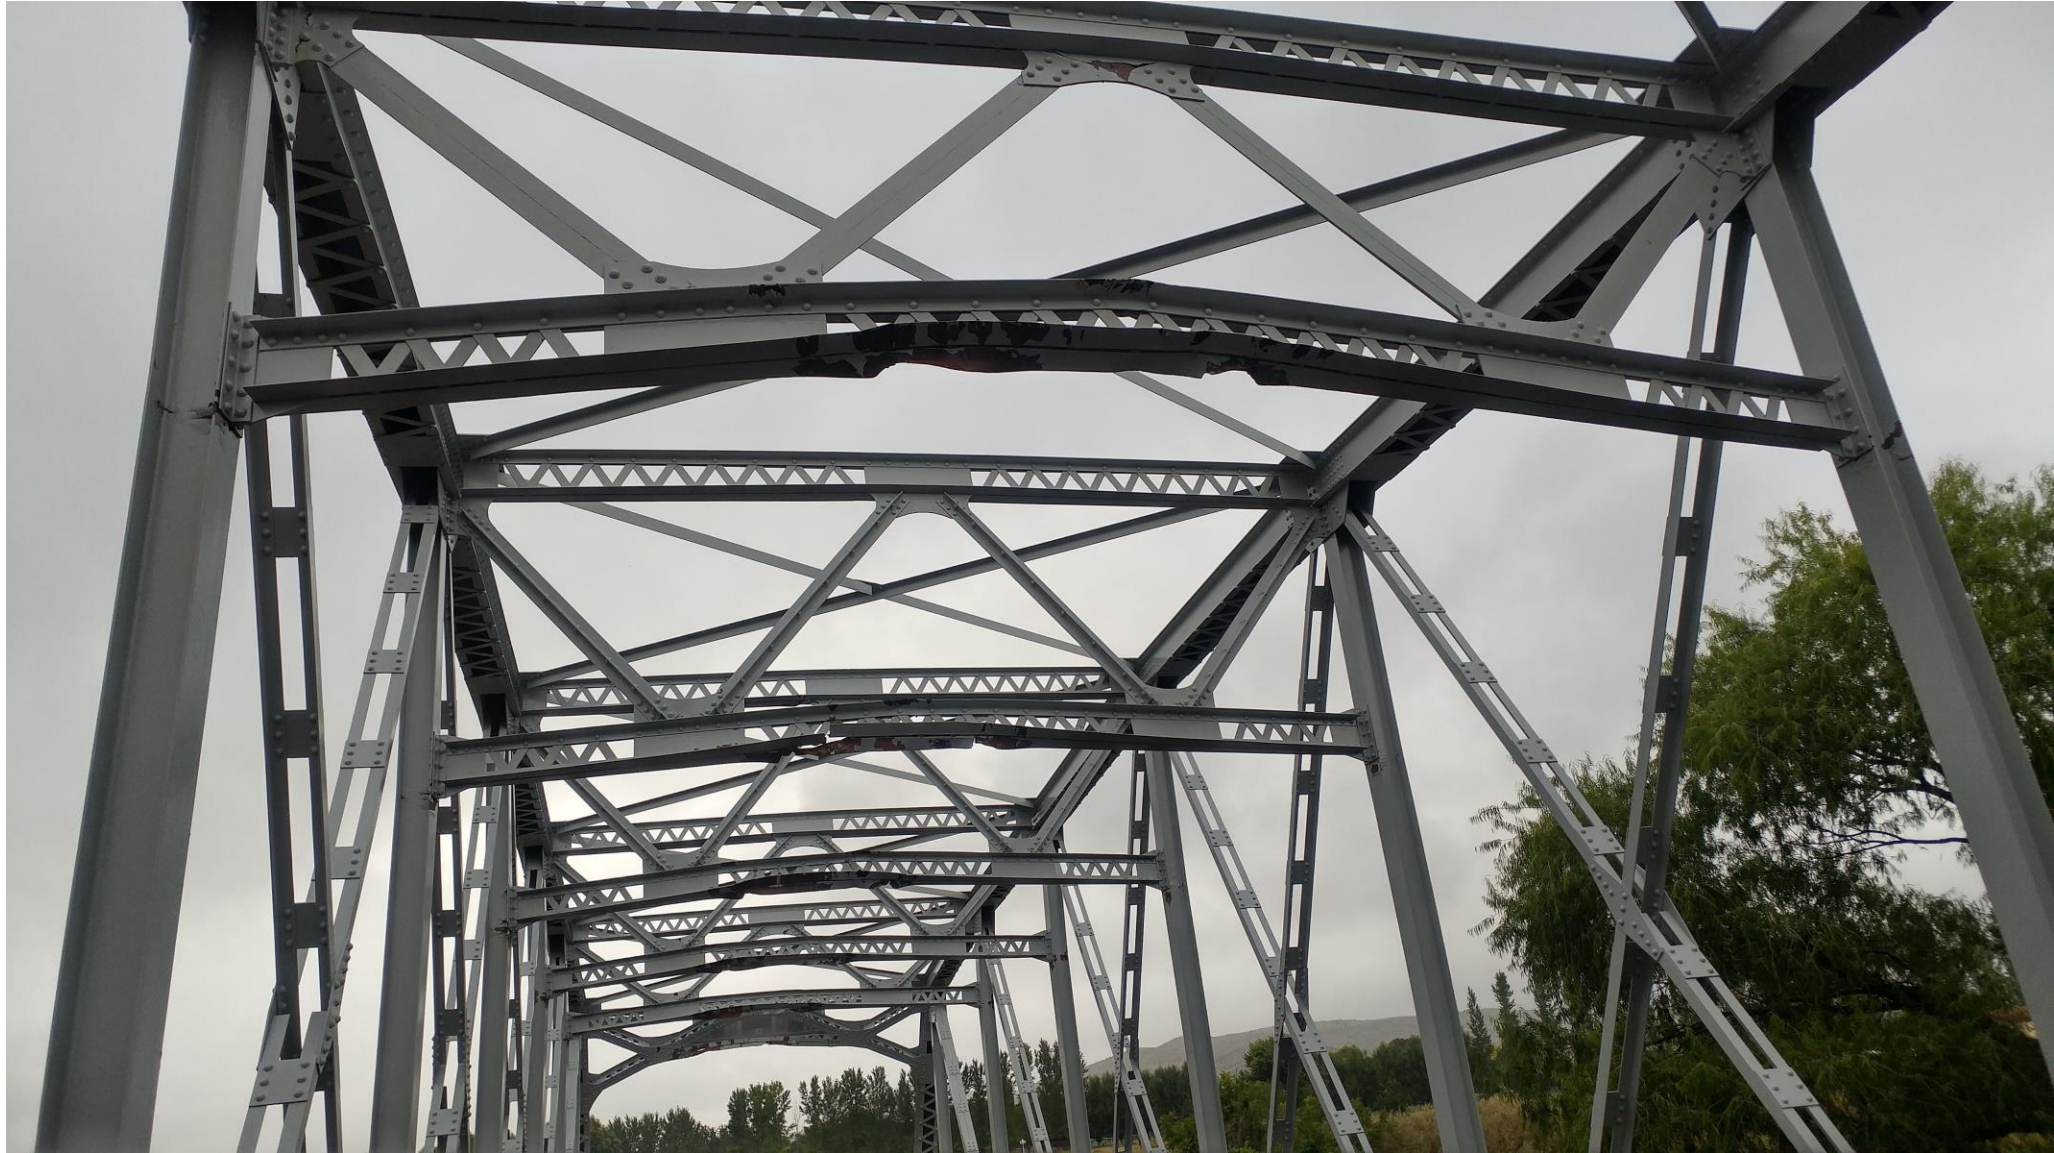
Bridge before repairs showing bracing damage.

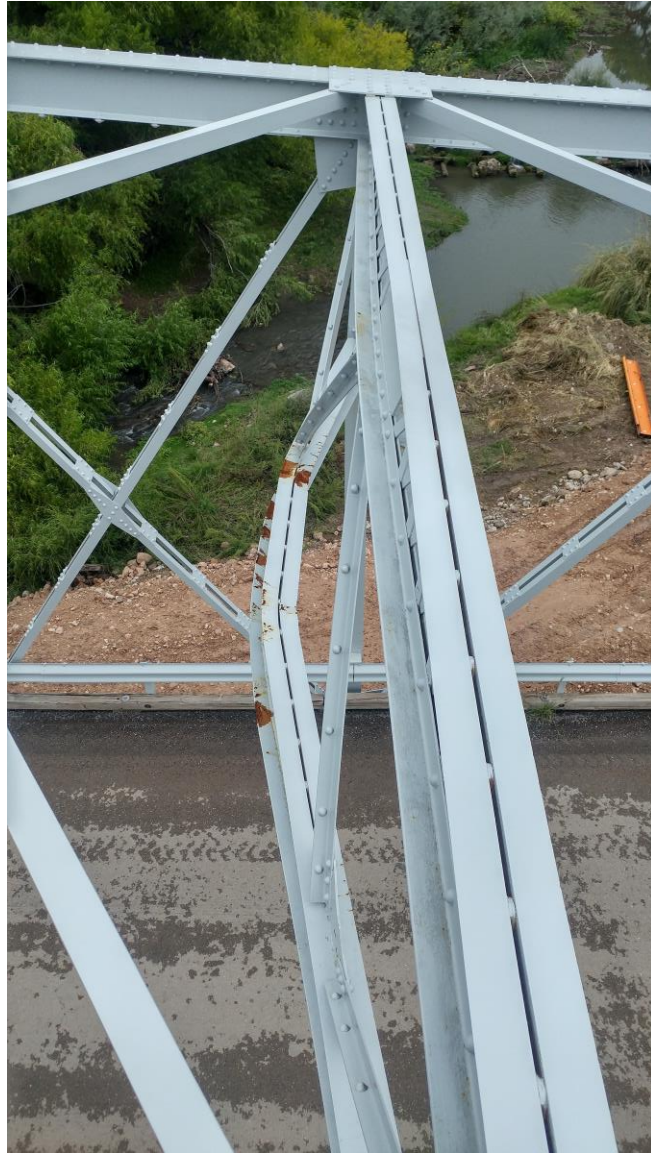
Bridge before repairs showing bracing damage.

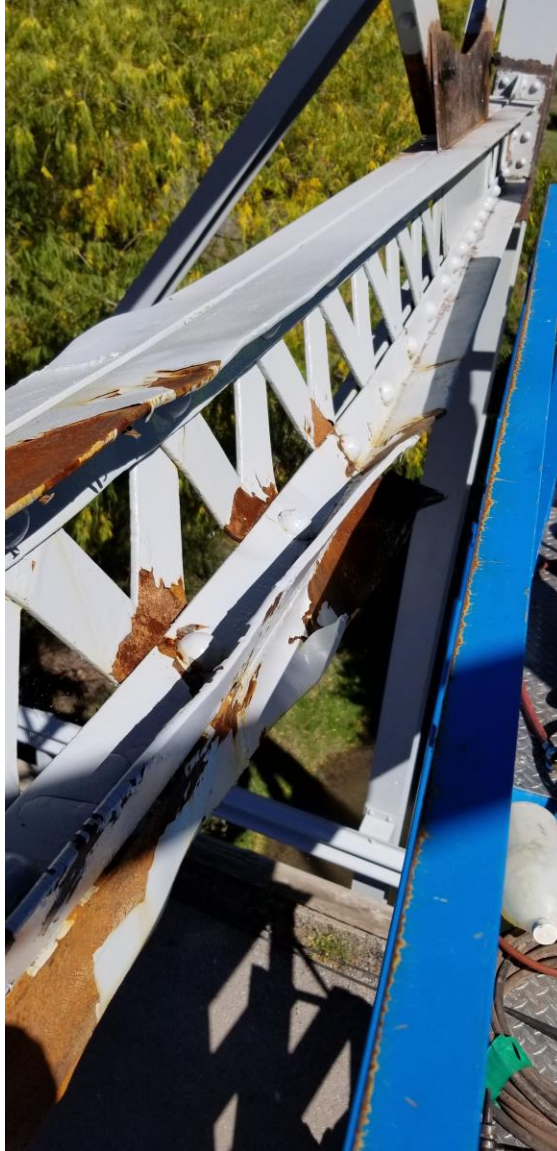
Bridge before repairs showing bracing damage.

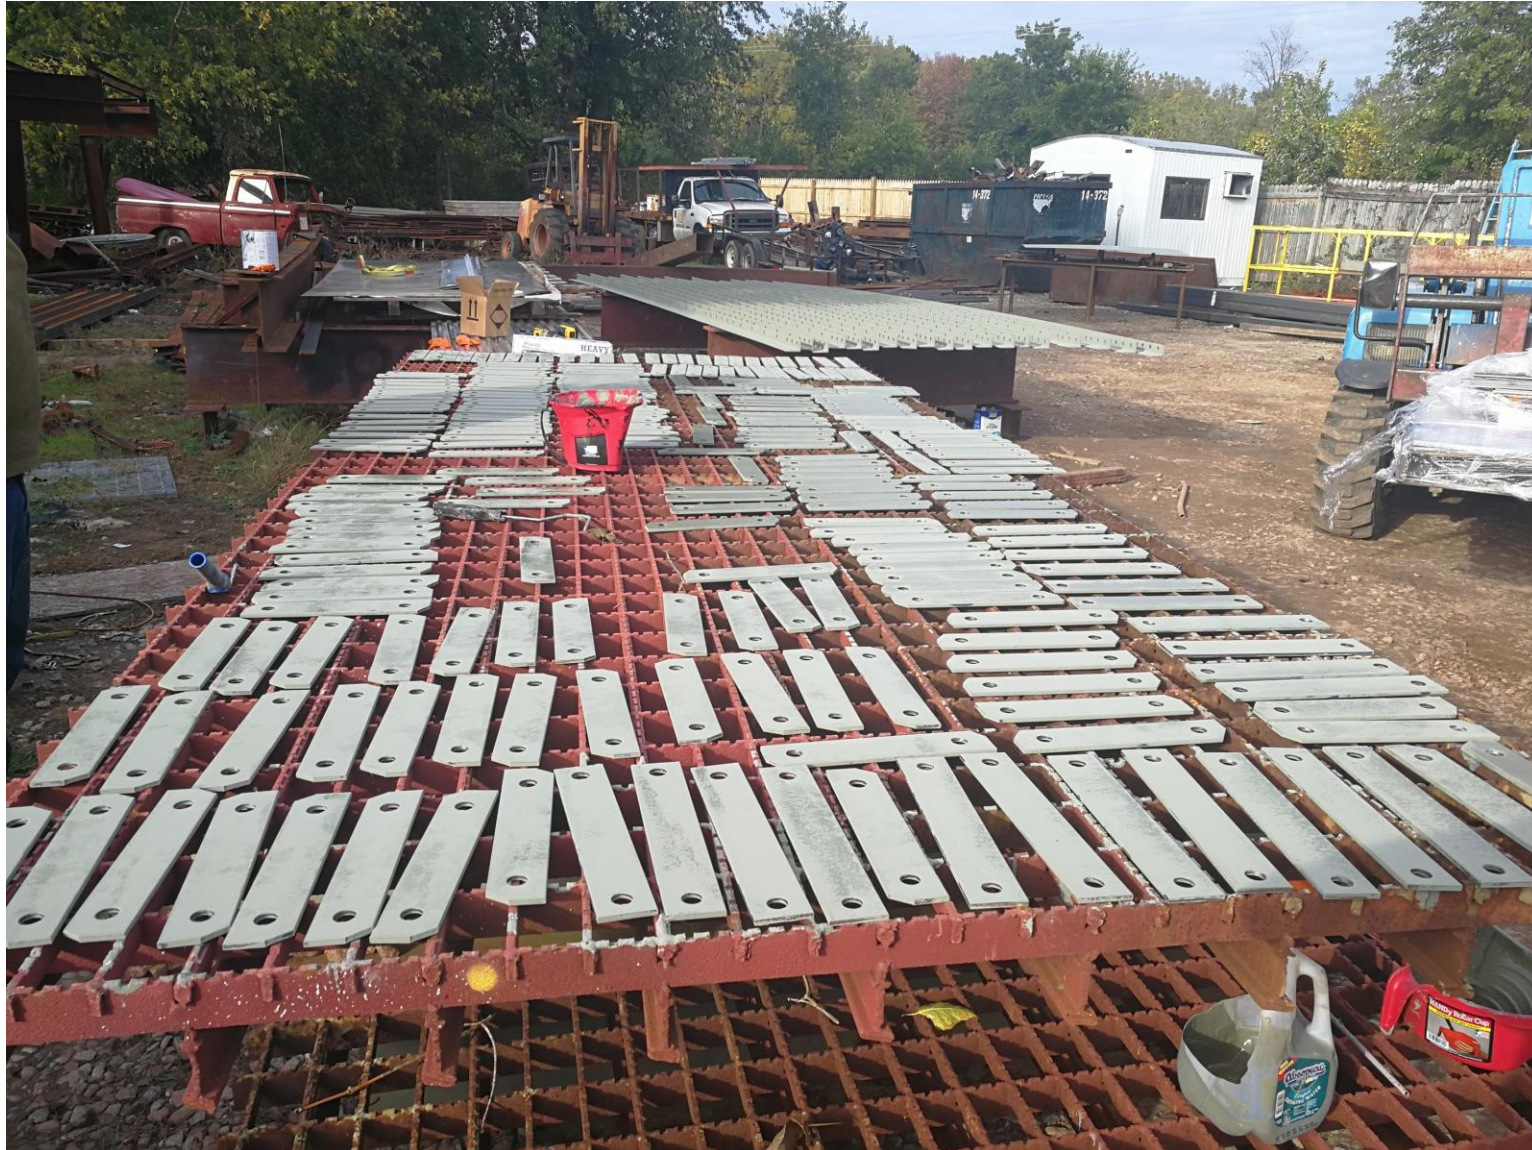
Lacing bars for replacement bracing.

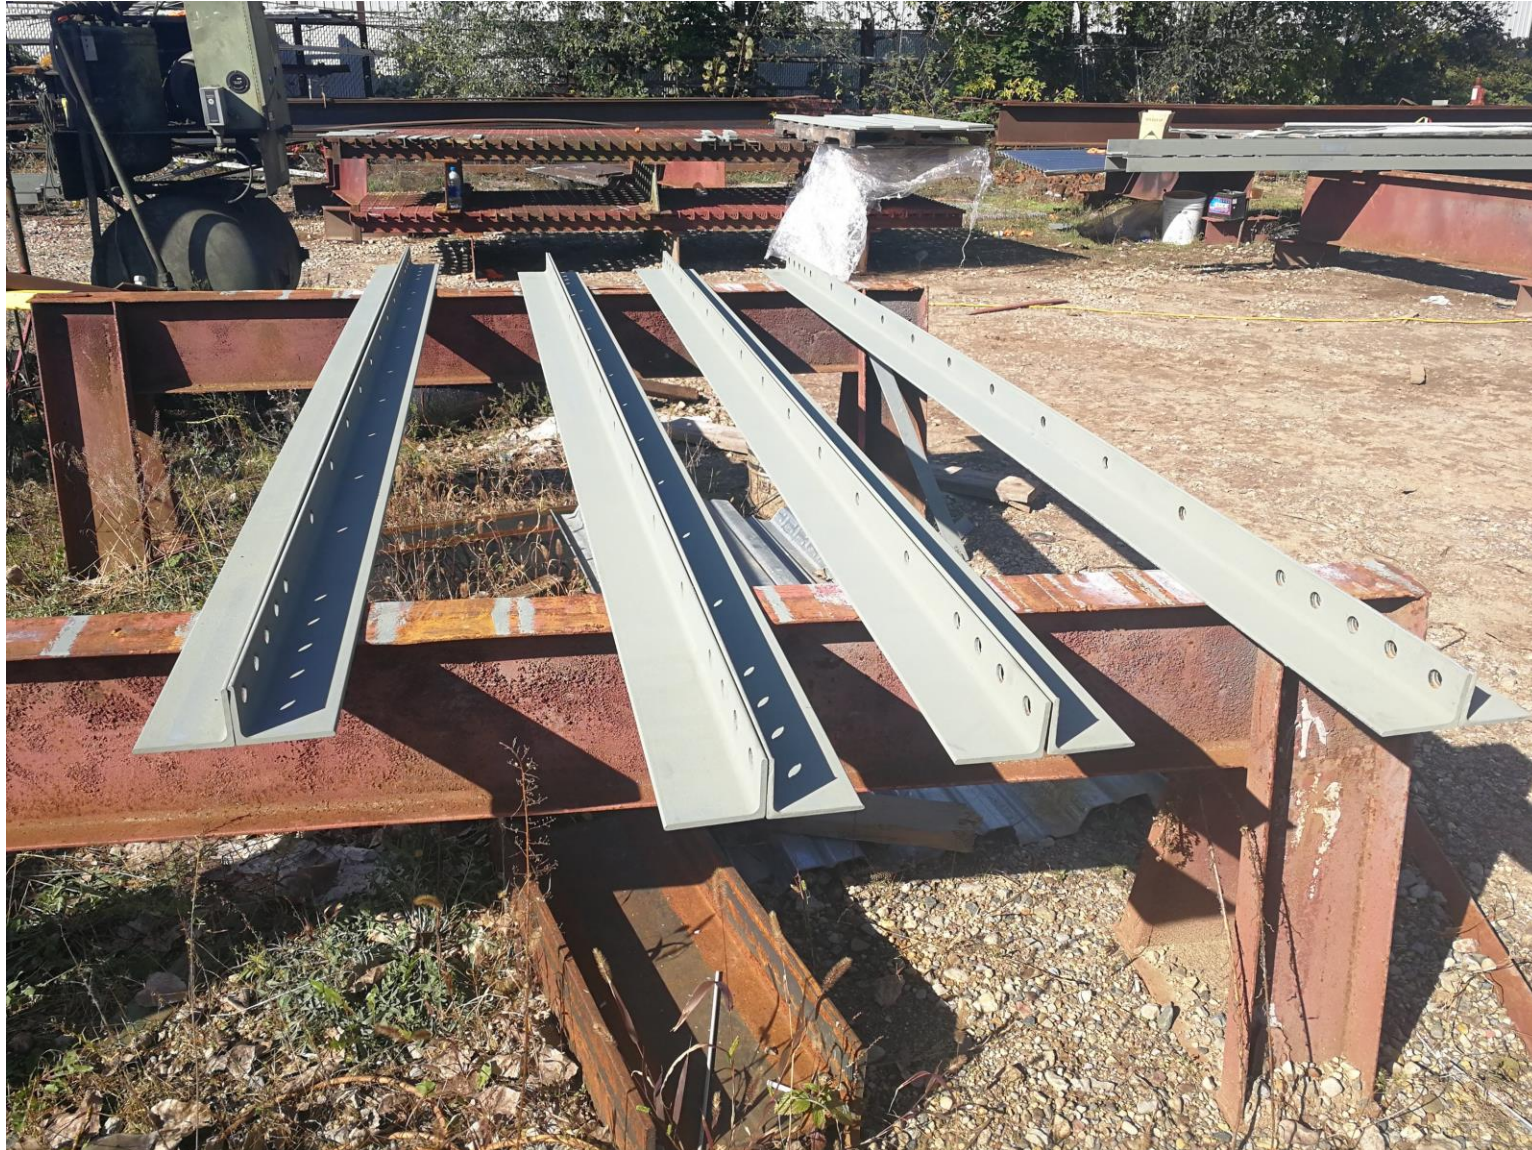
Angle for replacement bracing.

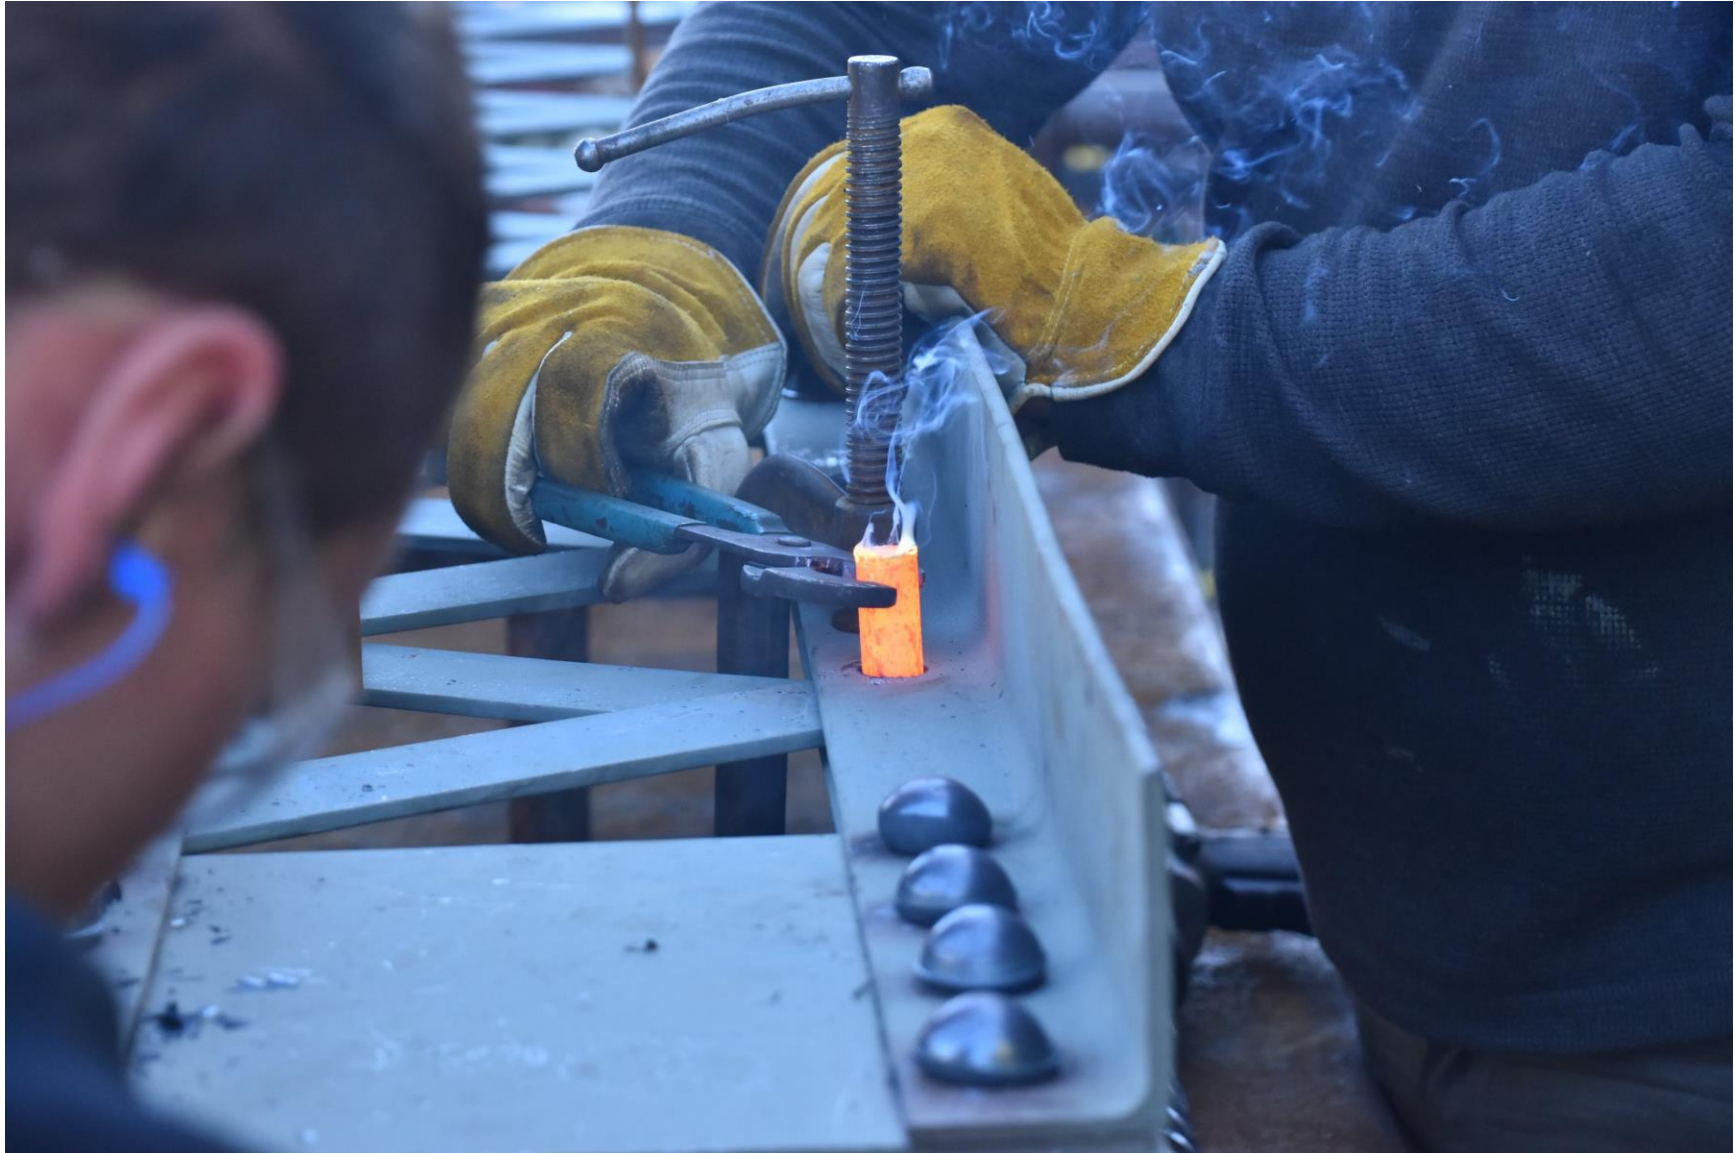
Hot riveting sway bracing.

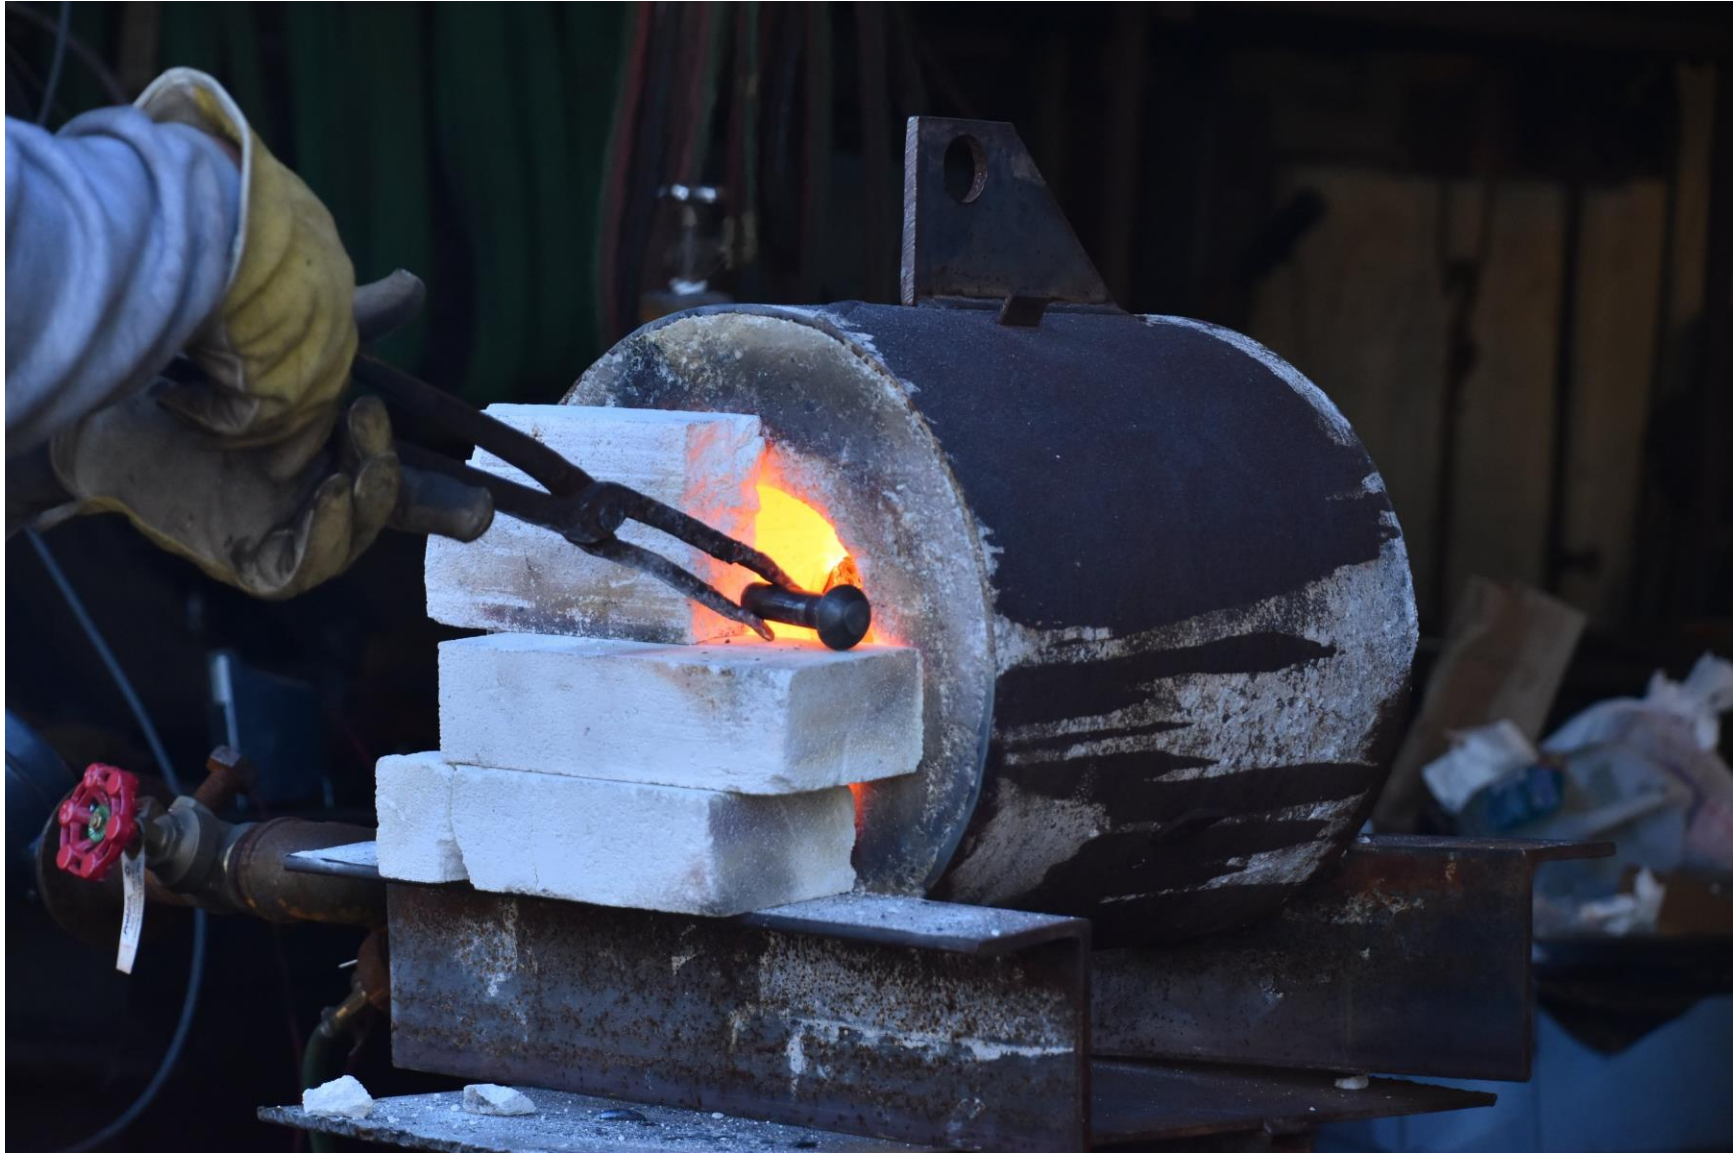
Hot riveting sway bracing.

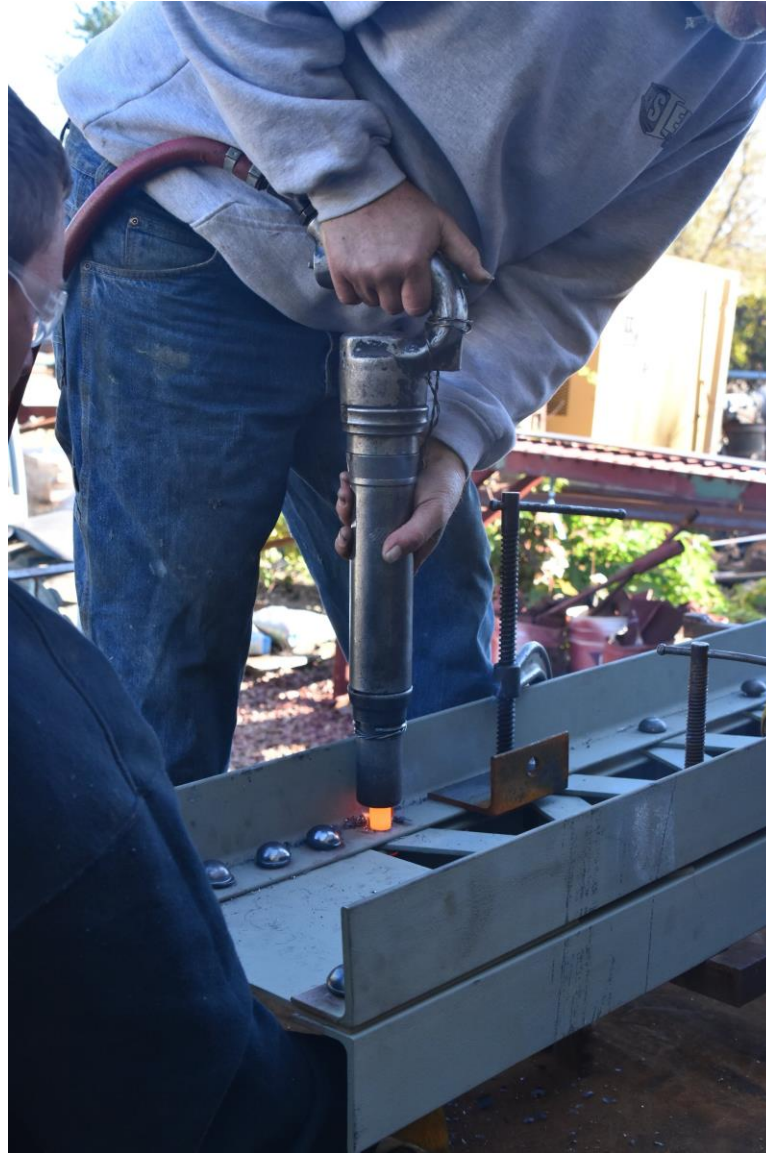
Hot riveting sway bracing.

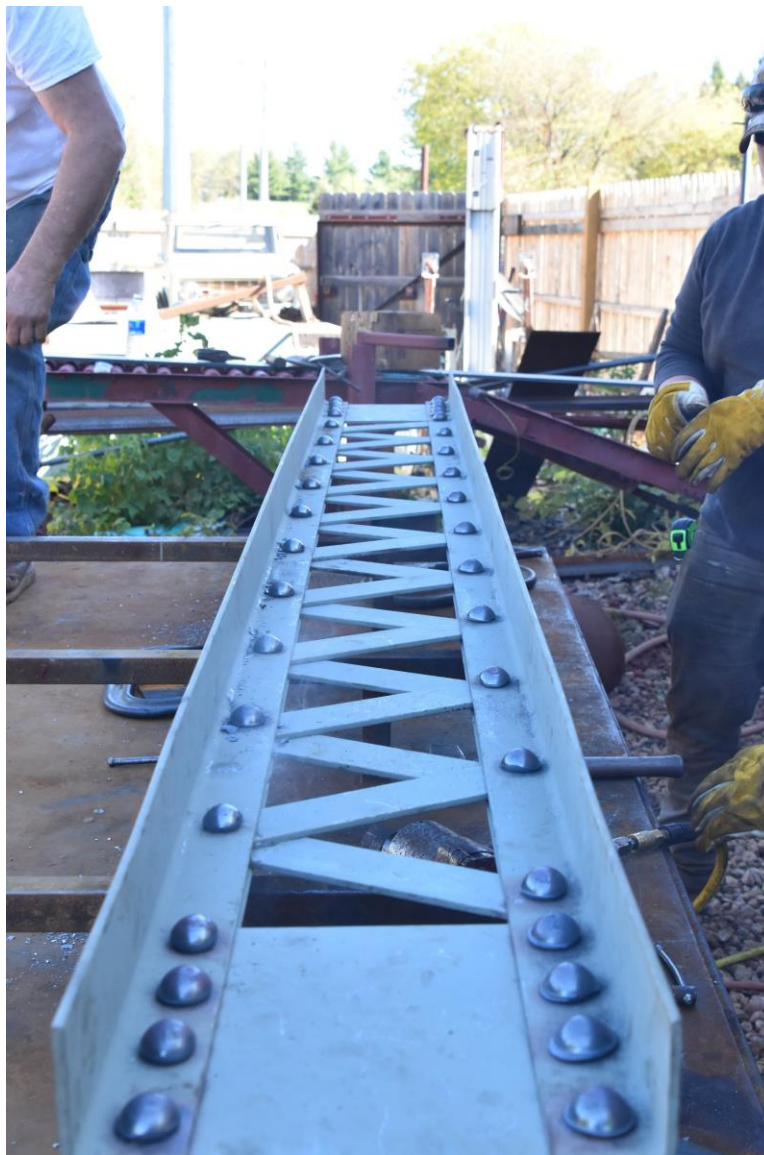
Completed replica bracing beam.

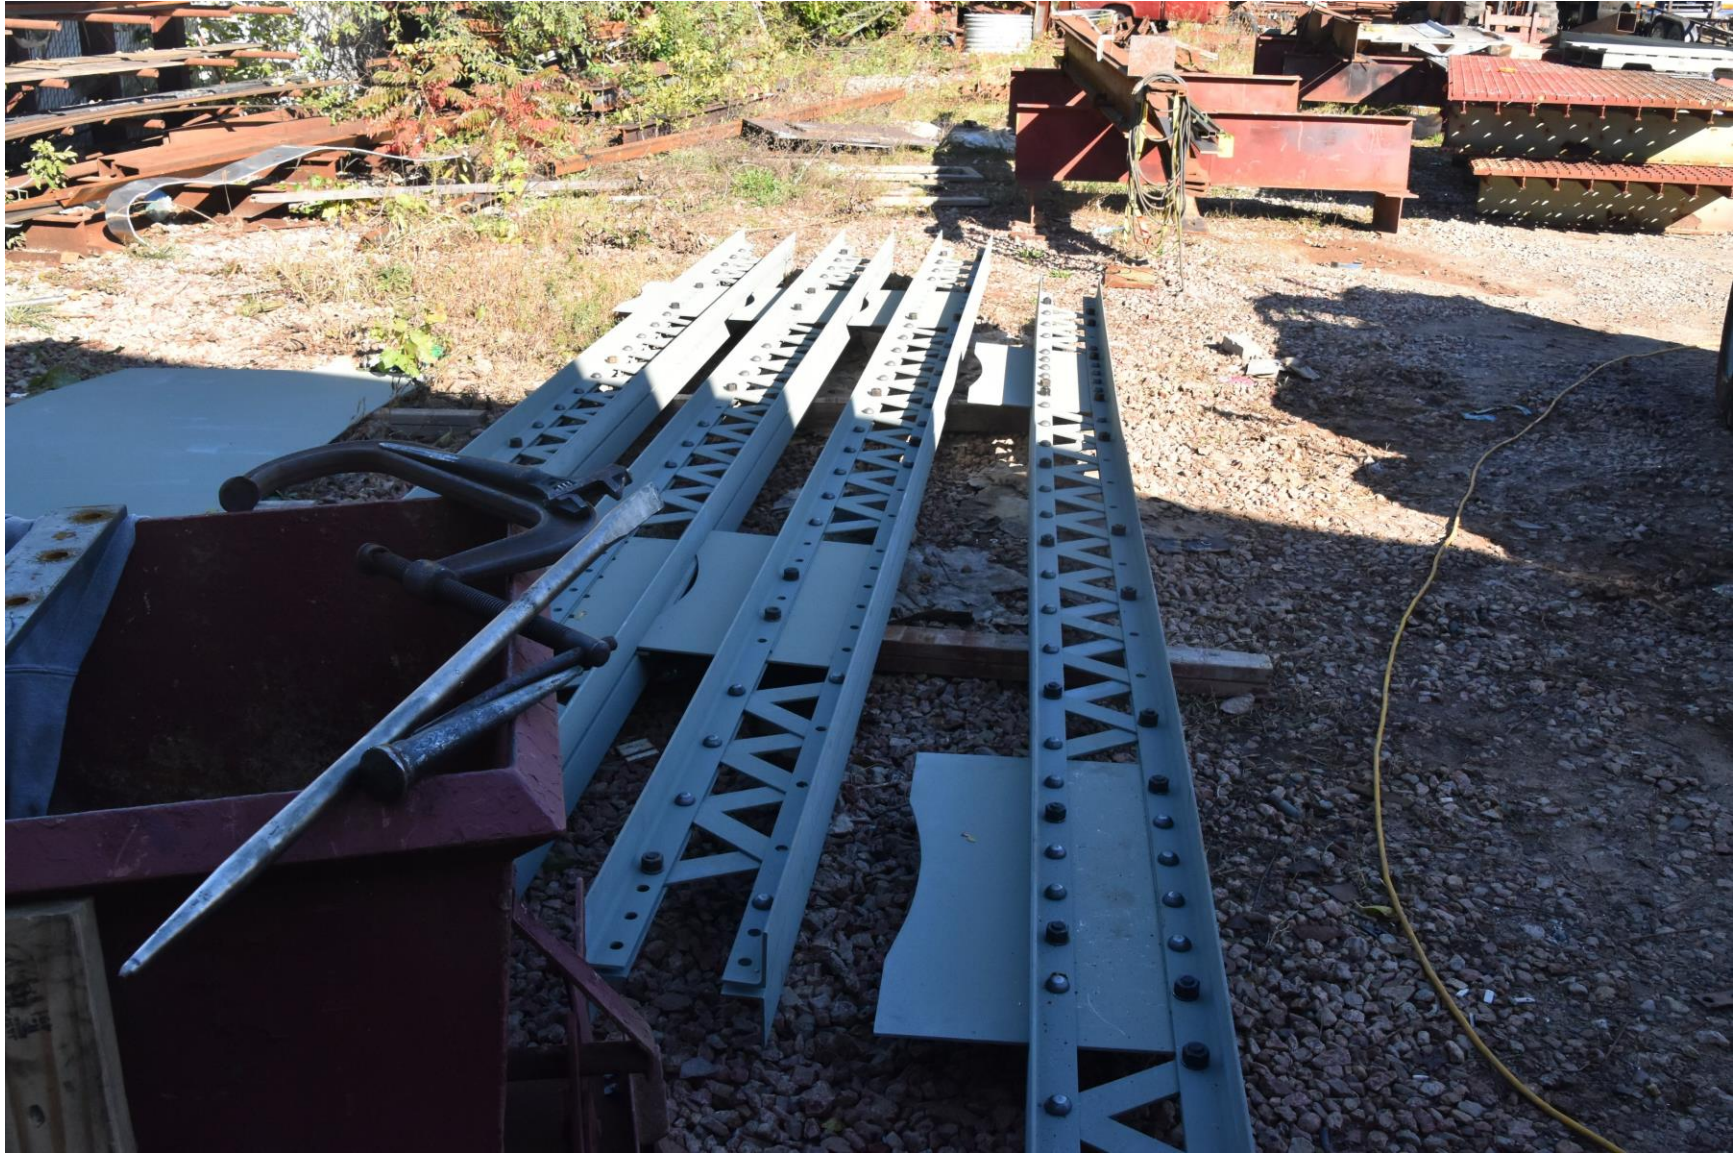
Completed replica bracing beams.

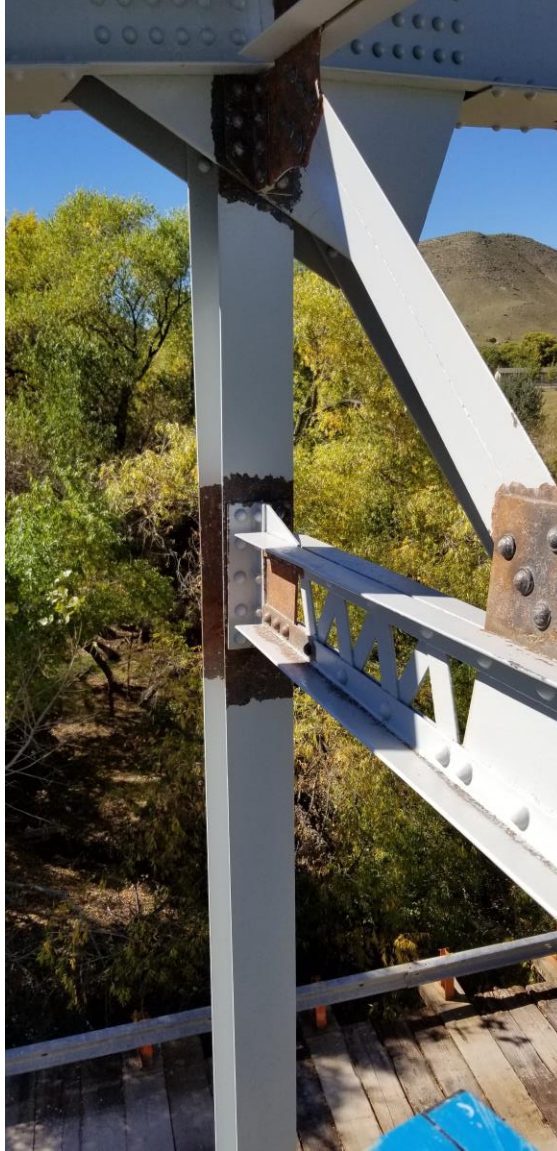
Field repair work.

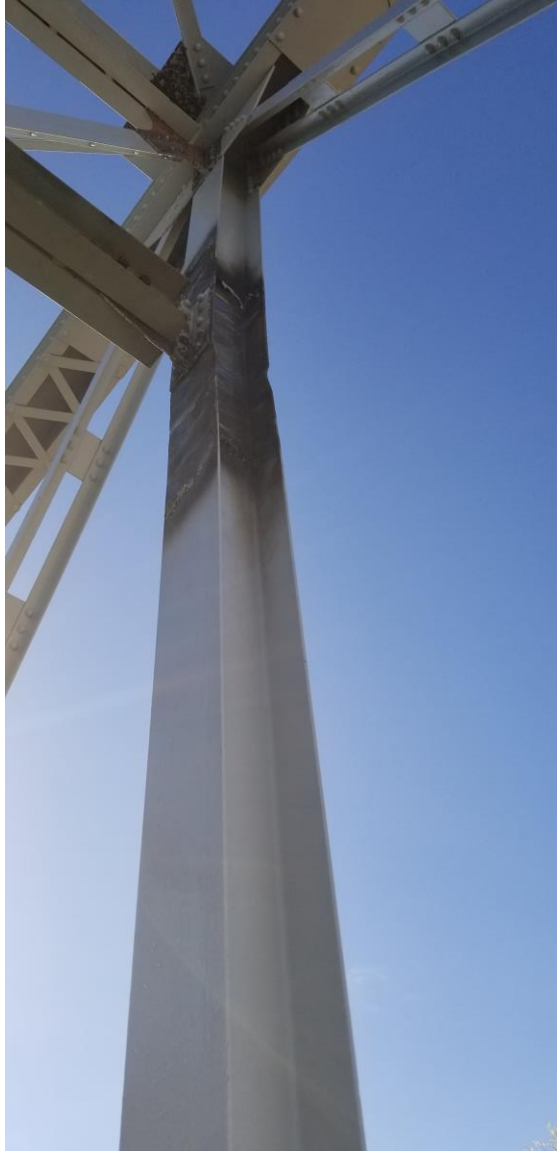
Field repair work.

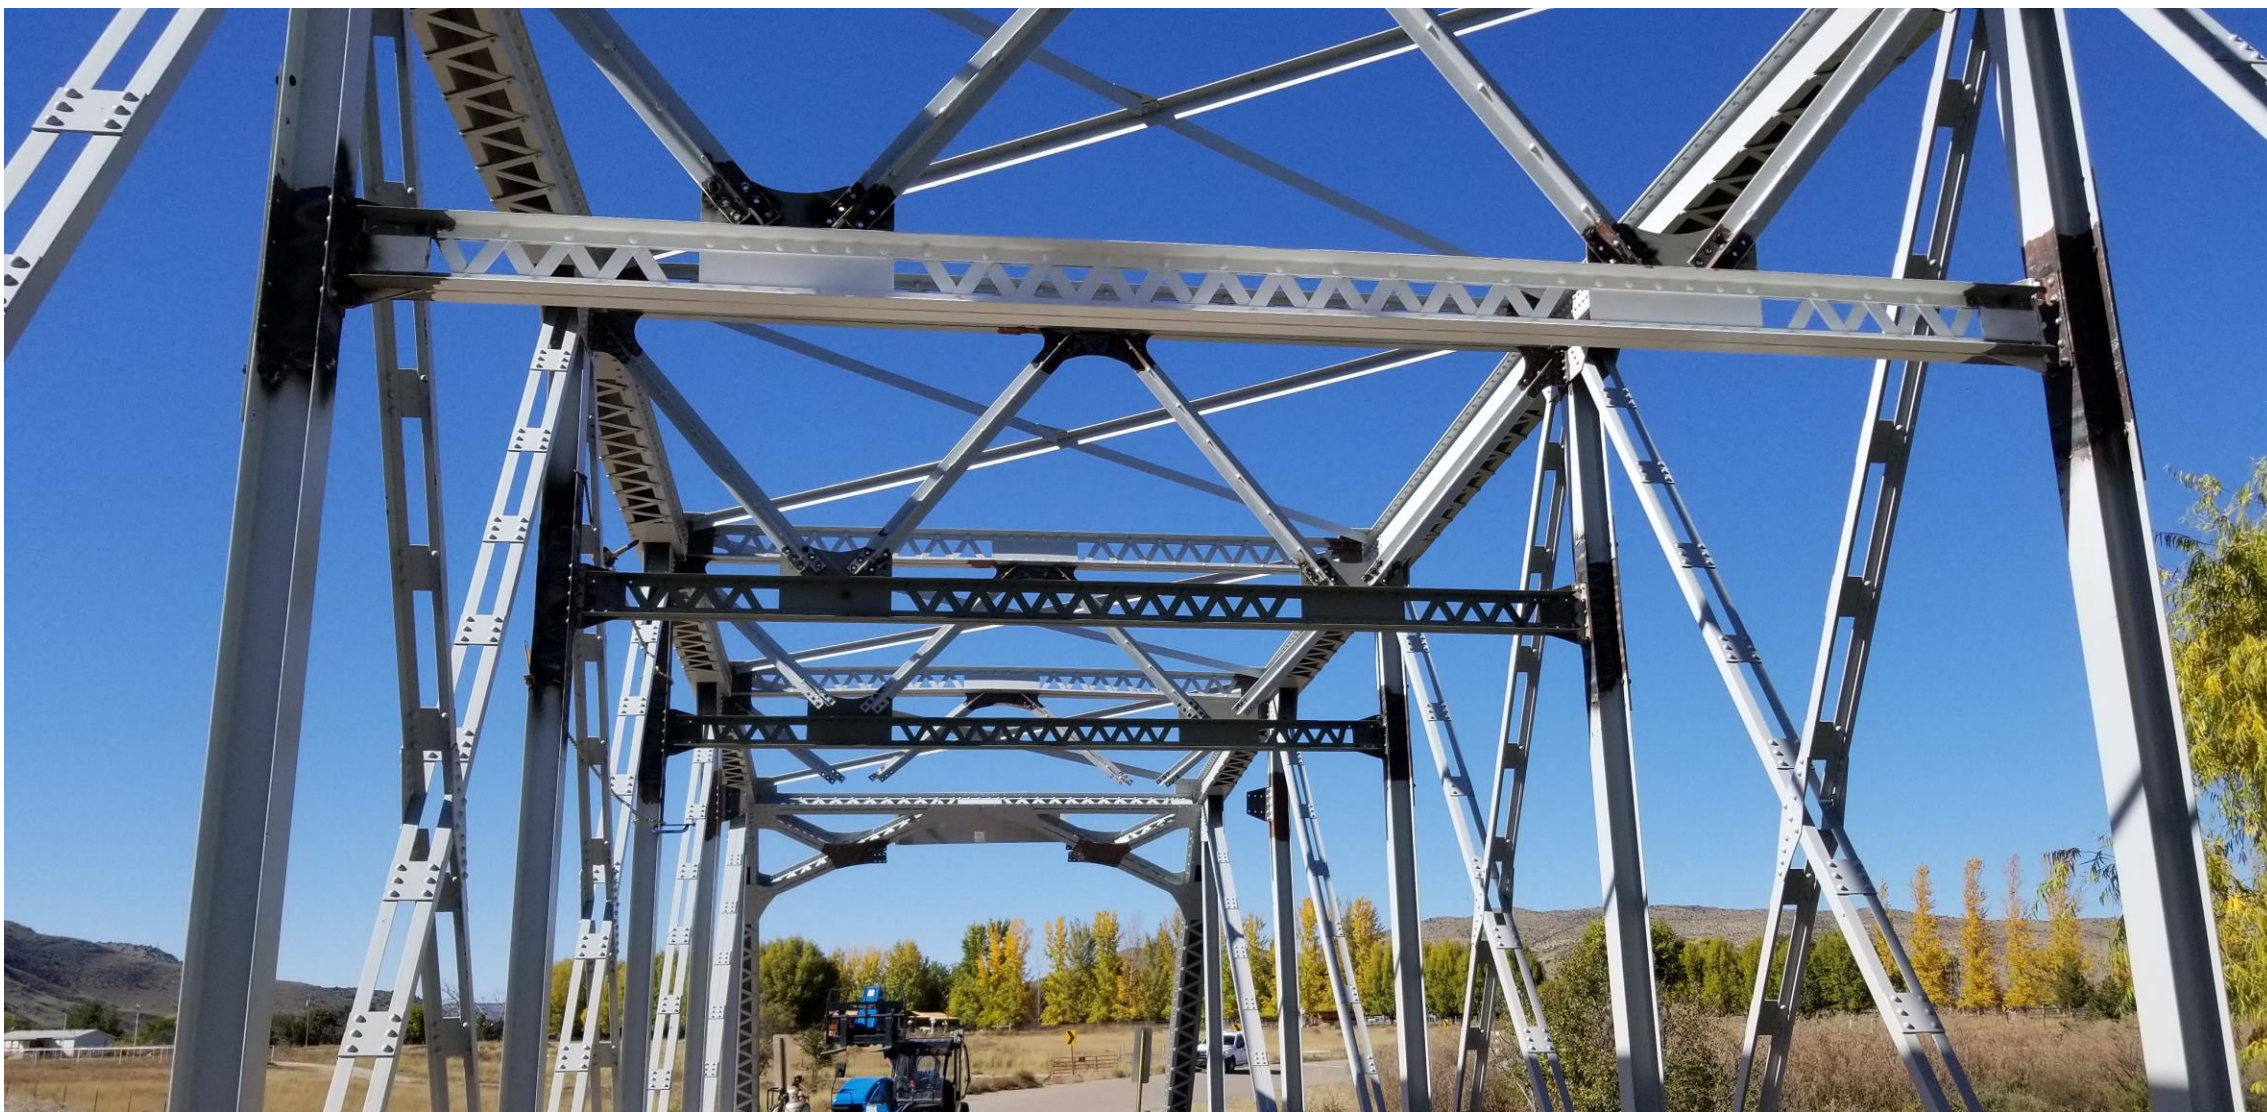
Field repair work.
