Project: Repairs to Historic NM-395 Lincoln County Bridge, New Mexico

Project Completed: October 2017

Overview: Heat straightening of vertical members, portal bracing, and sway bracing of historic riveted through truss damaged by over-height truck. The bridge was built in 1927 and consists of a 140 foot span. Bach Steel completed shop riveting of replica lower sway and portal bracing beams. This was followed by field riveting of the replica beams in place onto the bridge, with heat straightening also being completed to correct members to remain in place. This project was completed (including painting work by the Prime Contractor) in the 30 day period as required by contract.

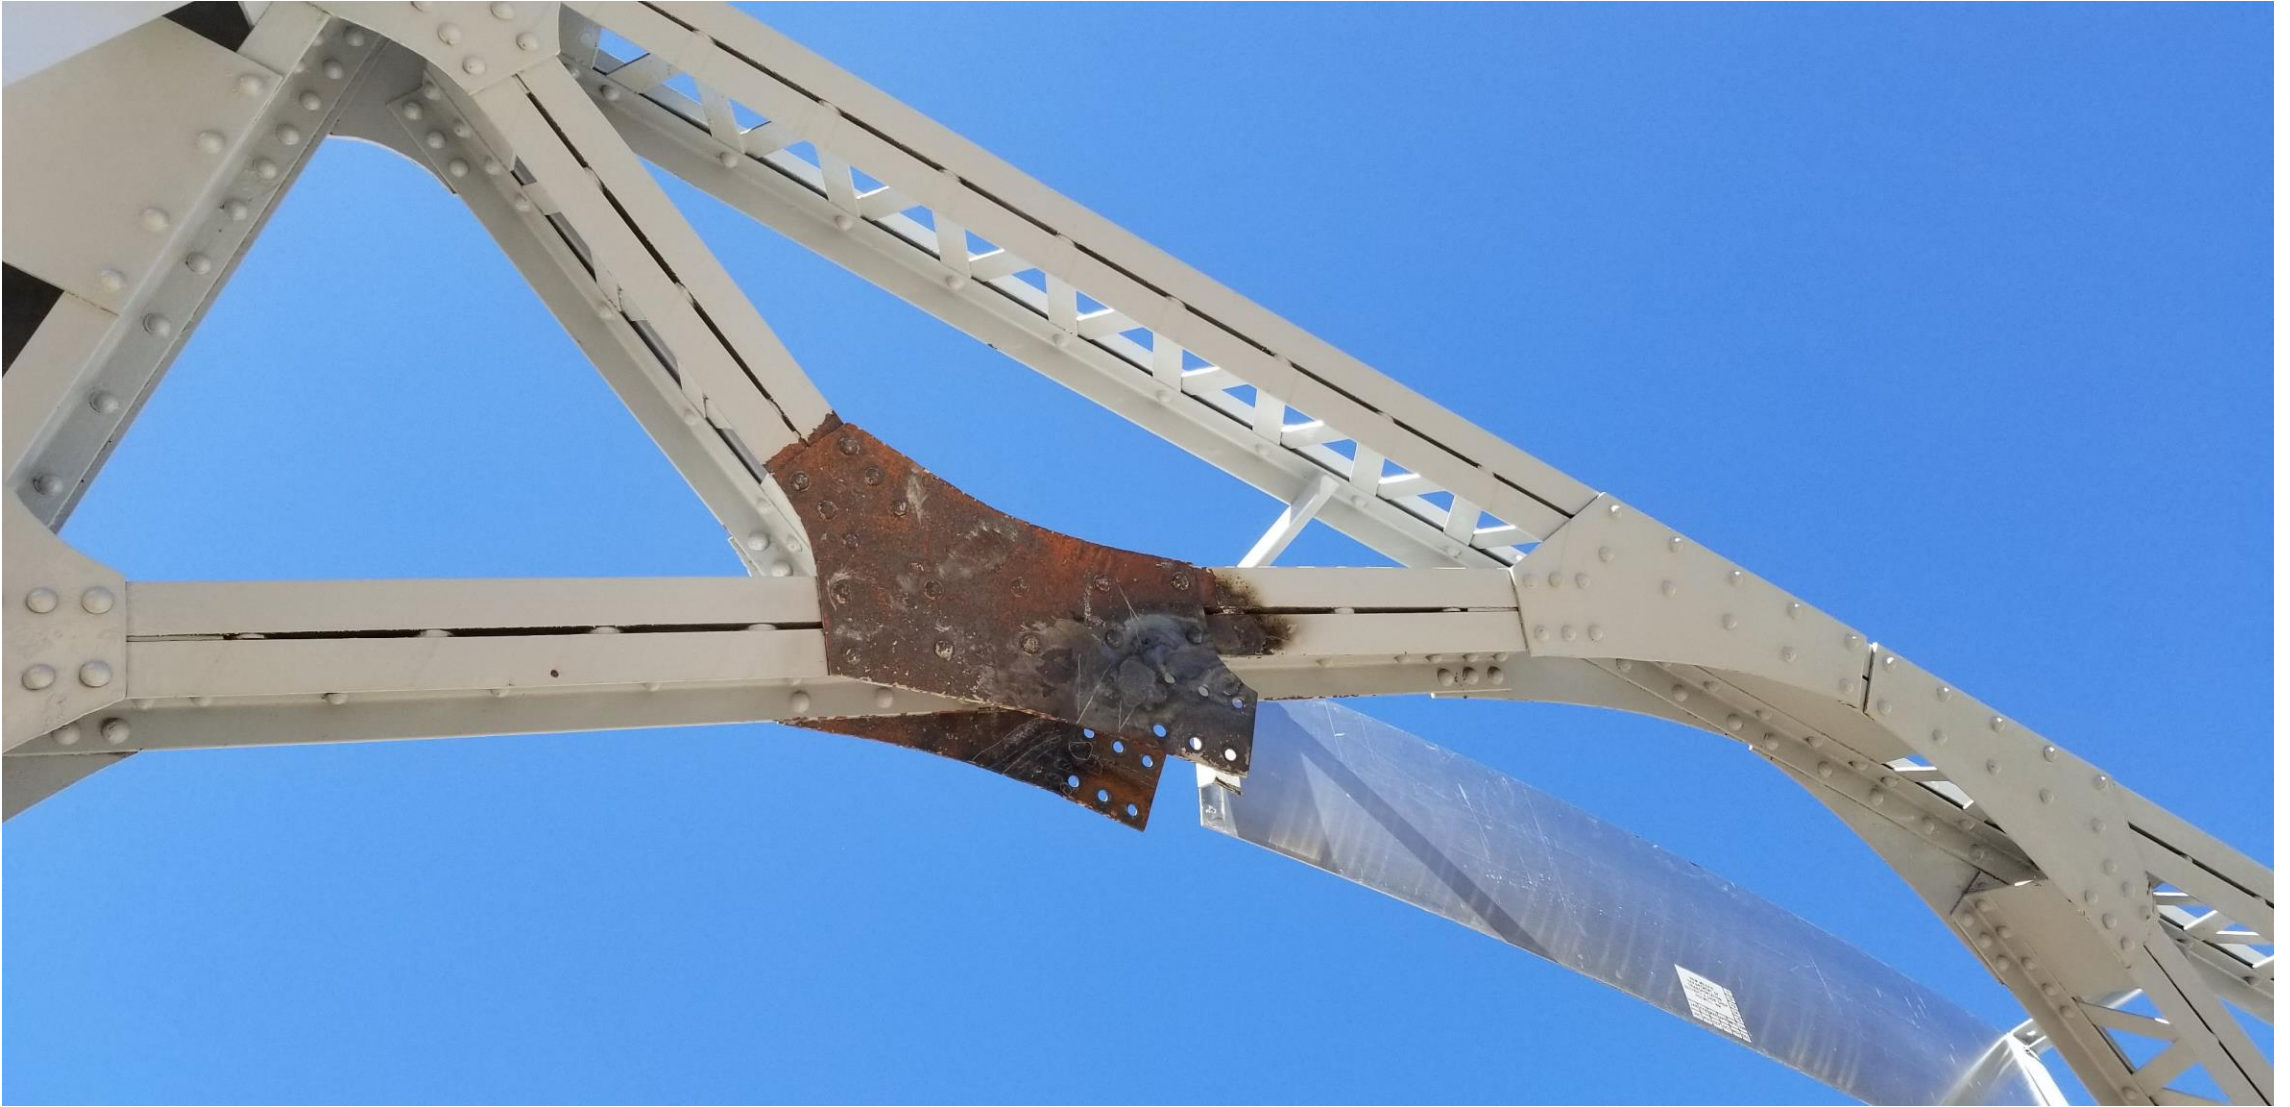
Field repair work.

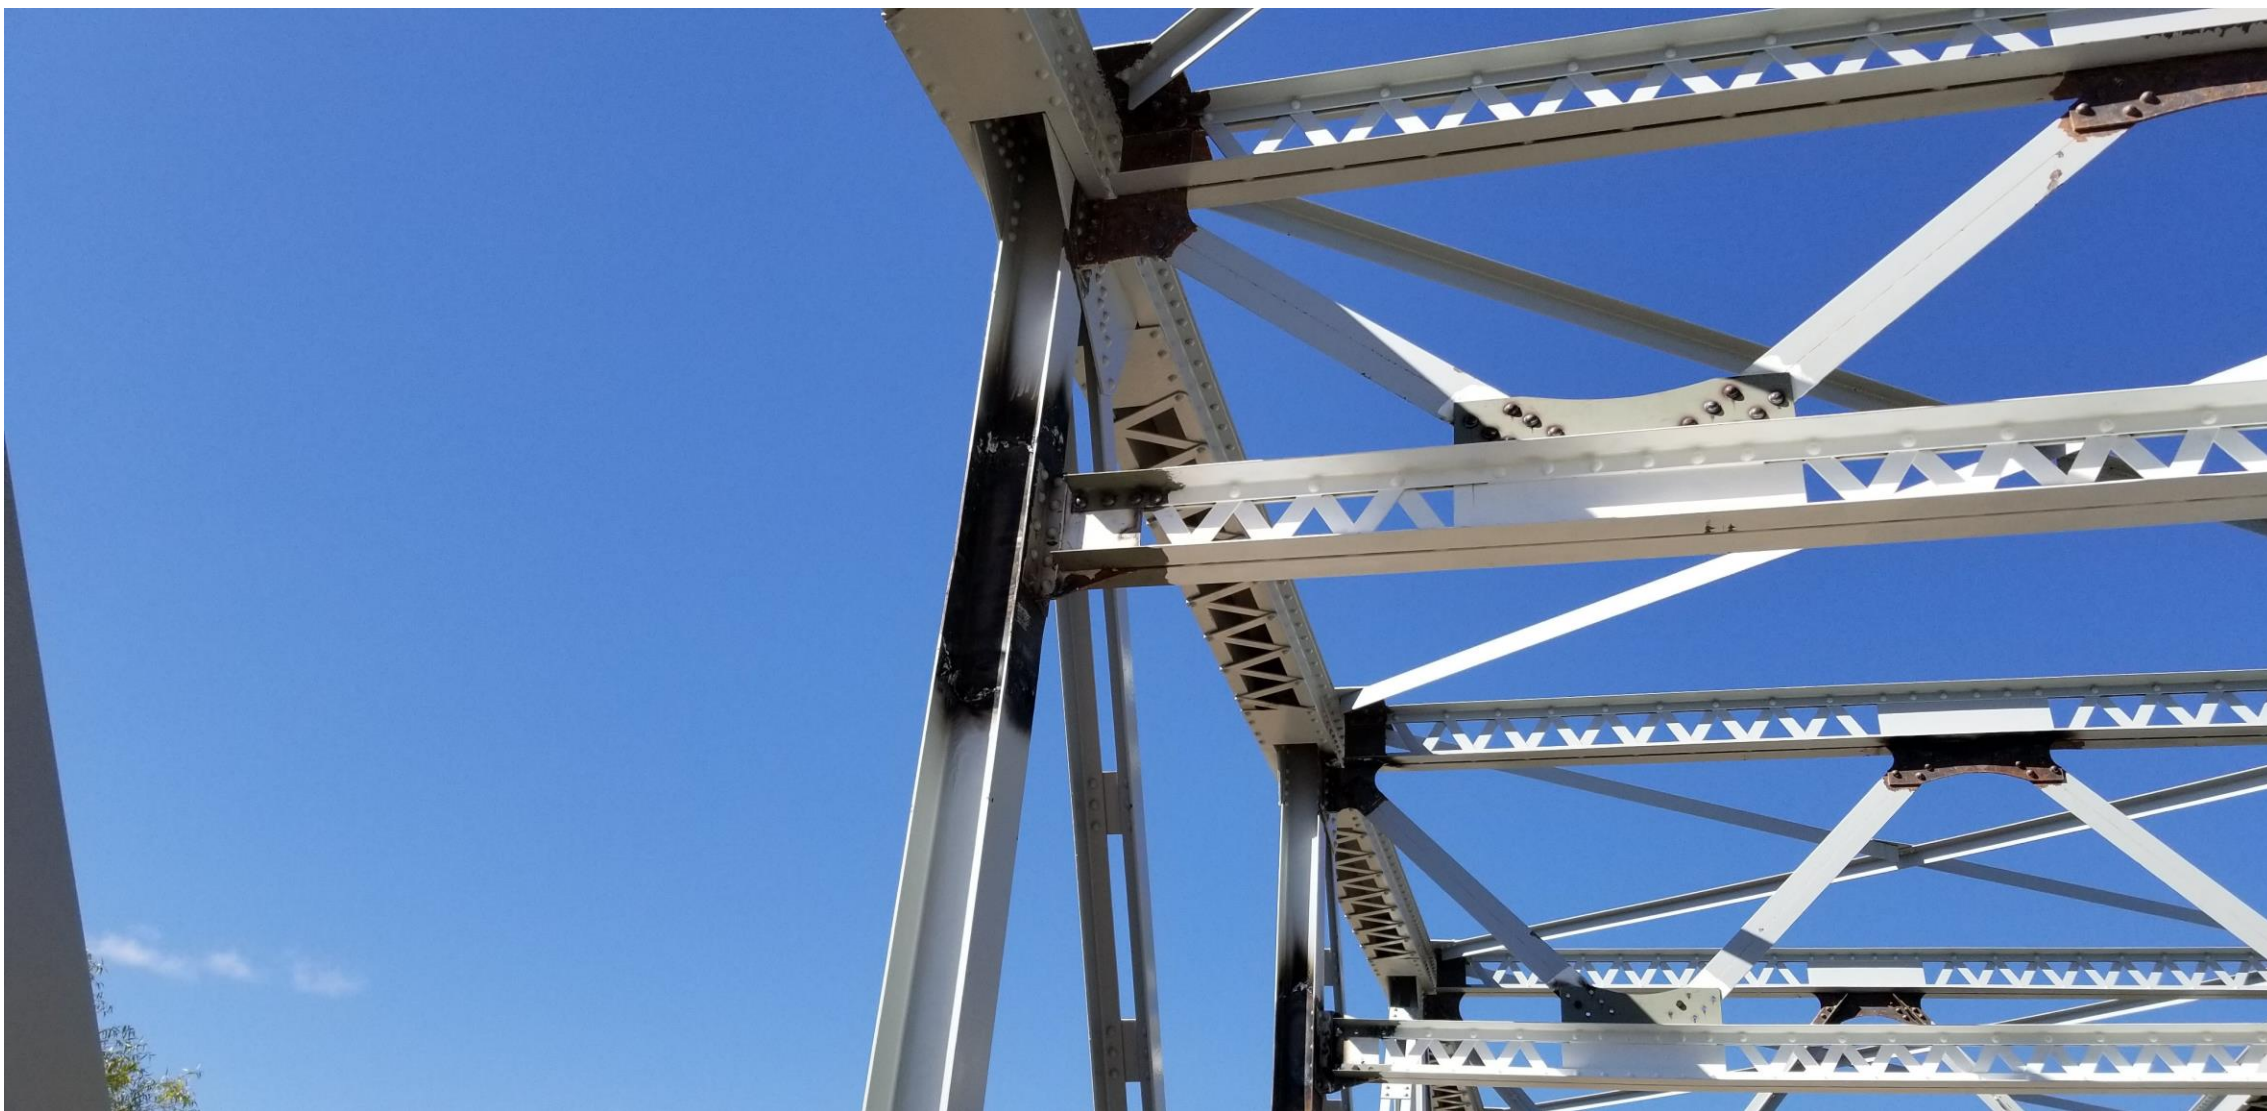
Field repair work.

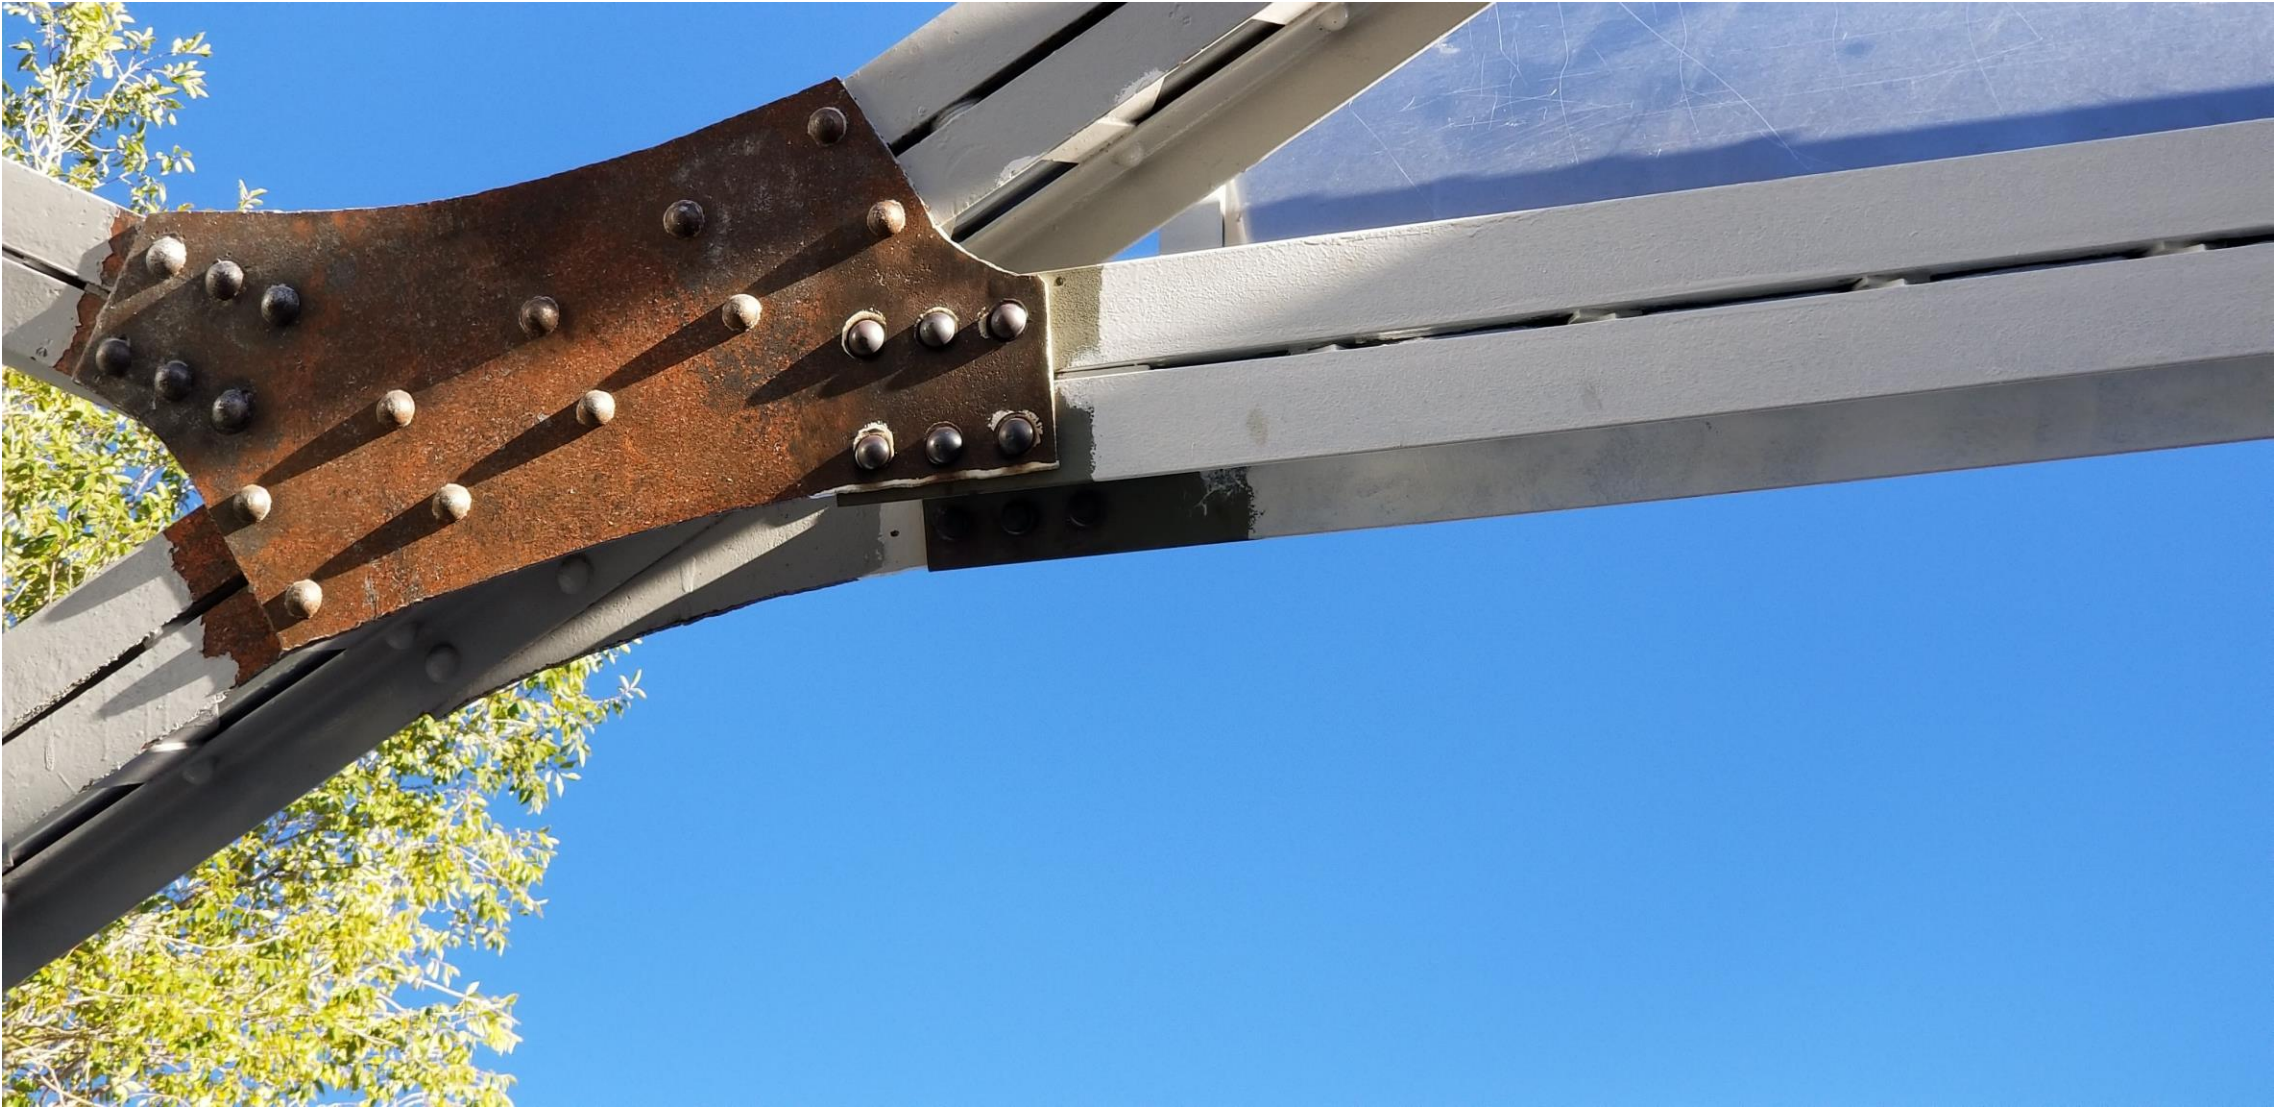
Field repair work.

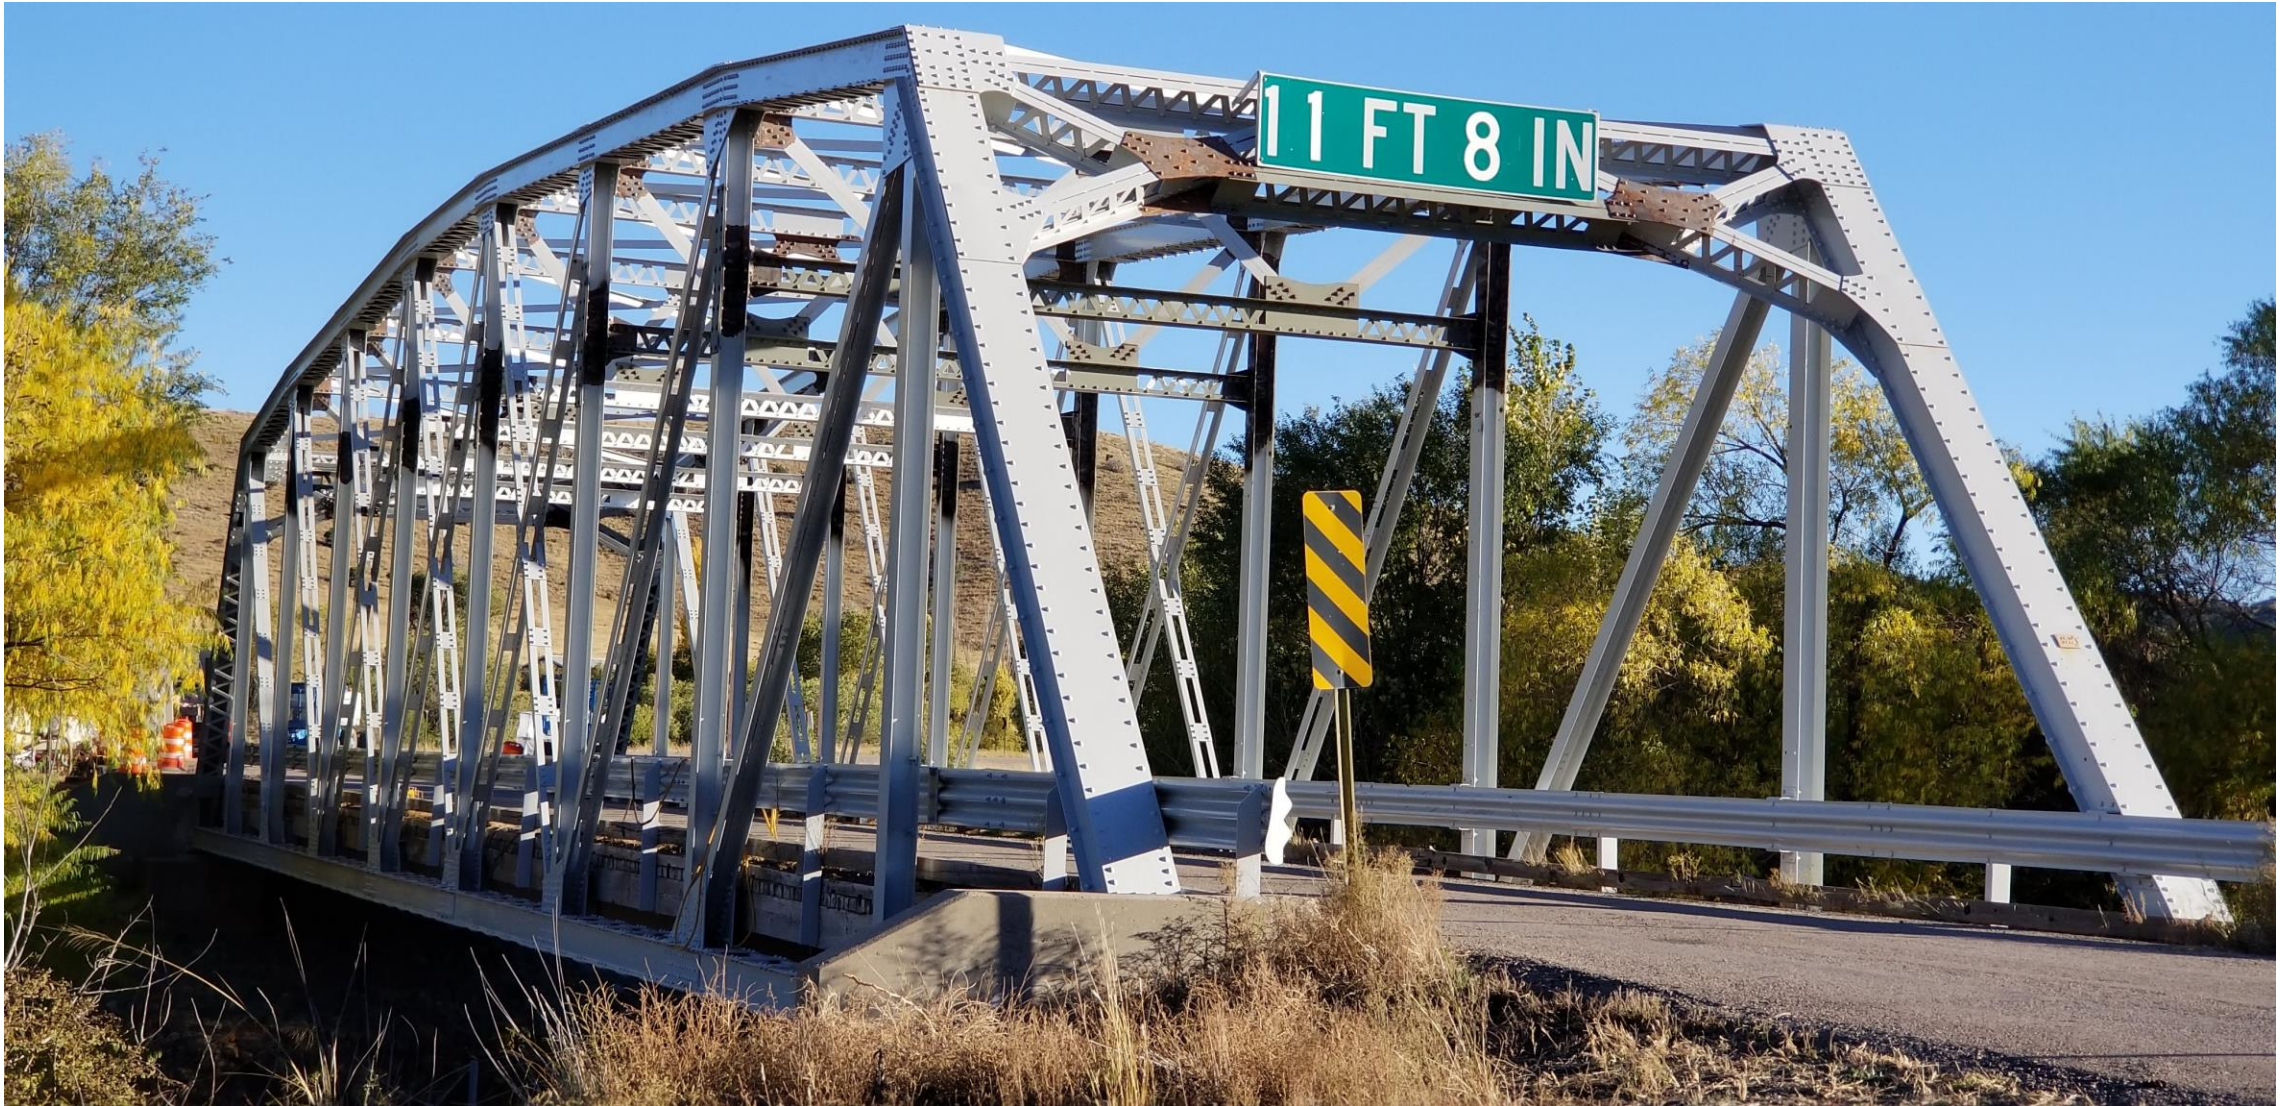
Field repair work.

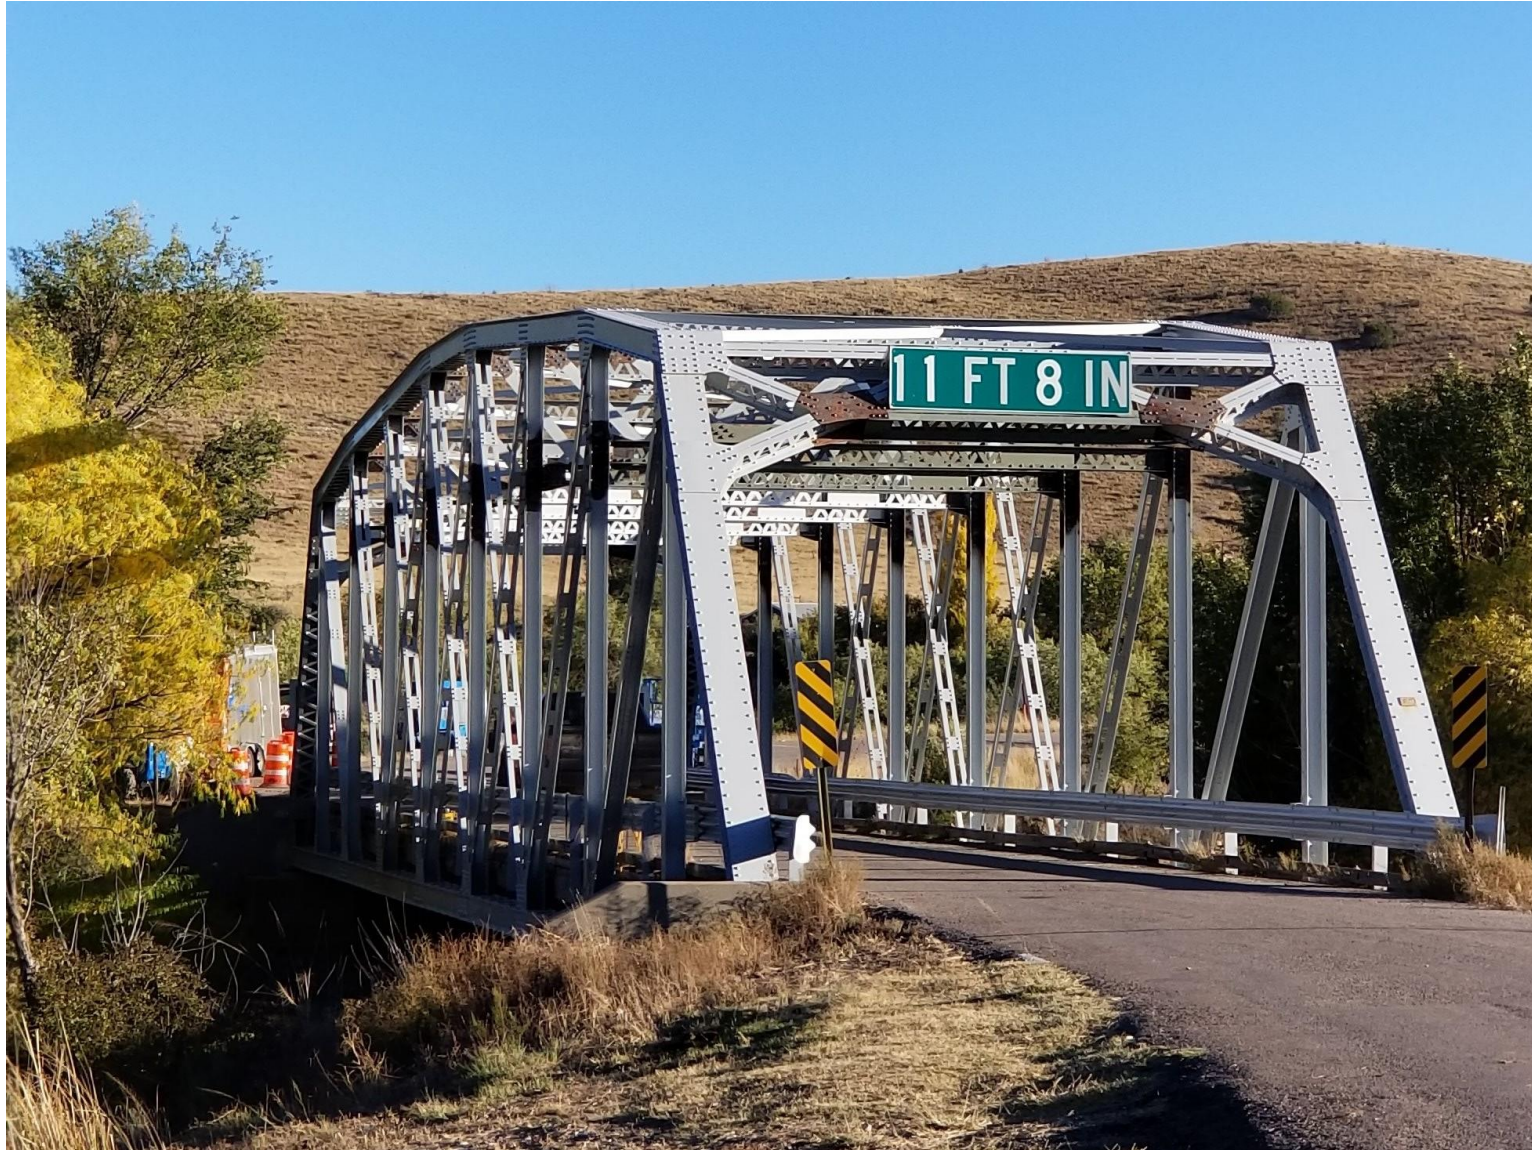
Field repair work.
