Nels Raynor, Craftsman

This is a story about a craftsman restoring a one hundred and four year old metal truss bridge. First, some background about the bridge. The multi-span State Street Bridge that spanned the Cass River in Bridgeport, Michigan, is in its final stages of restoration. No famous engineer designed this bridge. The bridge is a Pratt through truss, a common and popular truss design. Two large cast iron bridge plaques survive and are attached to the portals, the only ornamental fixtures connected to the bridge. A simple railing is made up of two four inch channels. The bridge was built by Joliet Bridge and Iron Company in 1906 and the mill stamps embossed on the steel sections show that Joliet Bridge and Iron purchased steel from the Cambria, Carnegie, and Jones and Laughlin mills to fabricate the bridge. What makes this bridge special is its place in time. In 1906 people and cargo were still traveling by horse and wagon, and only a few thousand cars were in use in the United States. In 1906 Henry Ford began production of his Model N car, and in October 1908 he began the production of his most famous car, the Model T, and would continue production until 1928, producin

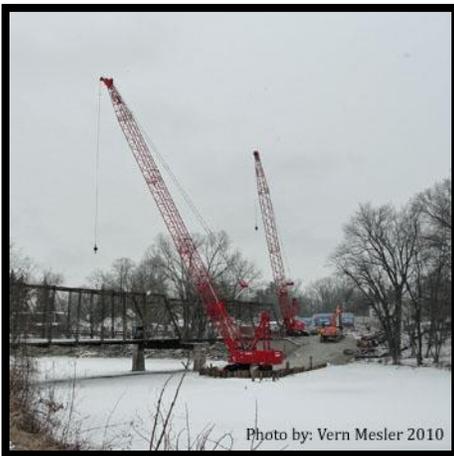
*State Street Bridge prepared for removal from its original abutments*

The State Street Bridge was removed from its abutments on January 13<sup>th</sup>, 2010, and placed in an empty lot within Bridgeport. On a cold January day Nels and his crew began dismantling the multi span bridge. As with any construction job, a multiple of unforeseen situations always present themselves, but Nels' focus was always on protecting the original material of the historic bridge. His experience with other restoration projects prepared him for the many challenges this restoration project would bring. One historic feature of a pin connected metal truss bridge is the bridge pin and recessed nuts, which are often replaced without replication and destroyed. The recessed nut is a historically significant feature of a historic metal truss bridge, and replacing it with a new standard threaded nut diminishes the overall historic appearance of the bridge and its historic record.

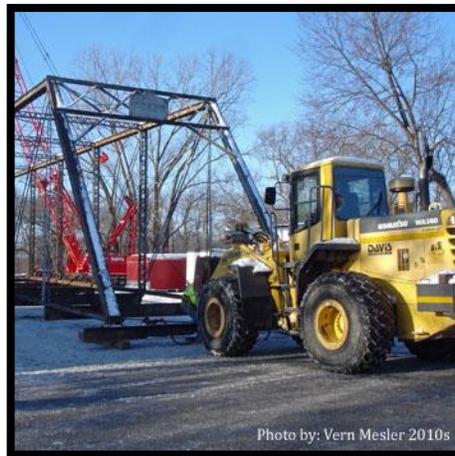
*A span of the State Street Bridge moved through Bridgeport to its restoration area.*

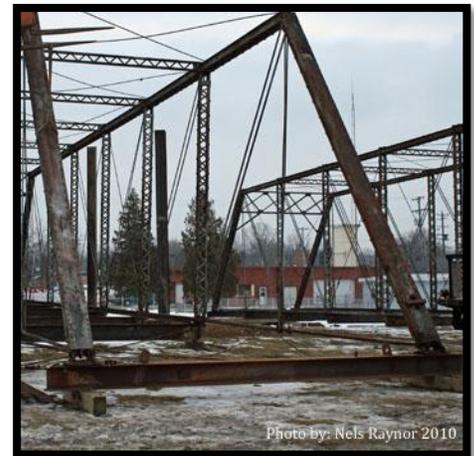
*Dismantling began in January in preparation for primer painting and restoration*

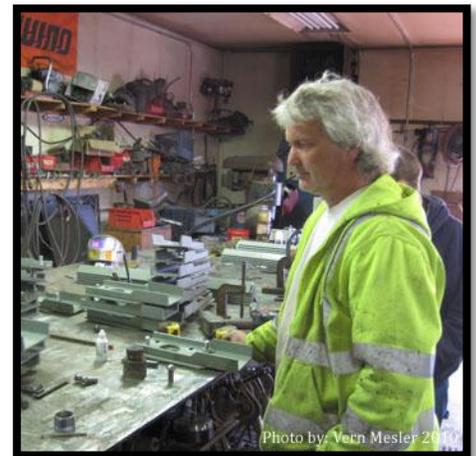
*Nels inspects new vertical splice sections for the State Street Bridge*

All of the vertical connections had to be replicated, from the bridge pin to the batten plate. Vertical end splices were fabricated to replicate the channel and the pin-hole connection reinforced riveted plate. To rivet the reinforcement plates, Nels modified a 100-ton C-frame web punch press he had acquired at an auction in Chicago to accommodate rivet dies he purchased for the job. Nels developed a procedure for punching, for riveting the replicated vertical pin connections and for arc welding full penetration welds to the original vertical channel to produce an accurate replication of the vertical connection. This replication procedure was repeated for the pin connected ends of the inclined end posts.

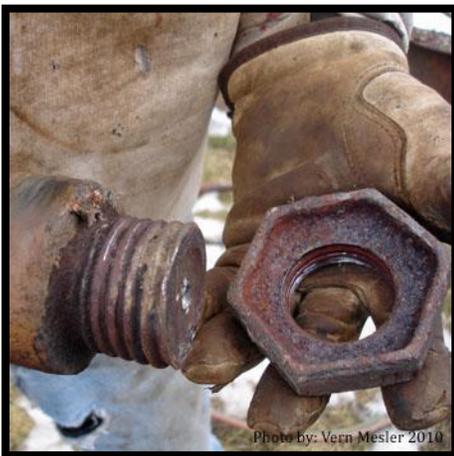
*Nels Raynor holds a bridge pin and recessed nut removed from the State Street Bridge*

An article from an 1897 Home Study Book I purchased some years ago from an antiques store titled "Why Recessed Nuts are Used for Chord Pins--Reason for Turning Down the Ends of the Chord Pins--The Use of Washers on Chord Pins" provided an answer for its unique design: "*due to variations in the widths of the members [as in a top chord member as shown in the Home Study drawing below], may be obviated by increasing the grip of the pin sufficiently to cover the variations and using washers. But washers for this purpose were found to be in some respects objectionable. They formed an additional item of expense in the manufacture of chord pins, were liable to get lost, and were inconvenient for the purposes of erection. This led to the idea of making the nut and washer in one piece. As a consequence, a patented recessed pin nut, made of wrought iron, pressed to the required form, appeared upon the market some years ago.*"

Nels Raynor was especially proud of removing all of the recessed nuts on the two span bridge without destroying them. Unfortunately, seven failed a non-destructive test (a failure that may be due to a possible manufacturing defect). However, the seven will be replicated to match the original, including the thread type, something rarely done on a restoration project.

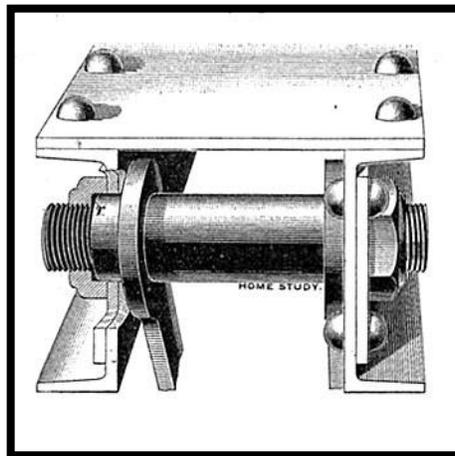
*Home Study drawing of a top chord member for a pin connected metal truss bridge*

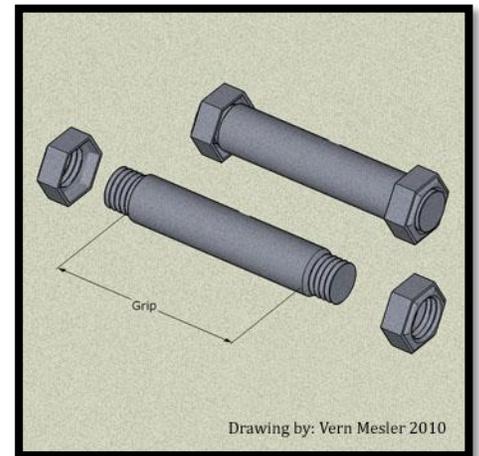
*The length of a grip is the unthreaded section of a bridge pin*

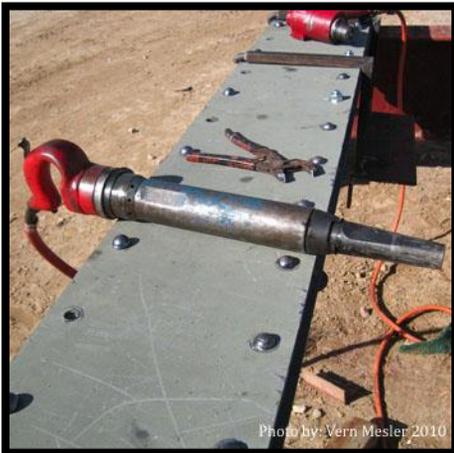
*#60 Boyer field rivet hammer  
on a riveted top chord cover plate*

Most of the rivets driven by Nels and his crew were in the new cover plates for the top chord and inclined end post channels. Nels used his #60 Boyer field rivet hammer for driving the rivets, along with a holder-on and bucking bar. He used a propane gas forge to heat the rivets.

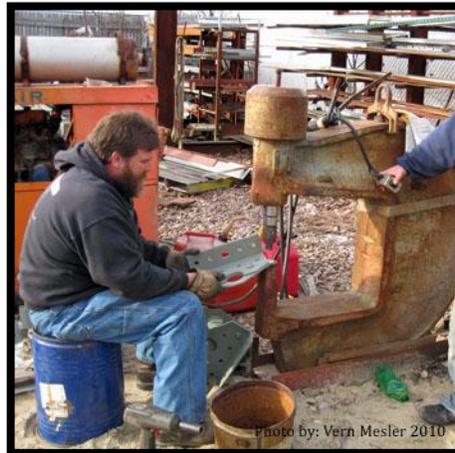
*Tom Platt "Kooter" rivets section of a  
bearing end pad with Nels' 100-ton  
C-frame hydraulic press*

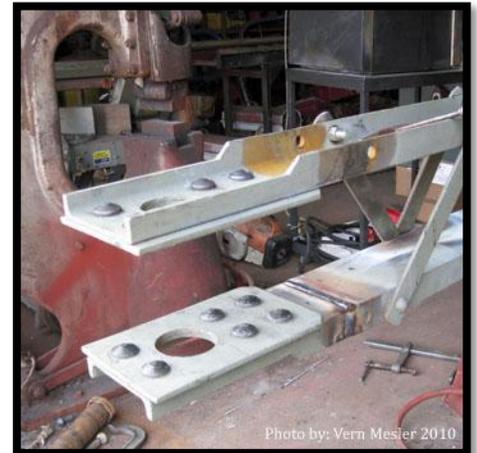
*Replicated vertical pin connections are  
arc welded with full penetration welds to  
the original vertical channel*
